| FH Reference:<br>125592 | Project : Berryhill Landslip Remedial Works | Date of Site Visit:<br>06/02/2020 |
| Prepared by:<br>Joshua Blacker<br>Engineering Geologist, Fairhurst | | Date:<br>06/02/2020 |

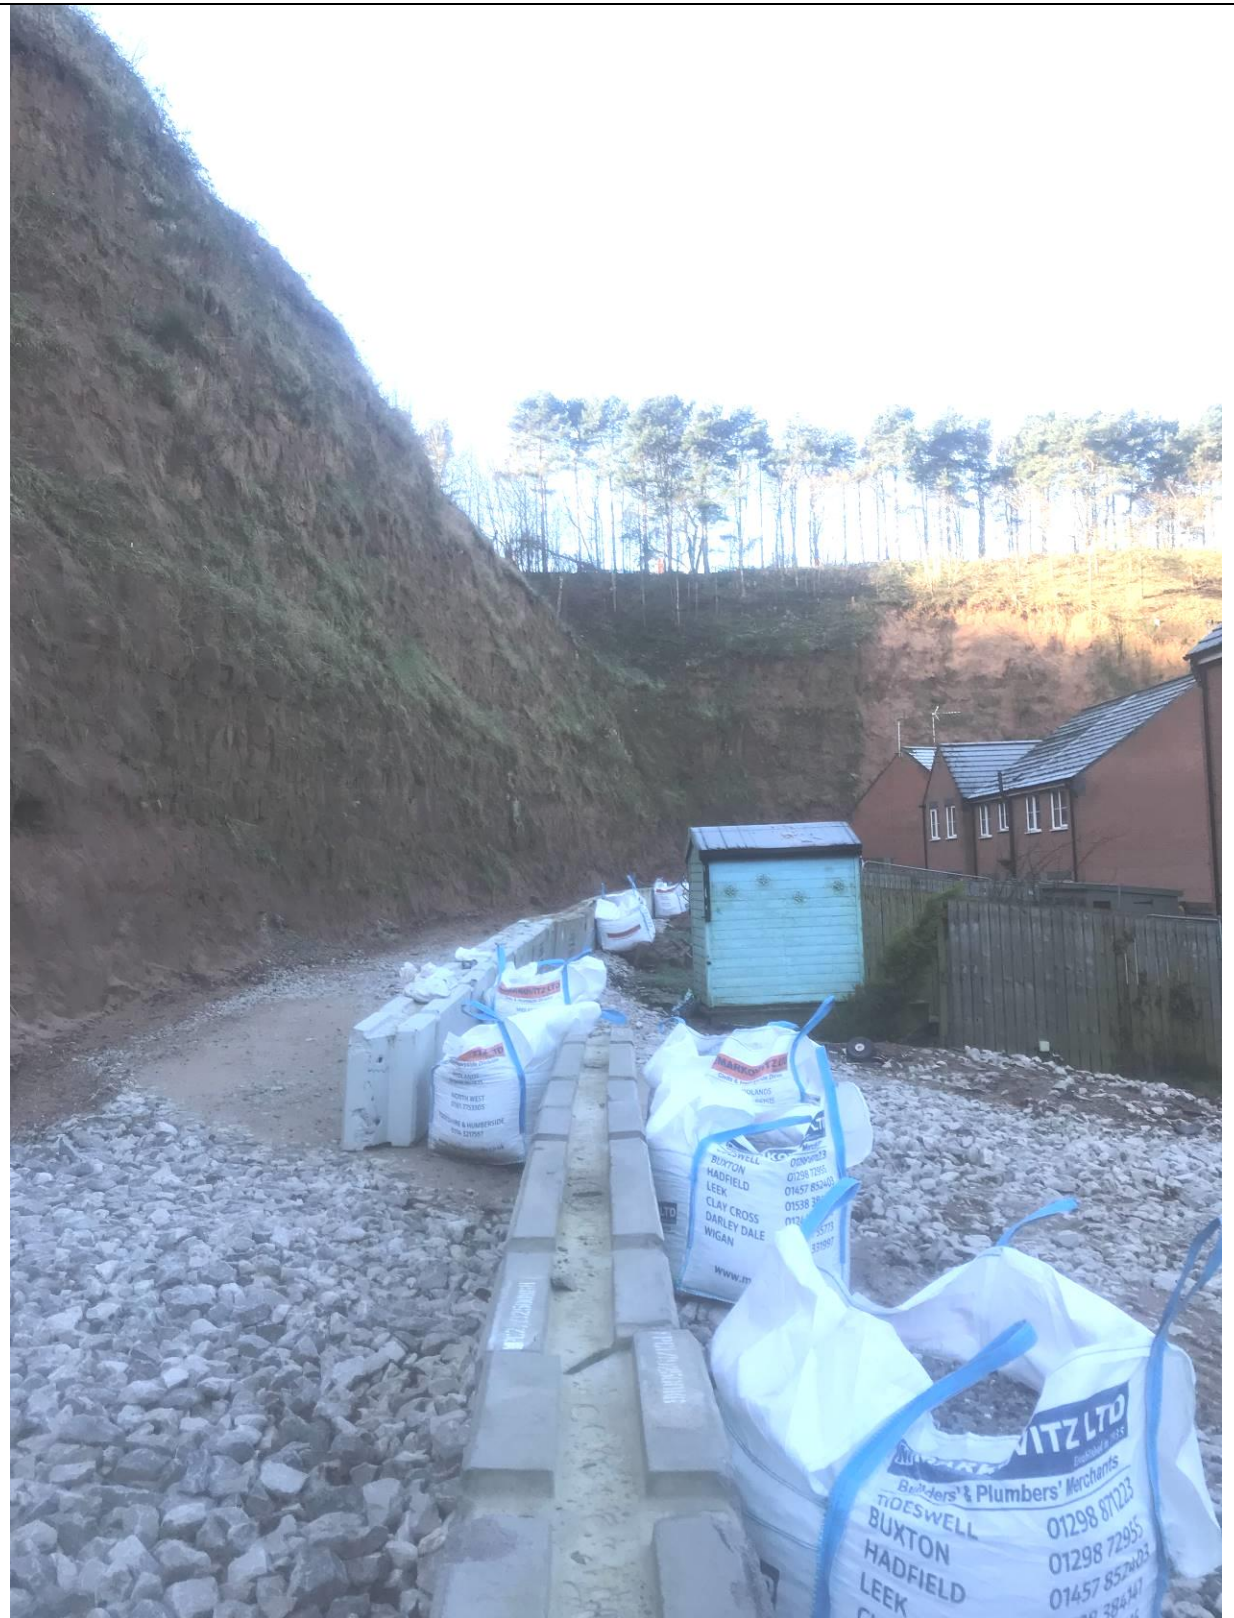
Photograph 1 : Looking along the southern flank of the quarry to the south west corner  
(Image taken on 06/02/2020)

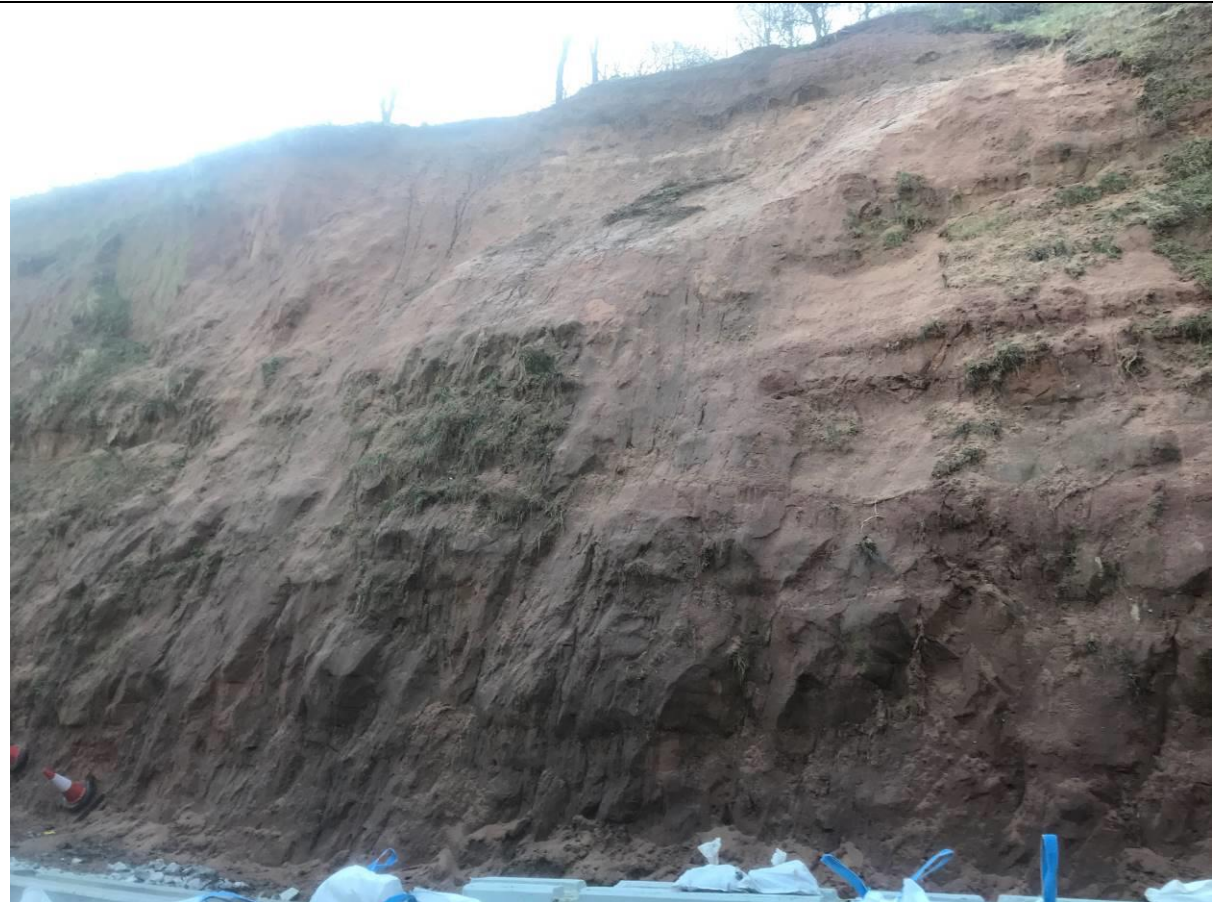
Photograph 2: Previous failure scar (Image taken on 06/02/2020)

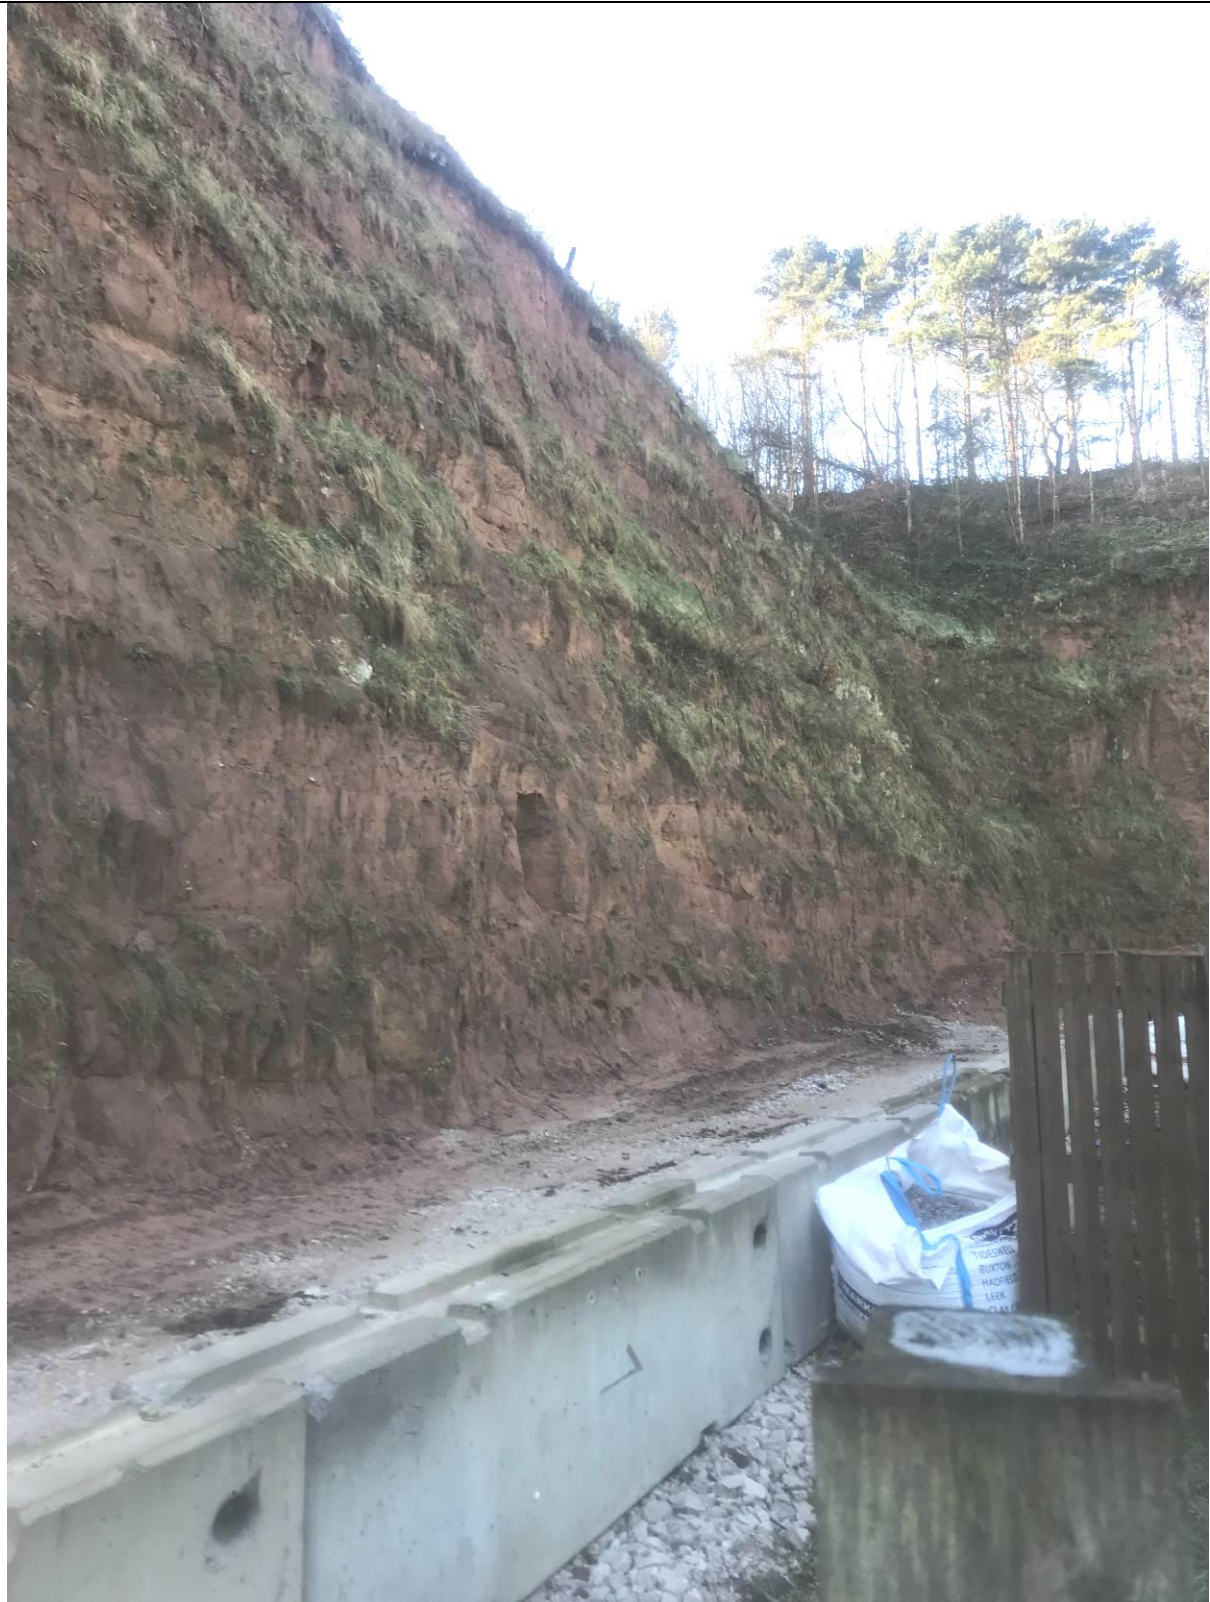
Photograph 3 : Looking west to the south west quarry corner (Image taken on 06/02/2020)

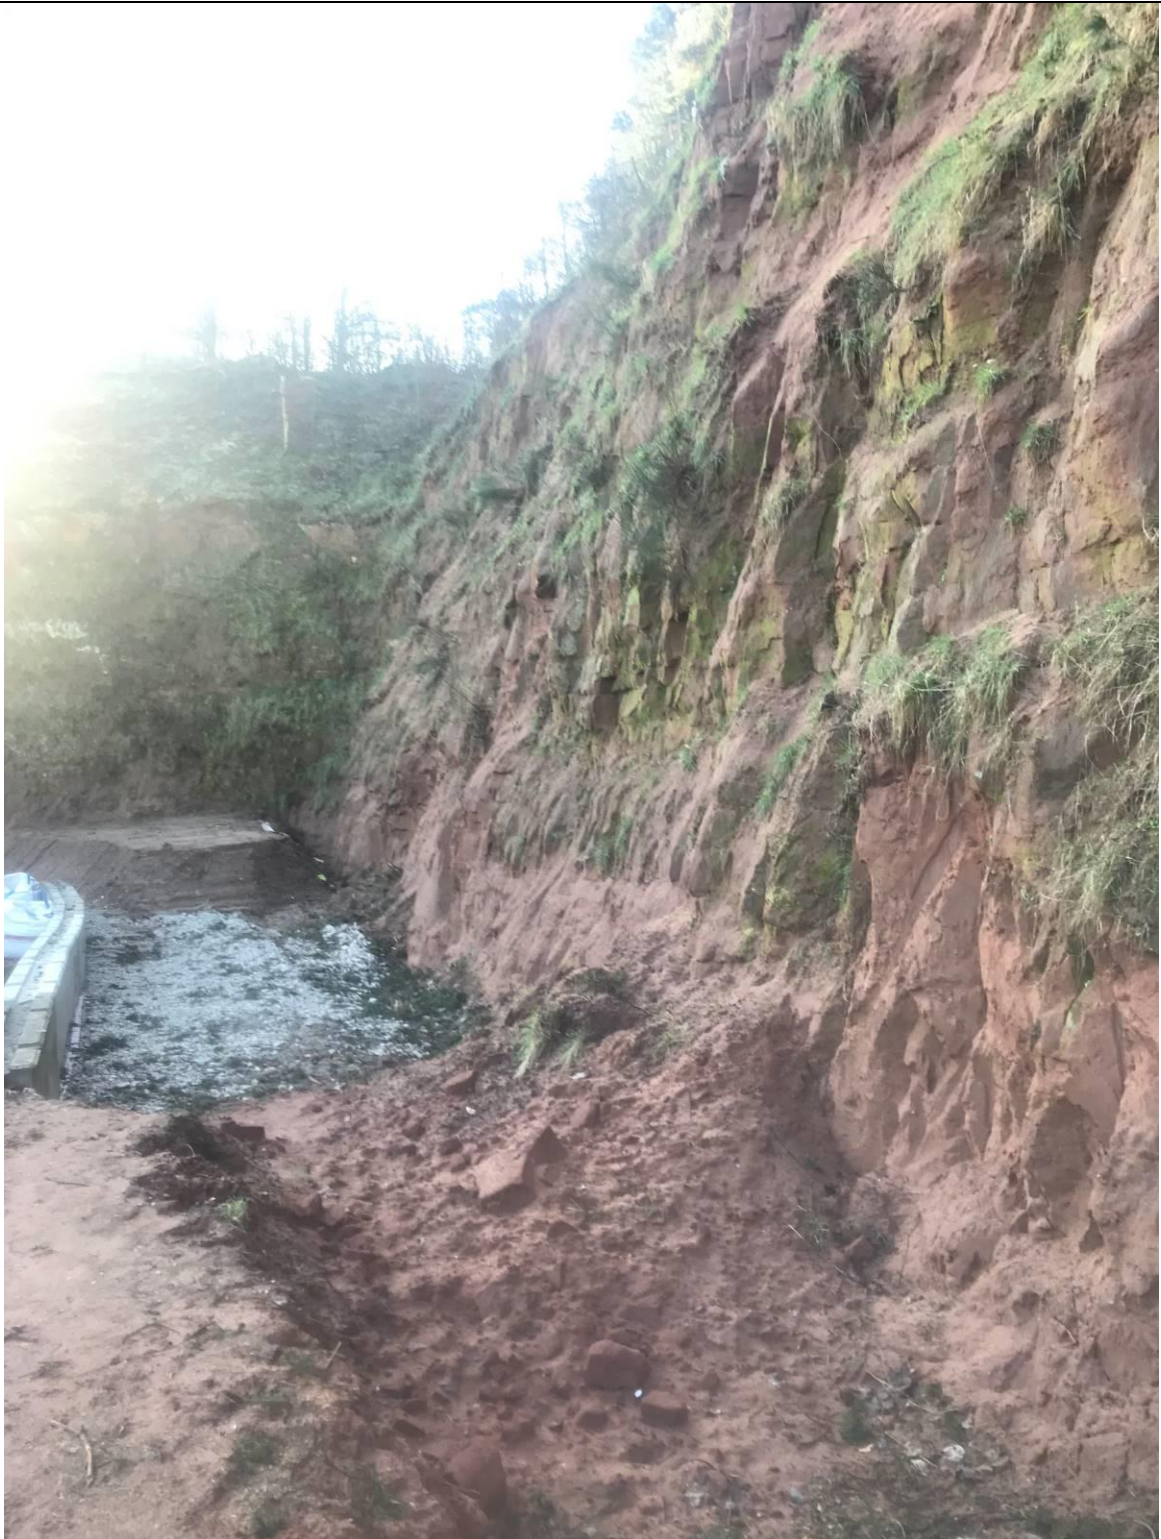
Photograph 4 : Looking at western flank and previous failure scar (Image taken on 06/02/2020)

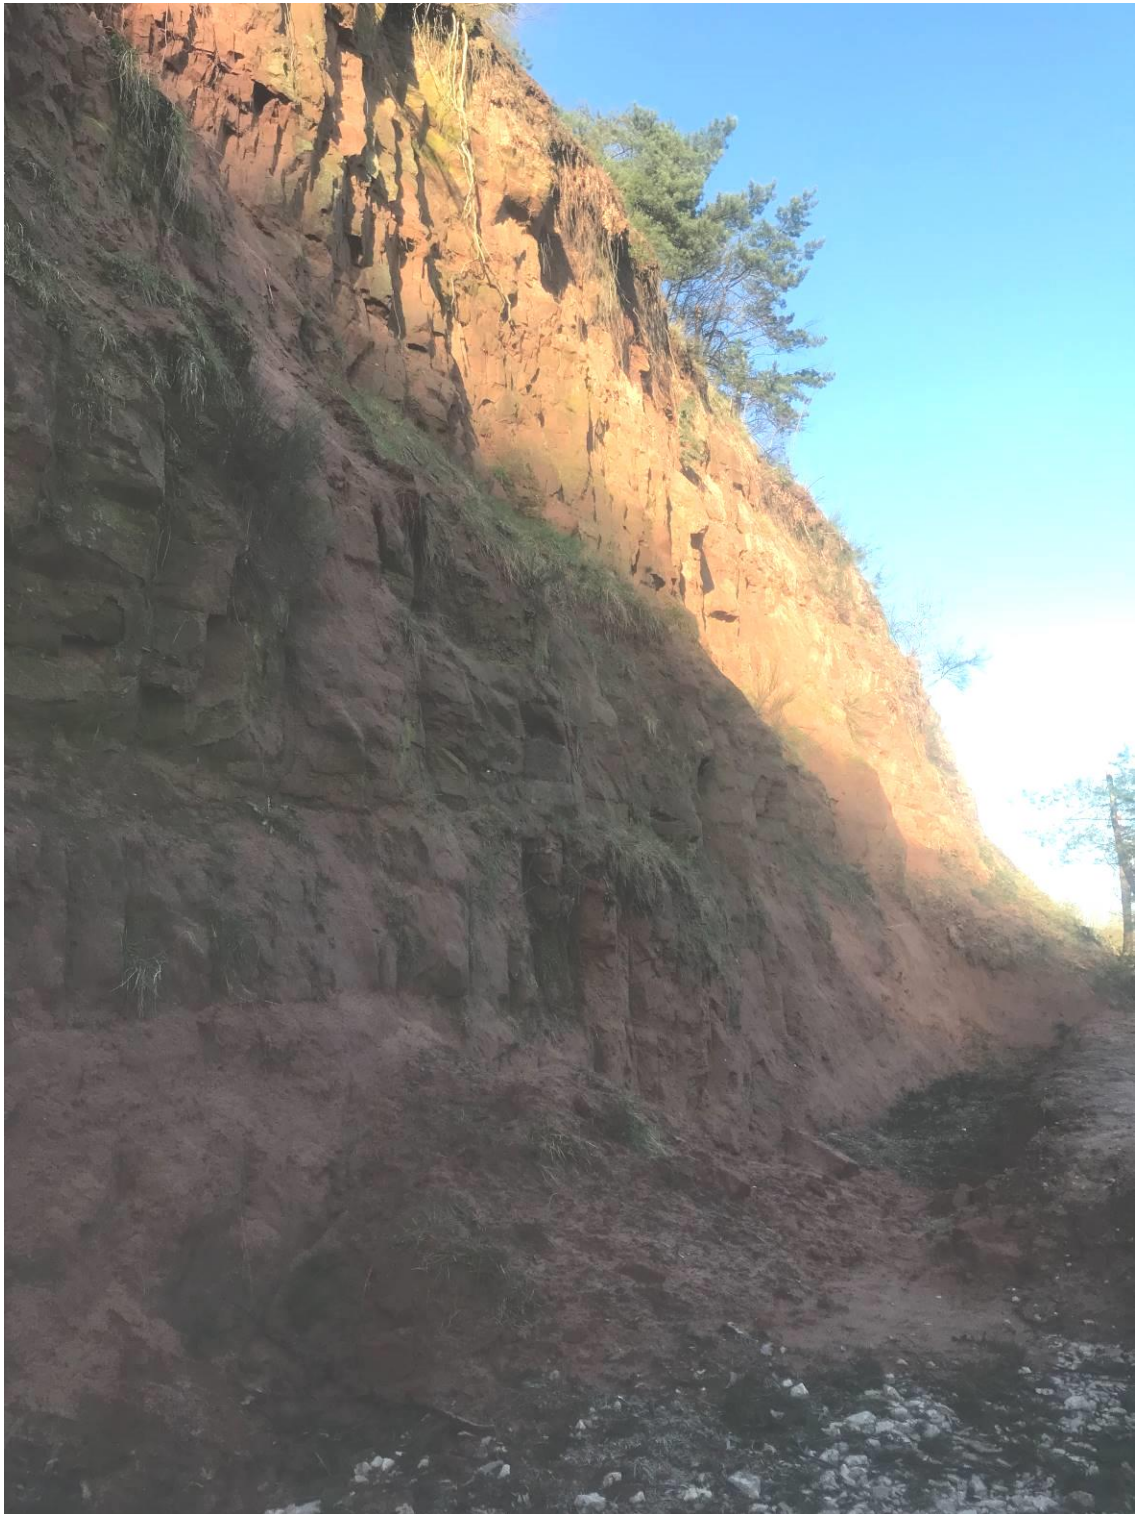
Photograph 5: Looking north to the end of Unit 8. Debris from small failure reported on the 24<sup>th</sup> November 2019. Note two grass clumps, approx. 30cm<sup>2</sup> on top of the previous small failure (Image taken on 06/02/2020).
