## **SITE INSPECTION - RESIDENTS MEMO**

FH Reference: 125592	Project : Berryhill Landslip Remedial Works	Date of Site Visit: 03/01/2020
inspections of the quarry November 2019) and the in early 2020.	ncil (MDC) have appointed Fairhurst to wall between completion of the emergency recommencement of the permanent works in on Friday 3 <sup>rd</sup> of January 2019, the weather	esponse works (w/e 24 <sup>th</sup> this portion of the quarry
A photographic record of the quarry has been collated and is being updated on inspection and no obvious visible changes have been noted from the previous site visit (23/12/2019). No further noticeable debris was noted in the rock trap at the toe of the slope. Fairhurst are not aware of any reported issues to MDC and the garden heras fencing remained in situ as agreed. No increase in risk has been determined from the recent inspection.		
If residents see or hear anything associated with the cliff face, please call 01623 463 050 to report this to the Council.

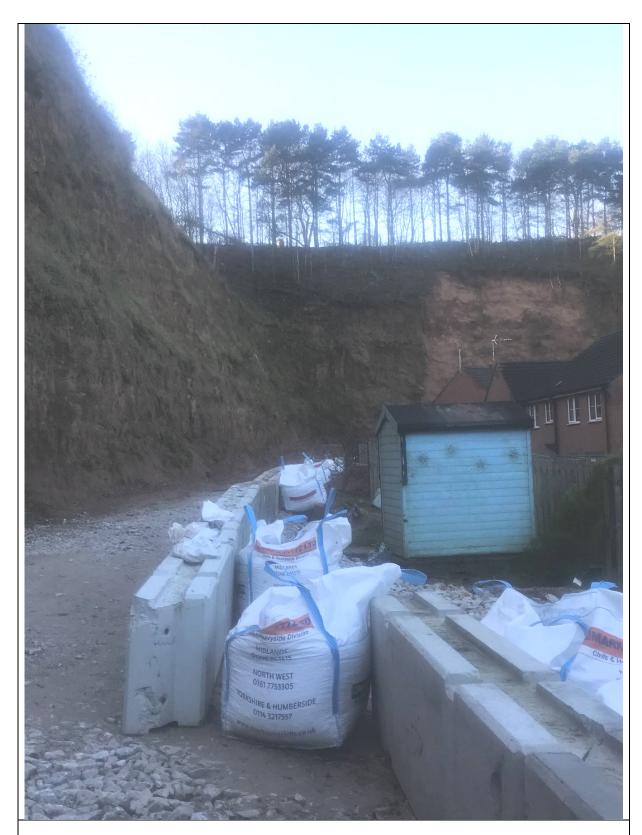
Photograph 1 : Looking along the southern flank of the quarry to the south west corner (Image taken on 03/01/2020)

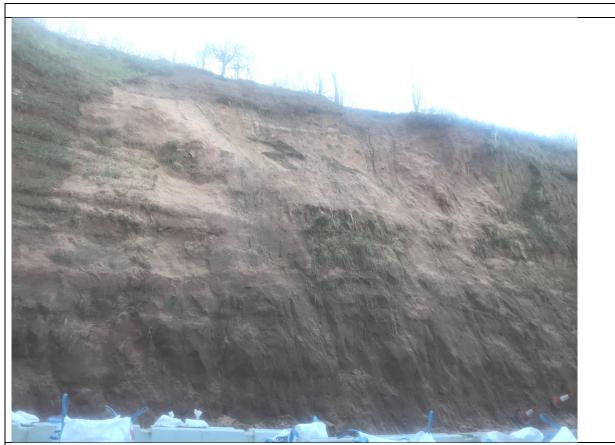
Photograph 2: Previous failure scar (Image taken on 03/01/2020)

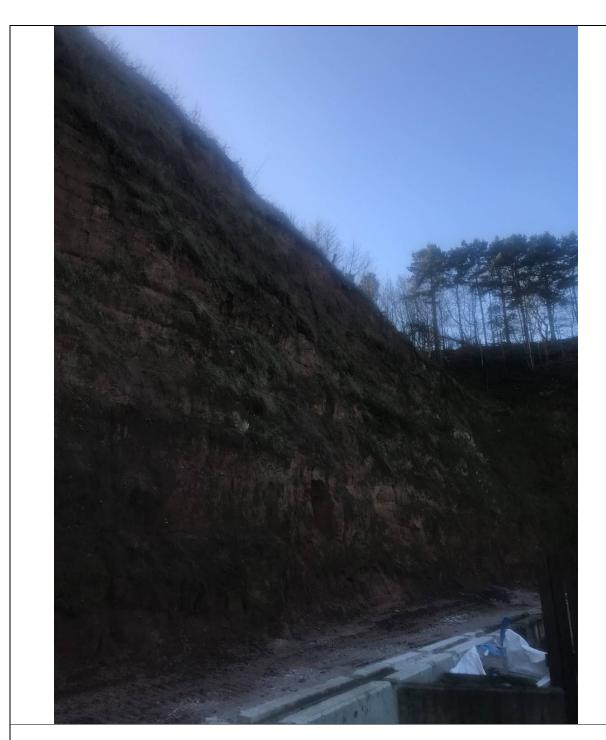
Photograph 3: Looking west to the south west quarry corner (Image taken on 03/01/2020)

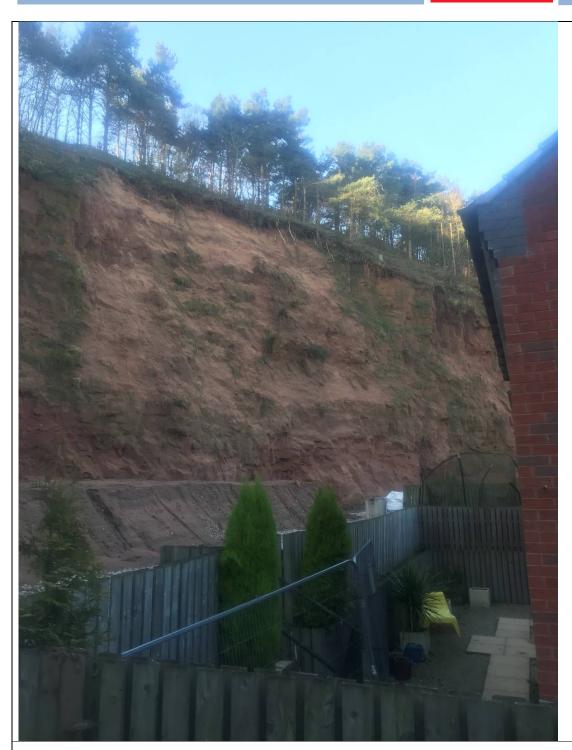
Photograph 4: Looking at western flank and previous failure scar (Image taken on 03/01/2020)

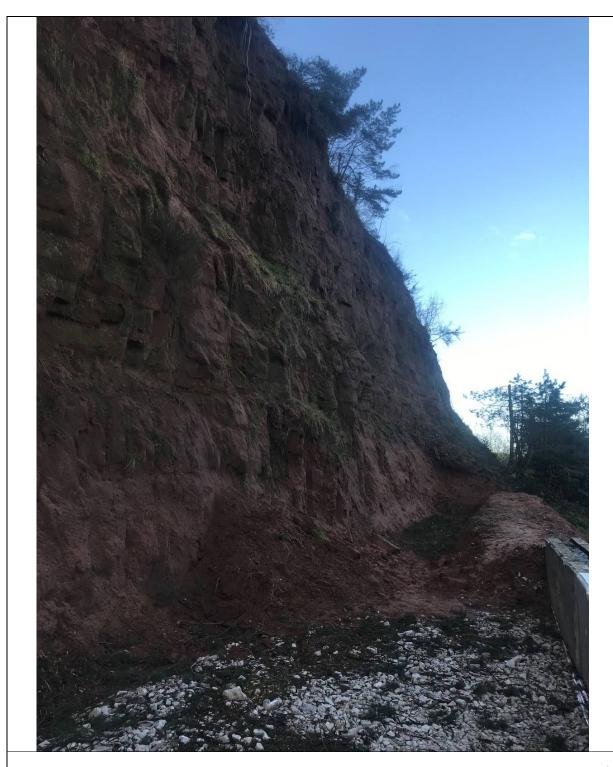
Photograph 5: Looking north to the end of Unit 8. Debris from small failure reported on the  $24^{th}$  November 2019. Note two grass clumps, approx.  $30 \text{cm}^2$  on top of the previous small failure (Image taken on 03/01/2020).
