FH Reference: 125592	Project : Berryhill Landslip Remedial Works	Date of Site Visit: 20/01/2020
<p>Mansfield District Council (MDC) have appointed Fairhurst to undertake regular site inspections of the quarry wall between completion of the emergency response works (w/e 24<sup>th</sup> November 2019) and the commencement of the permanent works in this portion of the quarry in early 2020.</p> <p>During a recent inspection on Friday 20<sup>th</sup> of January 2020, the weather was overcast with sunny spells. Heavy rain and strong winds are understood to have occurred earlier in the week across the region.</p> <p>A photographic record of the quarry has been collated and is being updated on inspection and no major visible changes have been noted from the previous site visit (13/01/2020). Only fine washout, small pieces rock and grass clump fall ranging from &lt;1-30cm<sup>3</sup> were noticeable in the rock trap at the toe of the slope. Fairhurst are not aware of any reported issues to MDC and the garden heras fencing remained in situ as agreed. No increase in risk has been determined from the recent inspection.</p> <p>If residents see or hear anything associated with the cliff face, pl

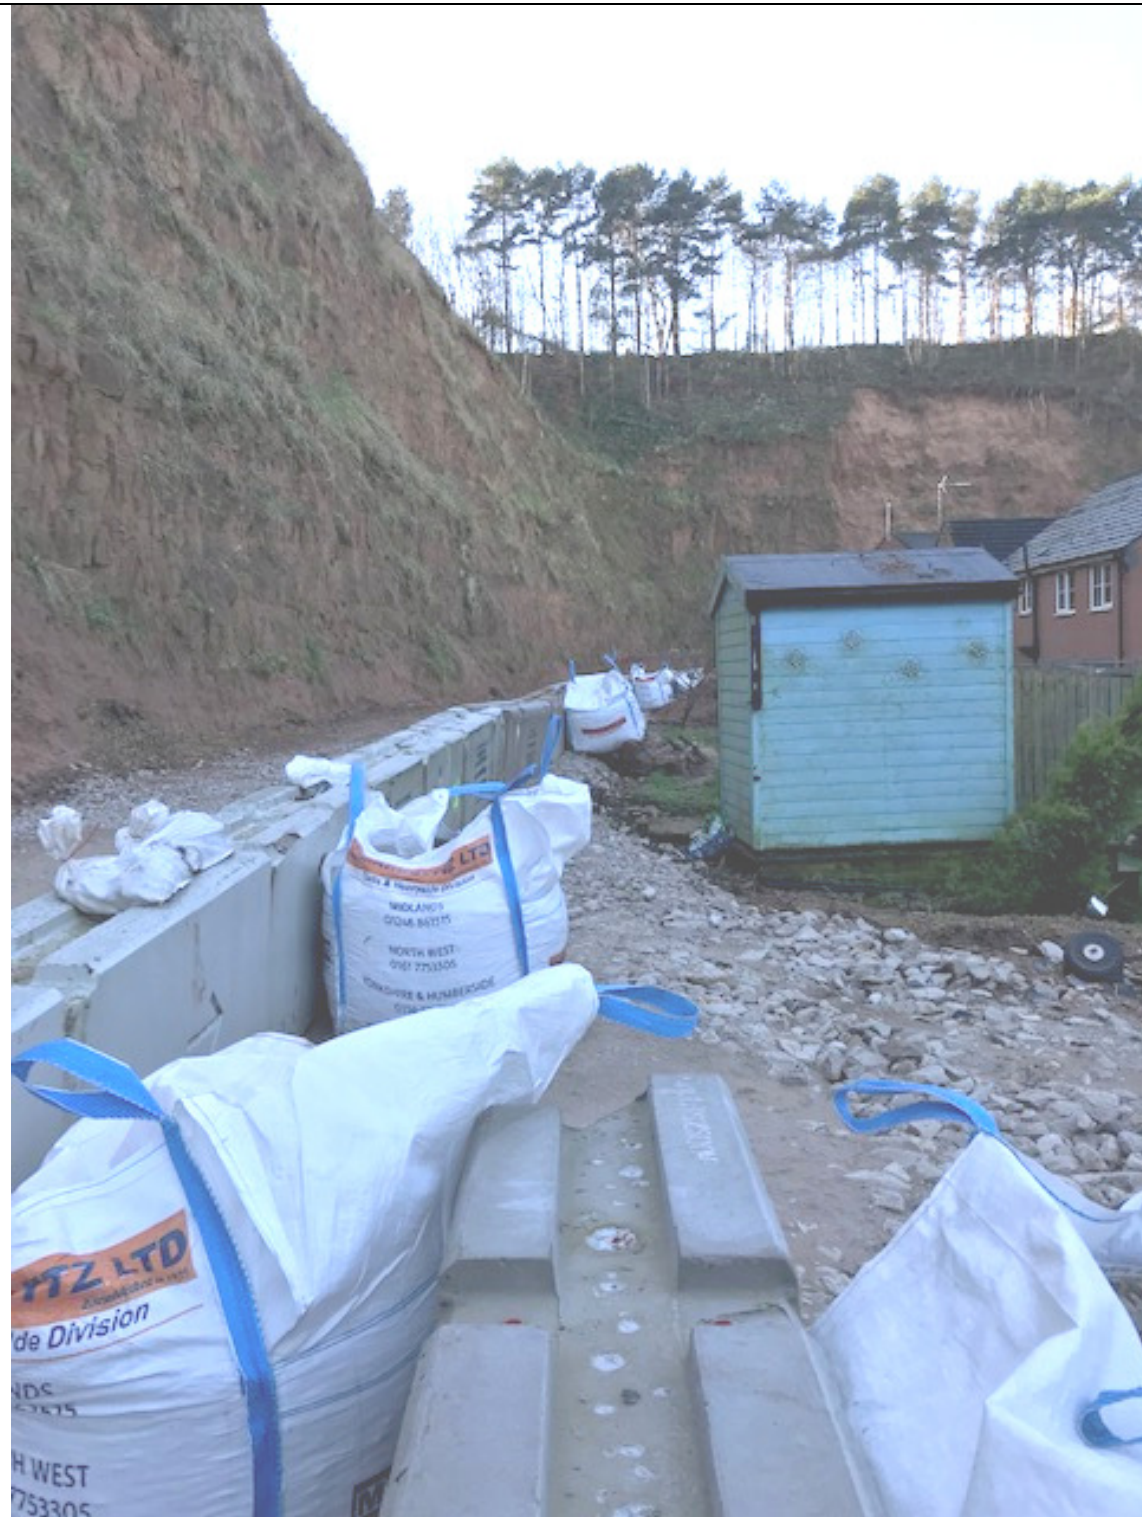
Photograph 1 : Looking along the southern flank of the quarry to the south west corner (Image taken on 20/01/2020)

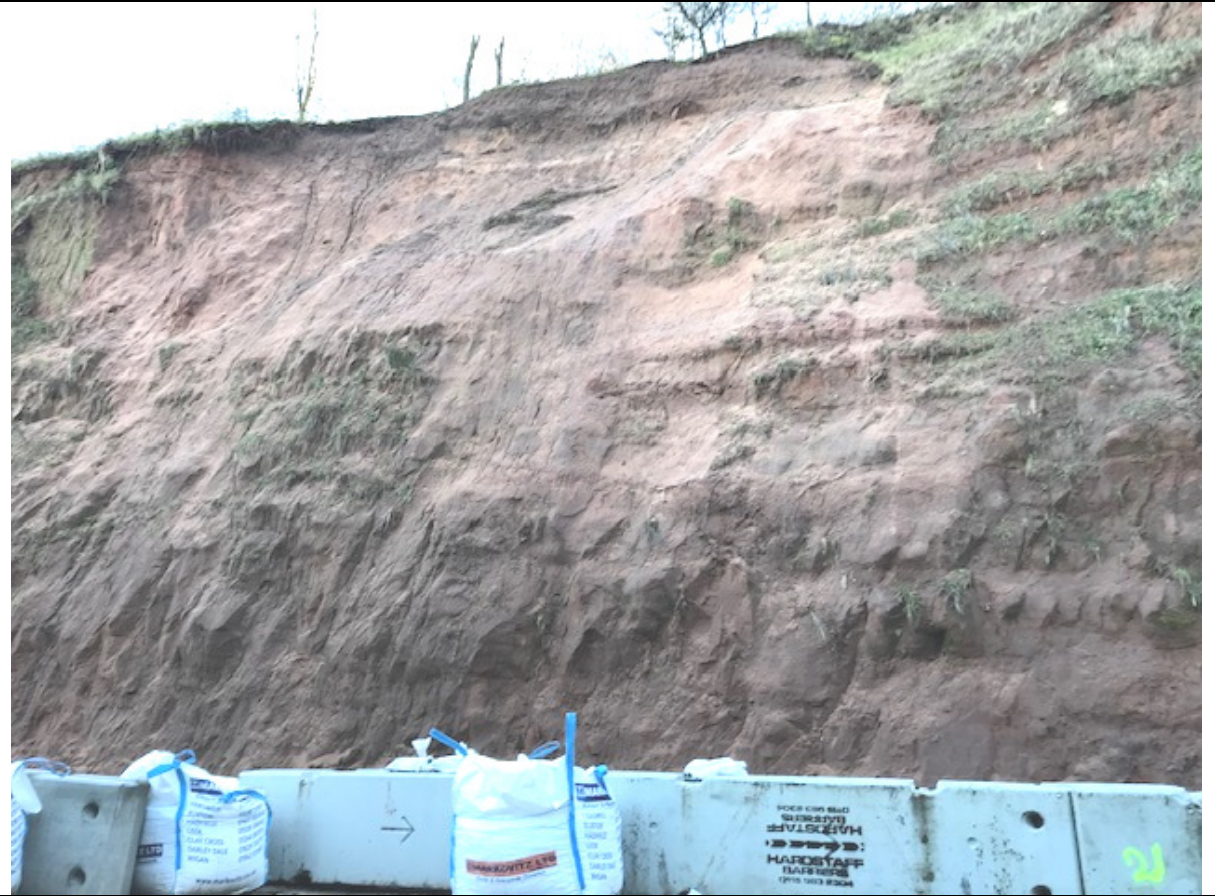
Photograph 2: Previous failure scar within the middle of Unit 9 (Image taken on 20/01/2020)

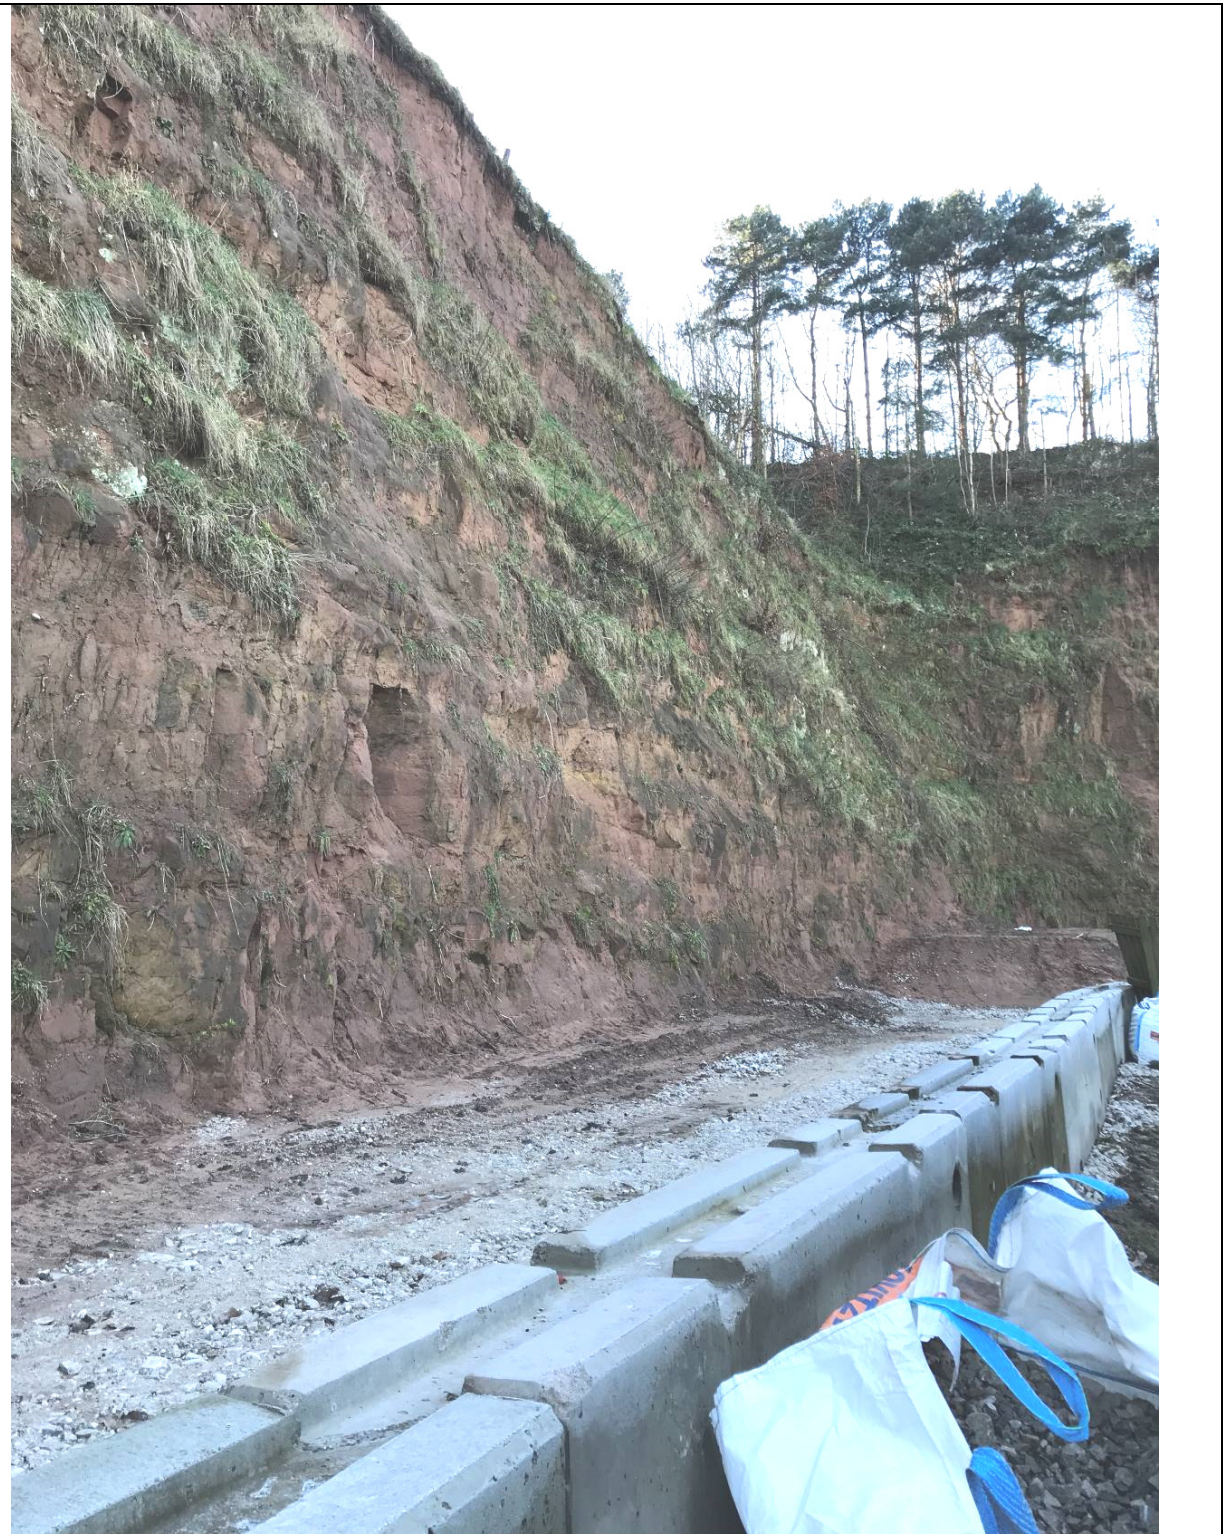
Photograph 3 : Looking west to the south west quarry corner (Image taken on 20/01/2020)

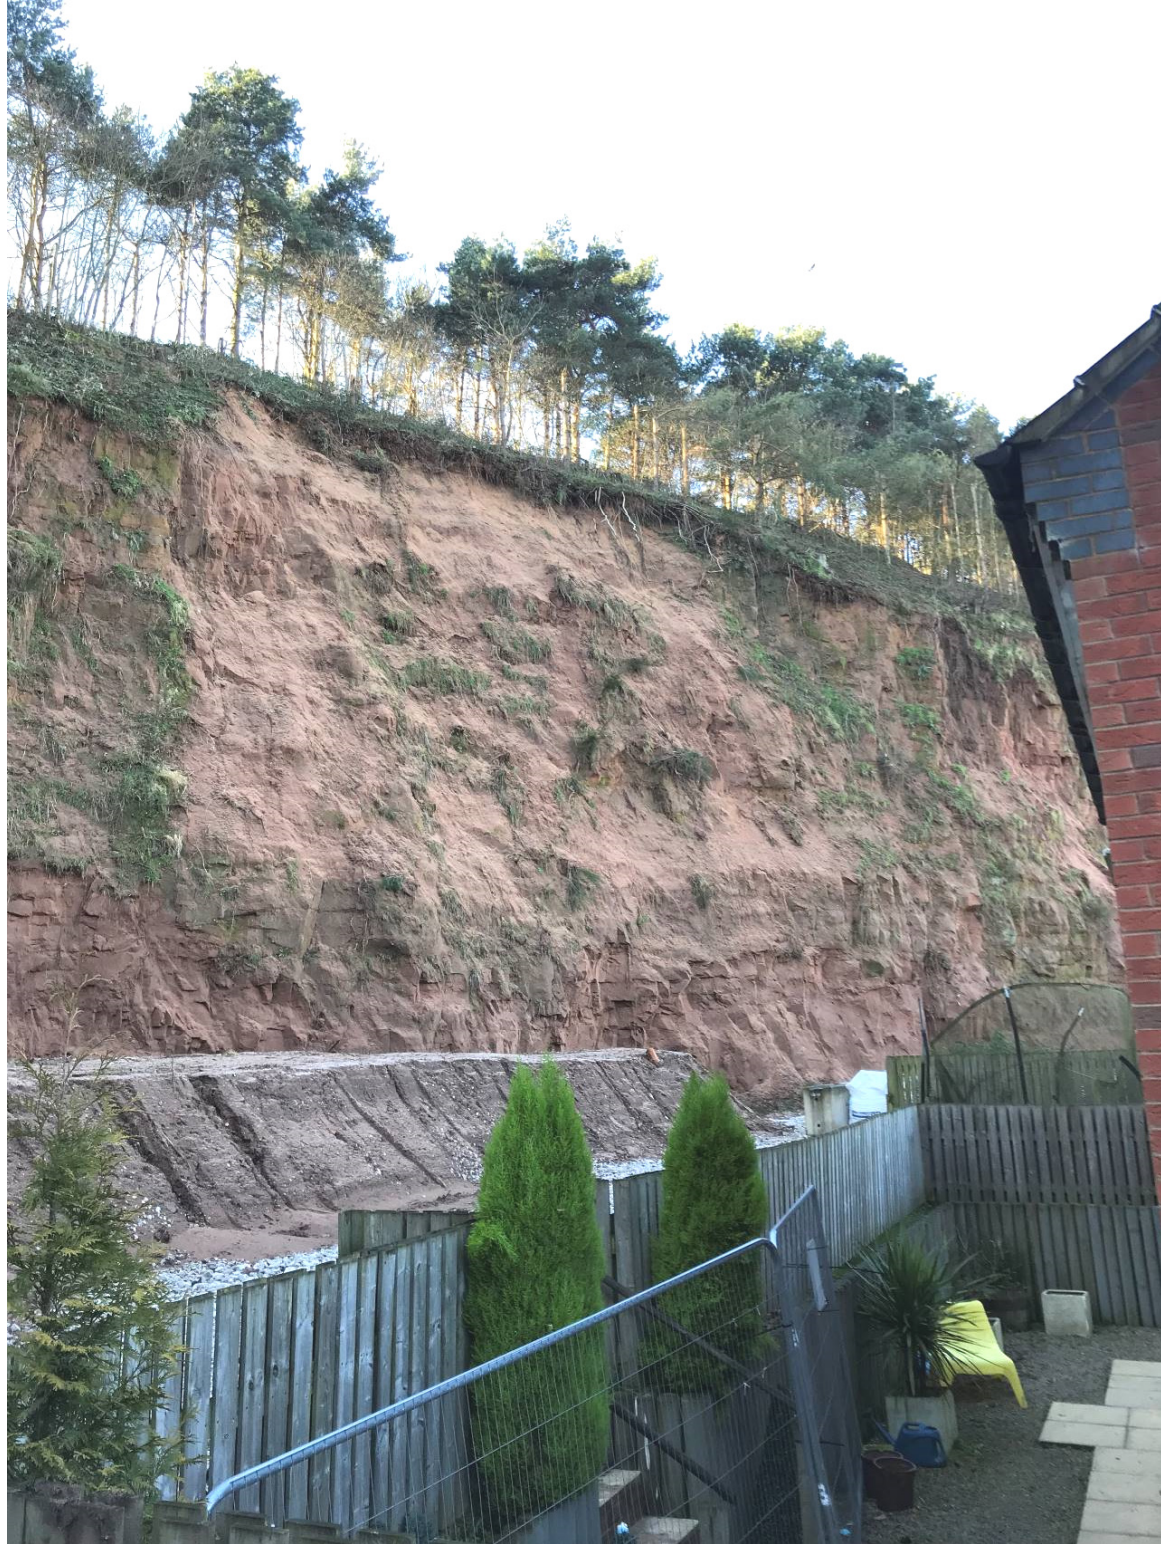
Photograph 4 : Looking at western flank and previous failure scar (Image taken on 20/01/2020)

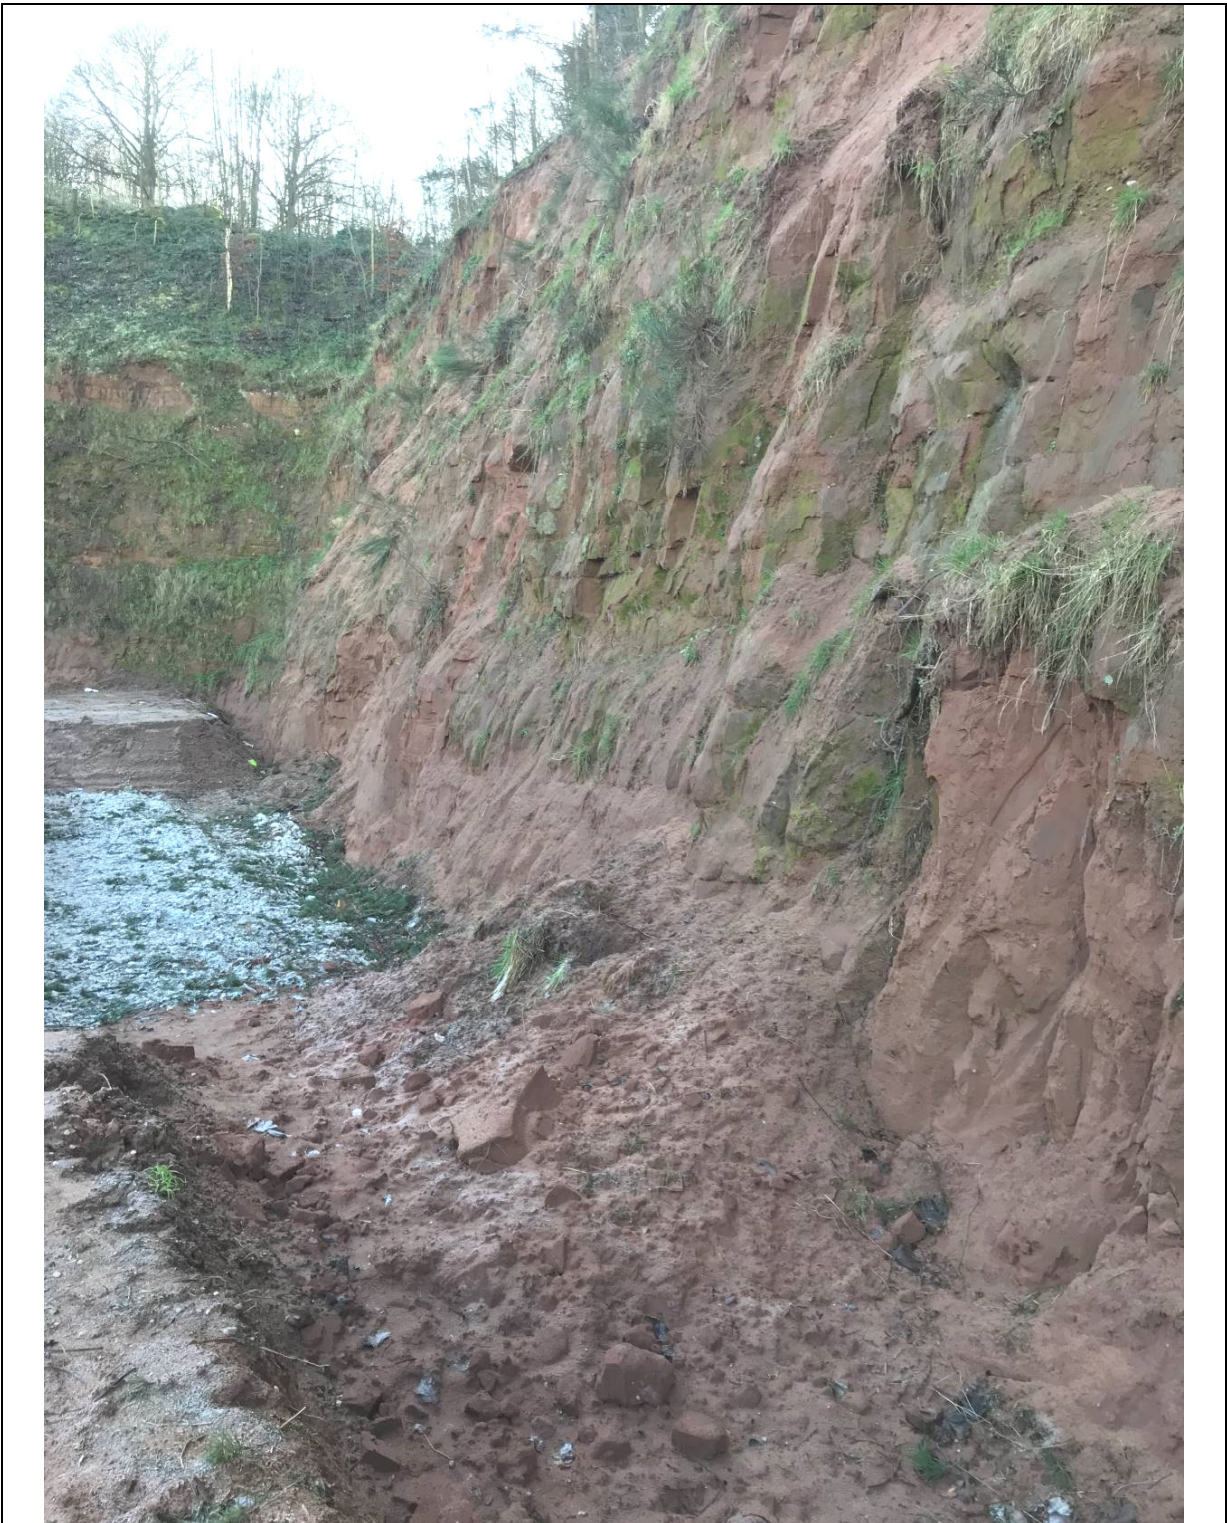
Photograph 5: Looking to the south, towards the south west corner from the end of Unit 8 at the debris cone and scar from the small failure reported on the 24th November 2019, which is gradually accumulating more debris from rock face fine washout and spalling. (Image taken on 20/01/2020).

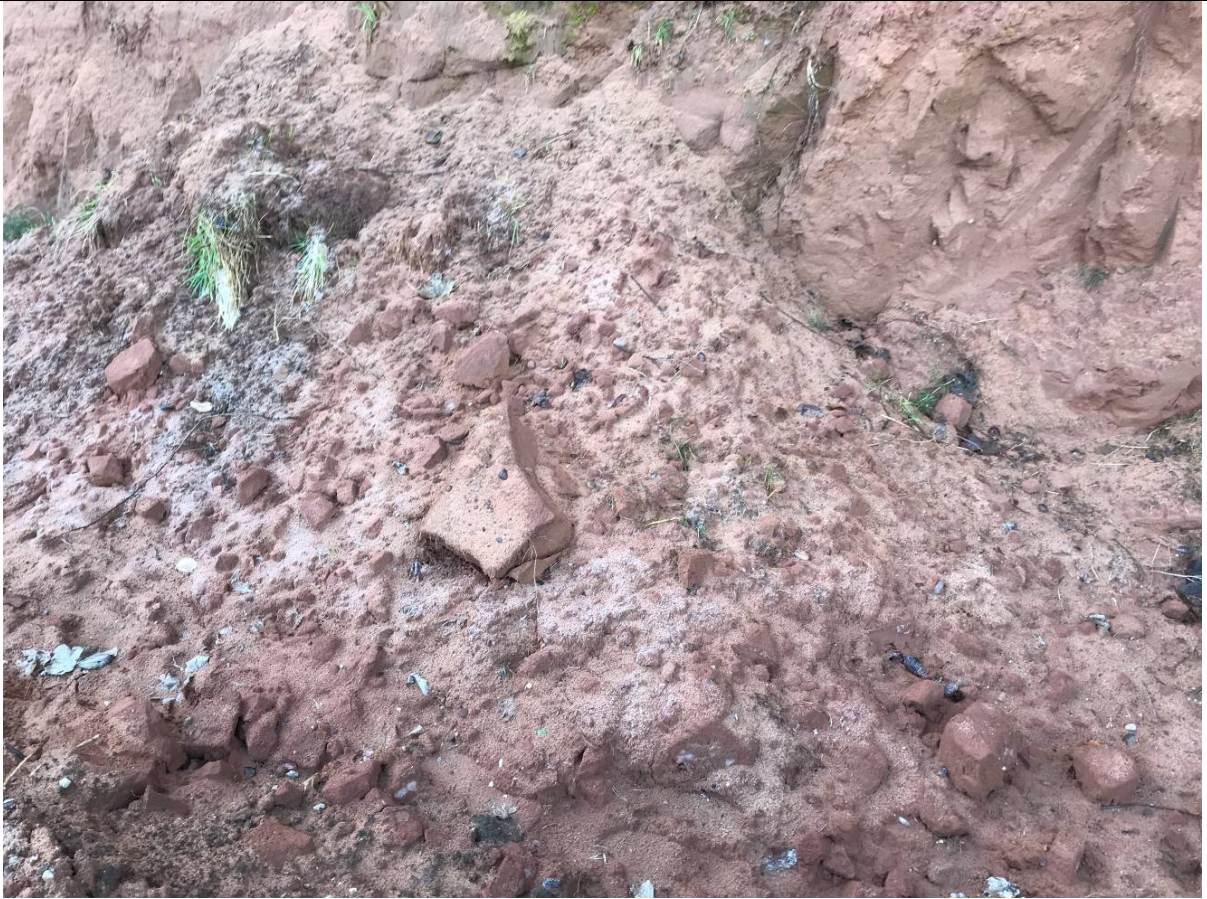
Photograph 6: Looking south west at the debris cone from the small failure reported on the 24th November 2019, which is gradually accumulating more debris from rock face fine washout and spalling (Image taken on 20/01/2020).
