FH Reference: 125592	Project : Berryhill Landslip Remedial Works	Date of Site Visit: 23/12/2019

SITE INSPECTION - RESIDENTS MEMO

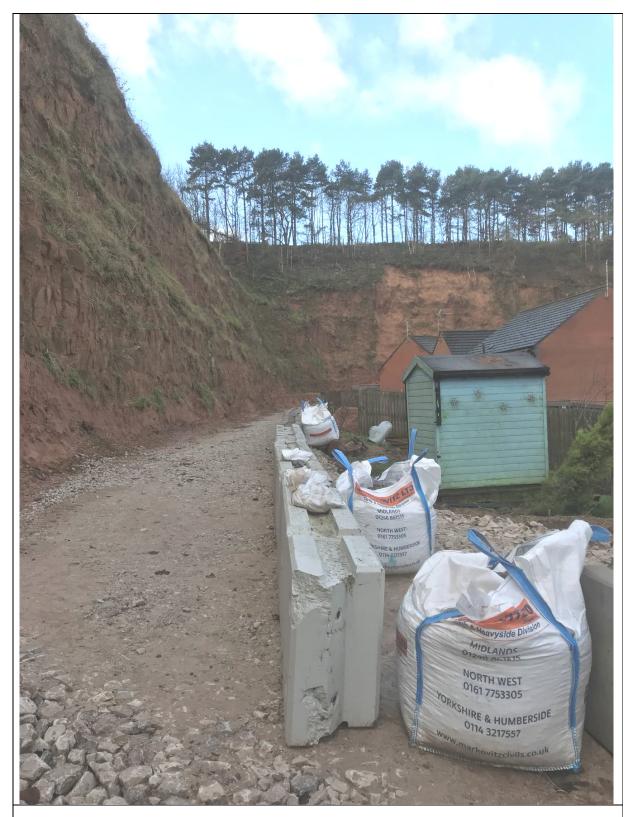
Photograph 1 : Looking along the southern flank of the quarry to the south west corner (Image taken on 23/12/2019)

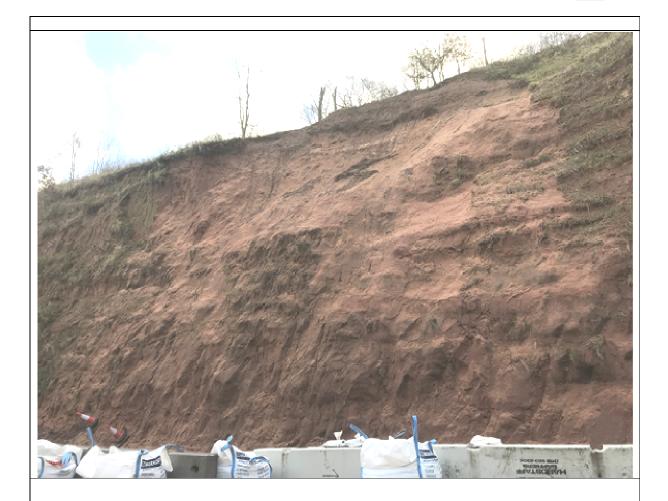
Photograph 2: Previous failure scar (Image taken on 23/12/2019)

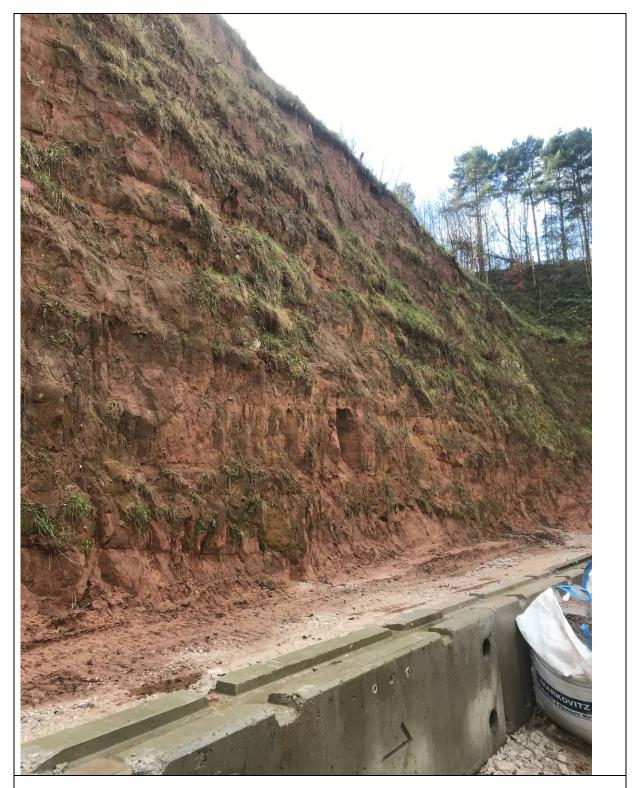
Photograph 3 : Looking west to the south west quarry corner (Image taken on 23/12/2019)

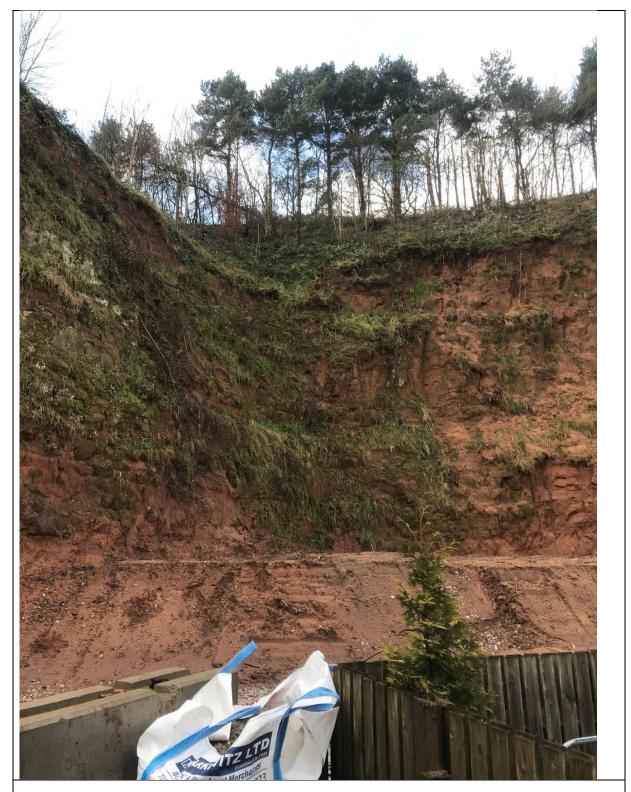
Photograph 4 : Looking at corner of western and southern flank (Image taken on 23/12/2019)

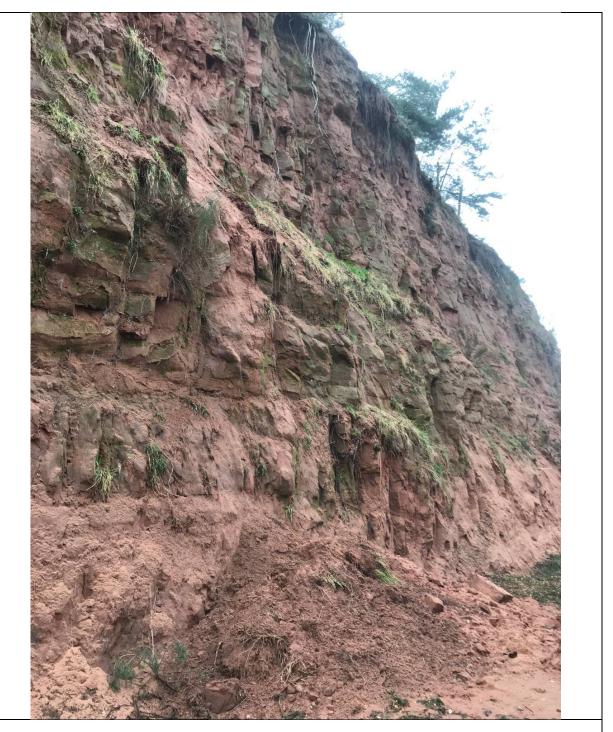
A photographic record of the quarry has been collated and is updated after each inspection. Only small, local visible changes have been noted from the previous site visit (16/12/2019). Two vegetation clumps approximately 30cm² were present on top of a small scale failure (previously reported on the 24/11/2019) located in the rock trap at the toe of the slope. Fairhurst are not aware of any reported issues to MDC and the garden heras fencing remained in situ as agreed. No increase in risk has been determined from the recent inspection.

Photograph 5: Looking north to the end of Unit 8. Debris from small failure reported on the 24th November 2019. Note two vegetation clumps, approx. 30cm² on top of the previous small failure (Image taken on 23/12/2019).
