FH Reference: 125592	Project : Berryhill Landslip Remedial Works	Date of Site Visit: 08/12/2020
<p>Mansfield District Council (MDC) have appointed Fairhurst to undertake regular site inspections of the quarry wall between completion of the emergency response works (w/e 24th November 2019) and the commencement of the permanent works in this portion of the quarry in early 2021 (tbc).</p> <p>During a recent inspection on Tuesday 8th of December 2020, the weather was overcast. On days previous to this inspection there had been heavy rainfall in Mansfield.</p> <p>A photographic record of the quarry has been collated and is being updated on inspection and no significant visible changes have been noted from the previous site visit. As per recent visits, cliff faces were noted to be partially saturated with what appeared to be surface water run-off from heavy rainfall from days previous. Small ravelling failures (<1m3) were evident in the rock trap, but still not to the extent that any rock trap clearance is necessary.</p> <p>Evidence of soil spalling down the face was still present to the rear of Unit 8 (photo 4) originating from a previously identified vegetation overhang. The increase i

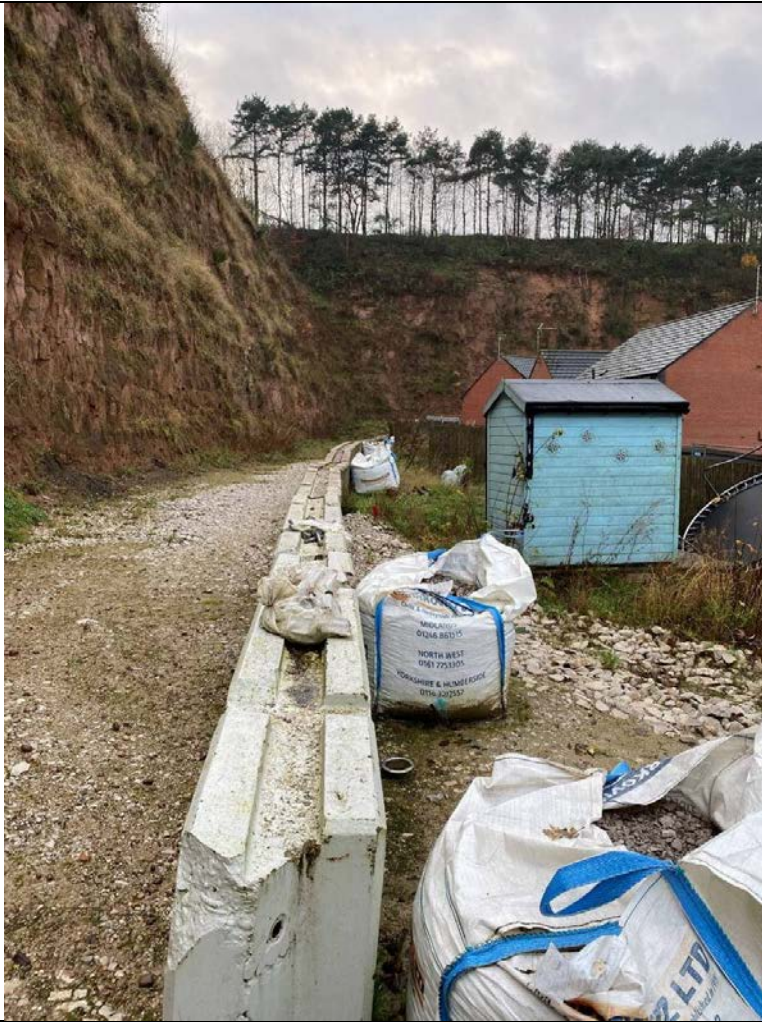
Photograph 1 : Looking along the southern flank of the quarry to the south west corner
(Image taken on 08/12/2020)

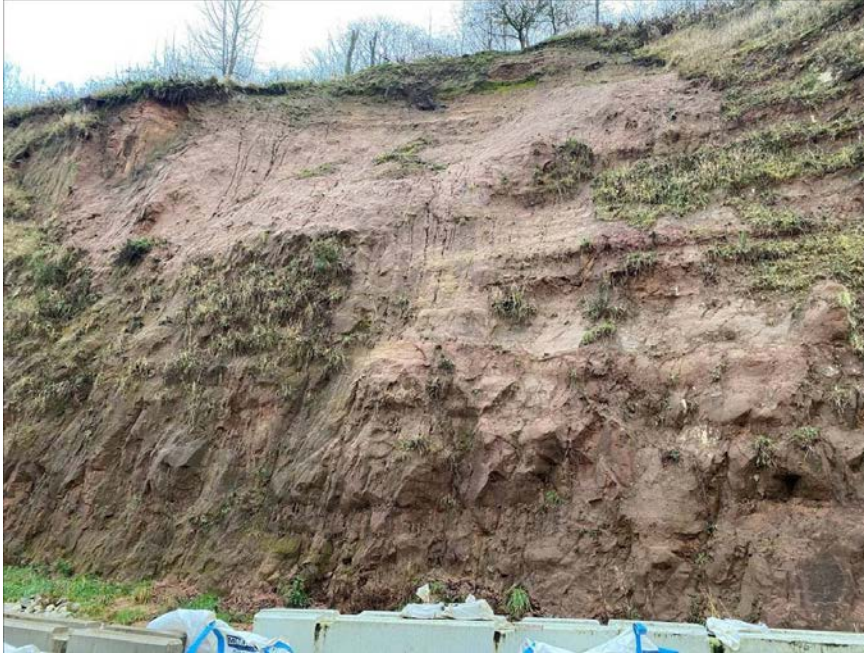
Photograph 2: Previous failure scar on which surface water run-off is apparent (Image taken on 08/12/2020)

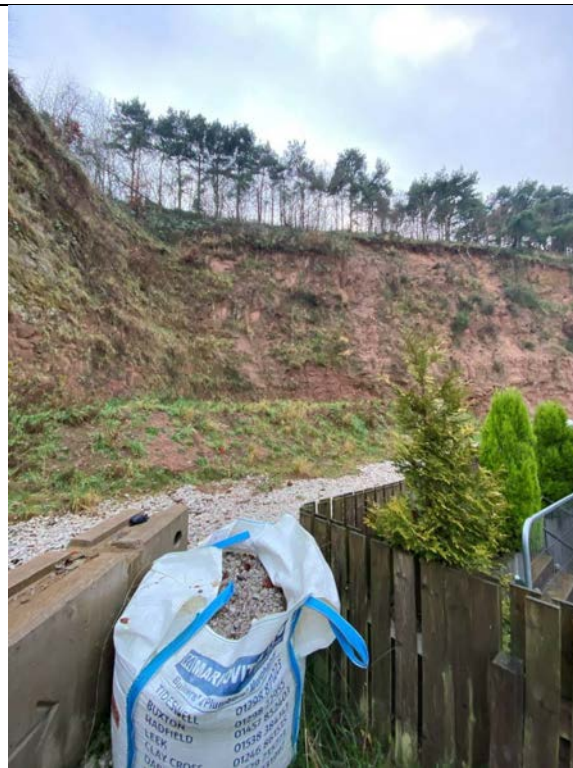
Photograph 3 : Looking west to the south west quarry corner (Image taken on 08/12/2020)

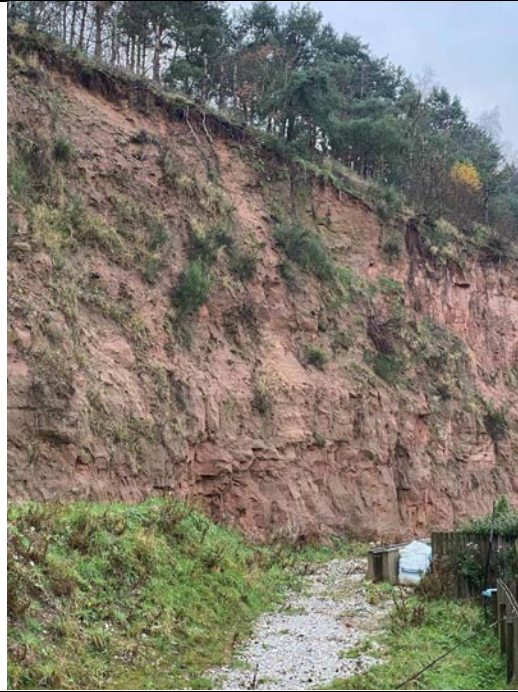
Photograph 4: Photograph 4: Looking at the western flank. Note towards the centre of picture the orange streak of sand being washed down the cliff face from what appears to be the soil crust at the crest of the cliff. This is creating talus (a sand mound with rocks in) at the toe of the cliff (Image taken on 08/12/2020).

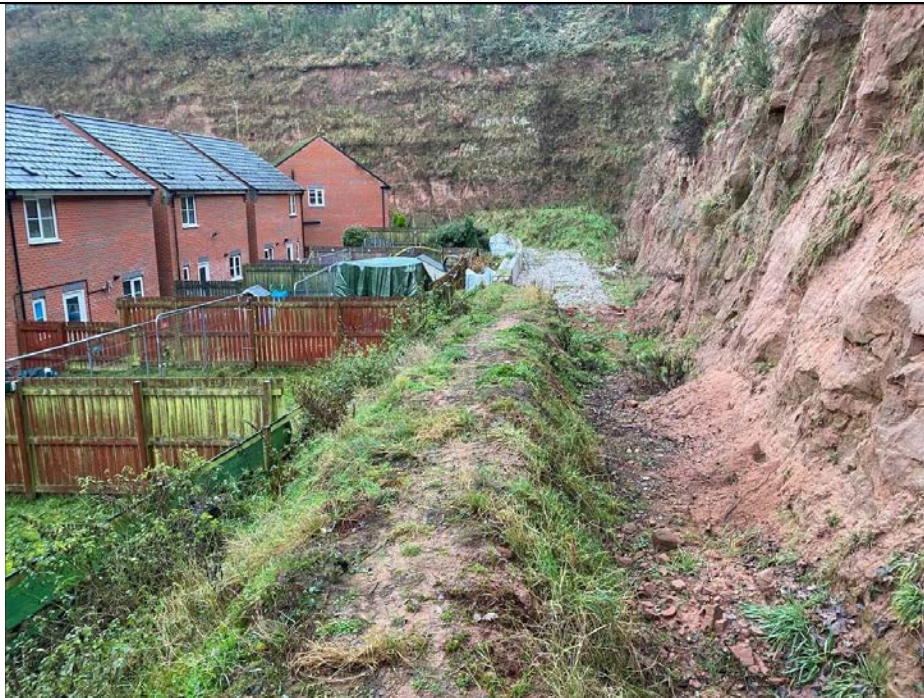
Photograph 5 : Looking at southern flank (background) and western flank (right-hand-side) (Image taken on 08/12/2020)

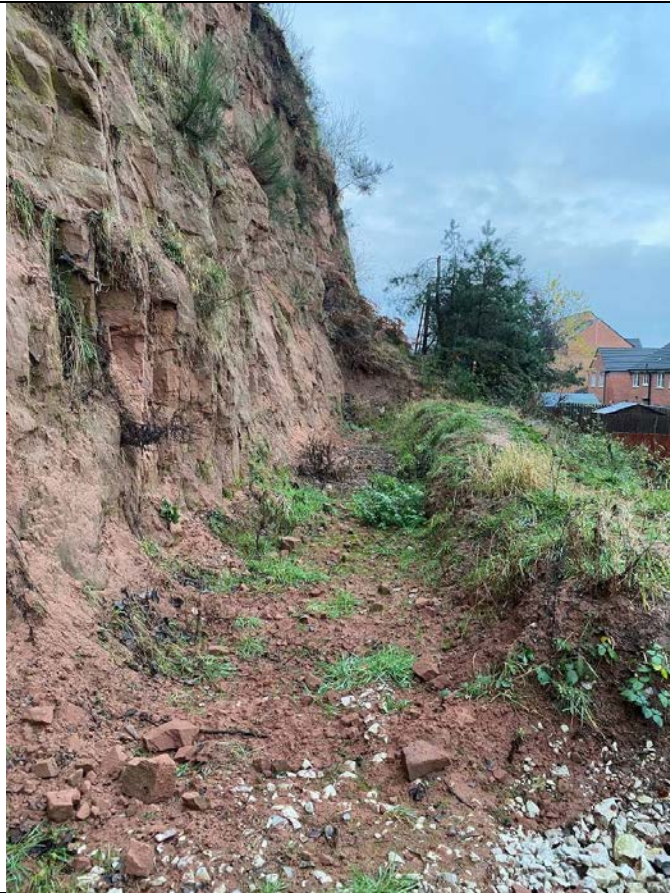
Photograph 6: Looking north to the end of Unit 8. Note the scattering of fresh soil and rock debris in the foreground, originating from what appeared to be just below the overhanging soil crust at the crest of the cliff face. (Image taken on 08/12/2020).
