FH Reference: 125592	Project : Berryhill Landslip Remedial Works	Date of Site Visit: 29/12/2020
<p>Mansfield District Council (MDC) have appointed Fairhurst to undertake regular site inspections of the quarry wall between completion of the emergency response works (w/e 24th November 2019) and the commencement of the permanent works in this portion of the quarry in early 2020.</p> <p>A photographic record of the quarry has been collated and is being updated after each weekly routine inspection.</p> <p>During a recent inspection on Tuesday 29th of December 2020, the weather was overcast with snowy spells and a dusting (~2cm) of snow on the ground. On days previous to this inspection there had been heavy rain and light snowfall in Mansfield. As per the last site visit on the 24th of December 2020 (undertaken in tandem with the emergency operations from the failure the previous night), the cliff faces were partially saturated with what appeared to be surface water run-off from heavy rain and light snowfall from previous days.</p> <p>As previously reported, a failure of overburden/completely weathered rock from the upper part of the slope occurred on the 23rd December 2020, resulting in

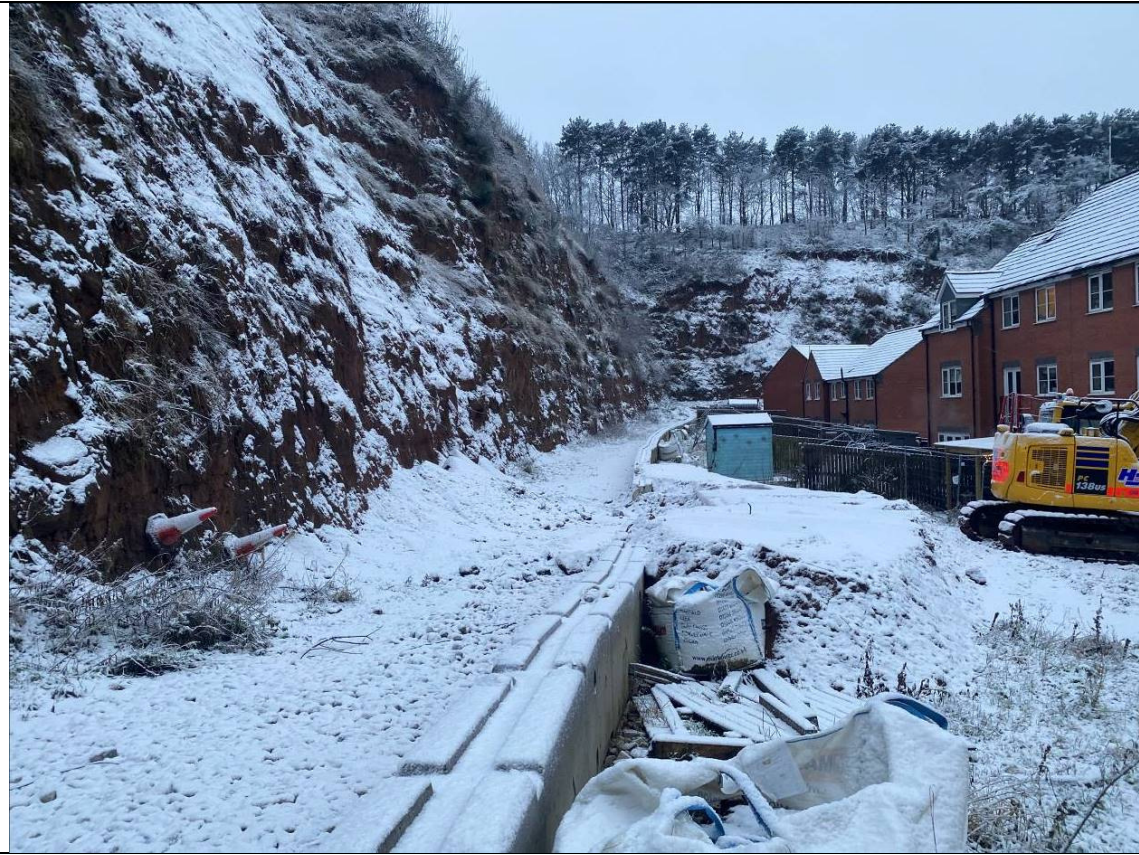
Photograph 1: Looking along the southern flank of the quarry to the south west corner. Note, the small amount ($<2\text{m}^3$) of slope debris at the toe of the slope, contained within the rock trap. The debris amassed following the recent failure on the night of 23rd of December 2020 and originates from the residual material at the crest of the recent failure scar (Image taken on 29/12/2020)

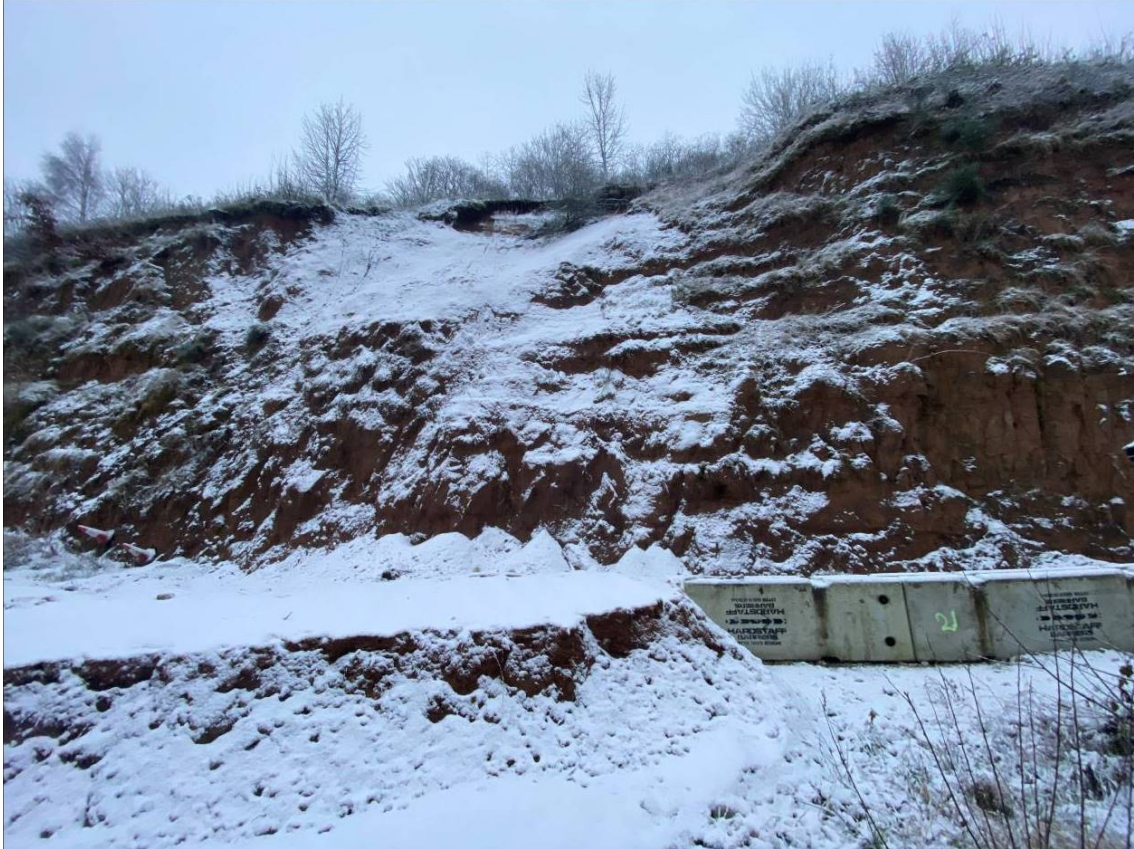
Photograph 2: Previous failure scars which appears to be partially saturated in surface water run-off from recent rain and snowfall. Note the small amount of failure debris ($<2\text{m}^3$) at the toe of the slope which has amassed since the recent failure on the 23rd of December 2020. (Image taken on 29/12/2020)

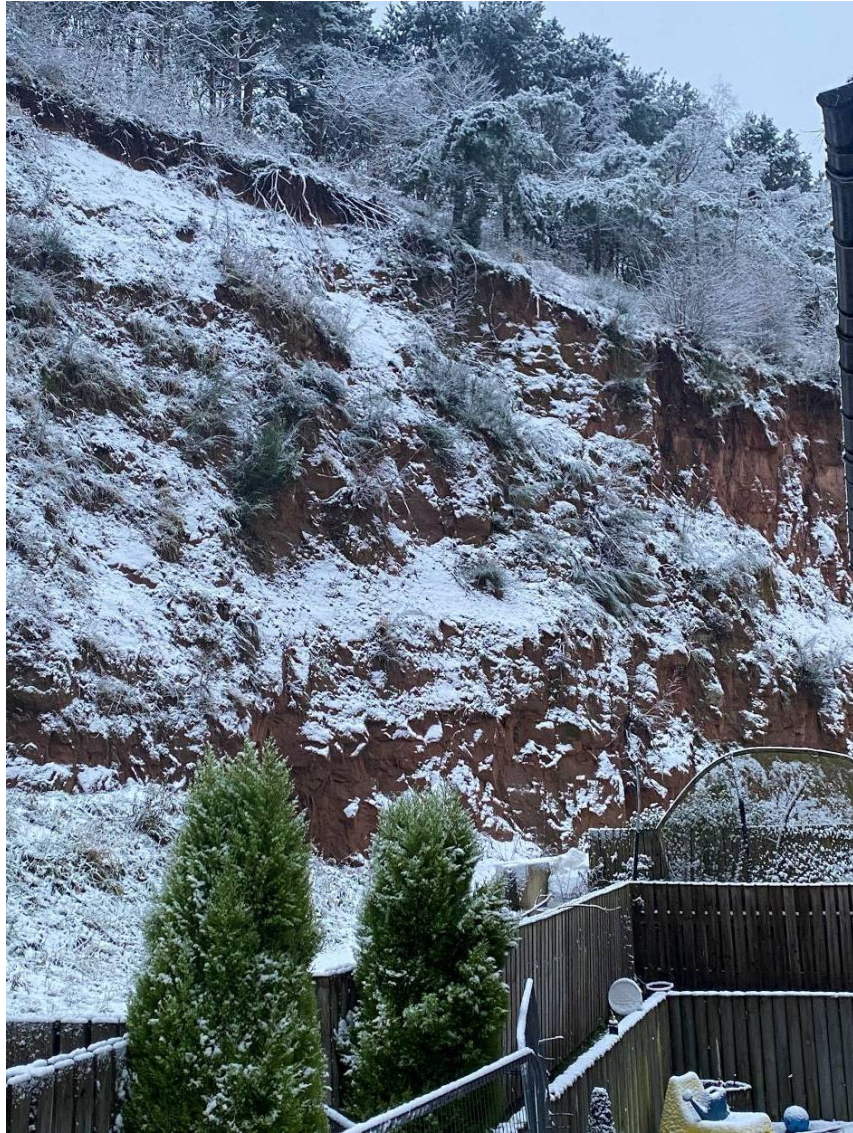
Photograph 4: Looking at the western flank where sand had previously been washed down the cliff face. No additional debris was on top of the talus at the toe of the cliff (Image taken on 29/12/2020).
