**Berry Hill Quarry, Mansfield**  
**Site Inspections Update**  
**February 2020**

### **Site Inspection Memo 18.02.2020**

FH Reference: 125592	Project : Berryhill Landslip Remedial Works	Date of Site Visit: 18/02/2020
<p>Mansfield District Council (MDC) have appointed Fairhurst to undertake regular site inspections of the quarry wall between completion of the emergency response works (w/e 24<sup>th</sup> November 2019) and the commencement of the permanent works in this portion of the quarry in early 2020.</p> <p>During a recent inspection on Friday 18<sup>th</sup> of February 2020, the weather was cloudy. There was a 1cm covering of snow on the crest and toe of the quarry.</p> <p>A photographic record of the quarry has been collated and is being updated on inspection and no obvious visible changes have been noted from the previous site visit (11/02/2020). Minimal further noticeable debris was noted in the rock trap at the toe of the slope. Fairhurst are not aware of any reported issues to MDC and the garden hedges fencing remained in situ as agreed. No increase in risk has been determined from the recent inspection.</p> <p>If residents see or hear anything associated with the c

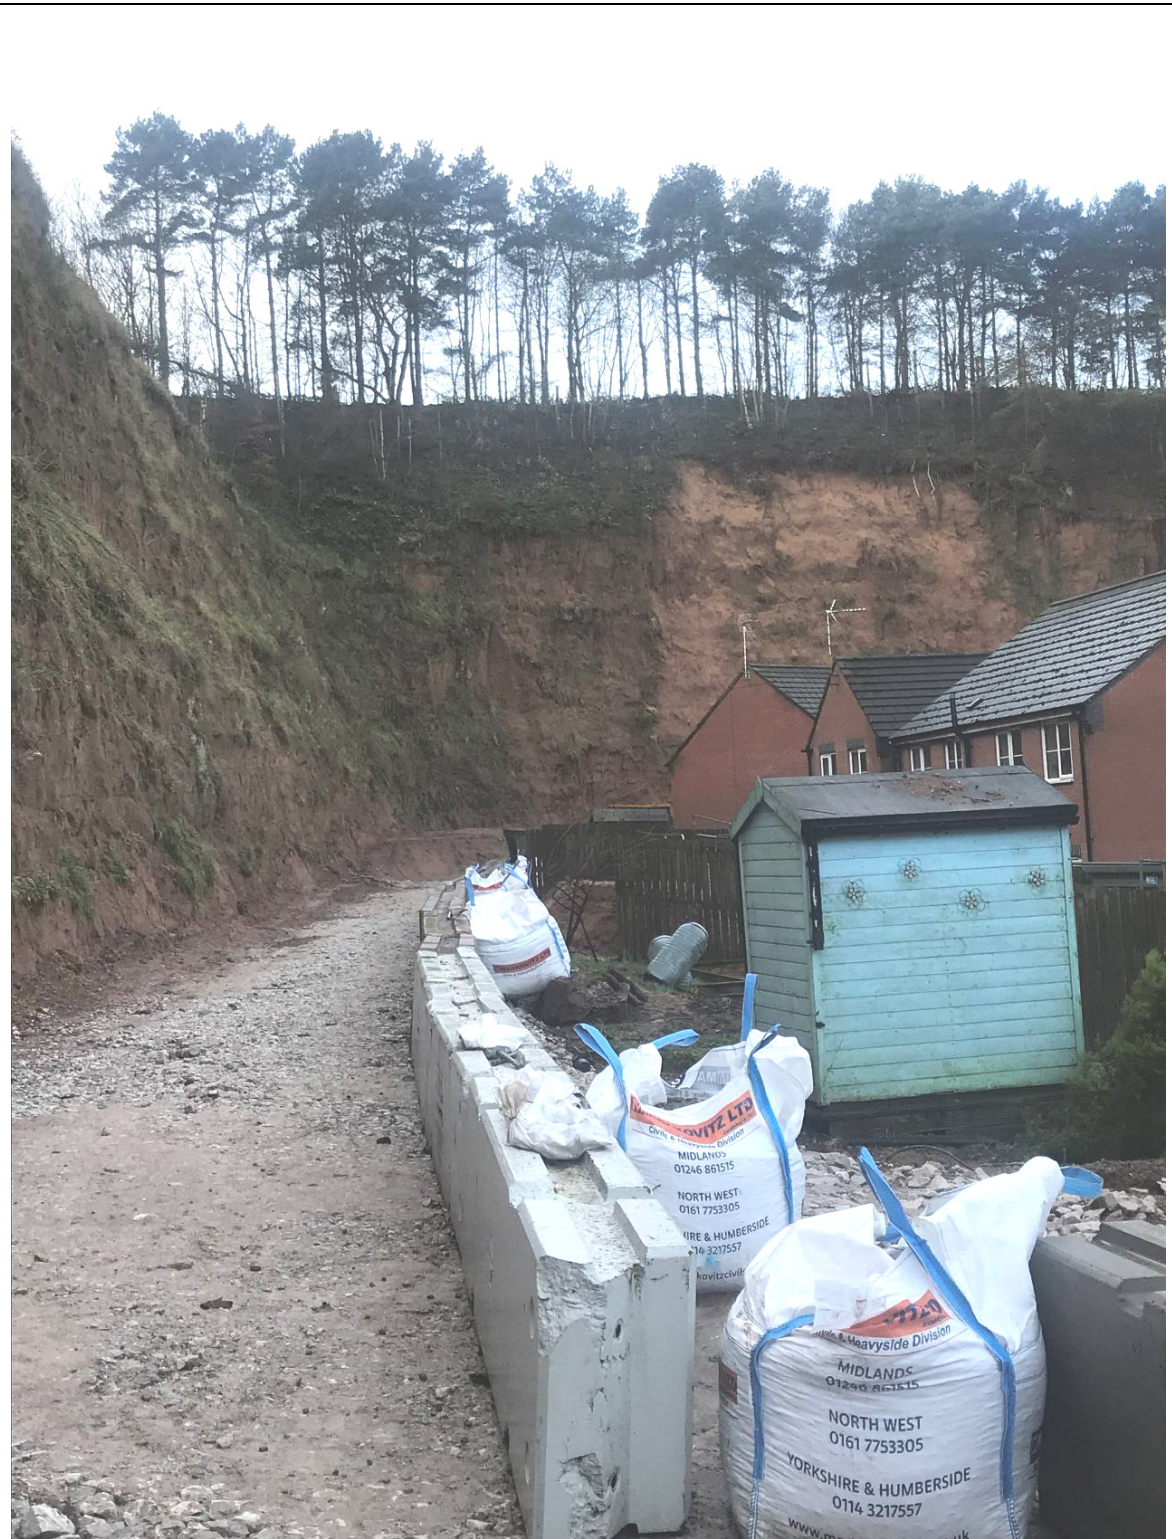
Photograph 1 : Looking along the southern flank of the quarry to the south west corner (Image taken on 18/02/2020)

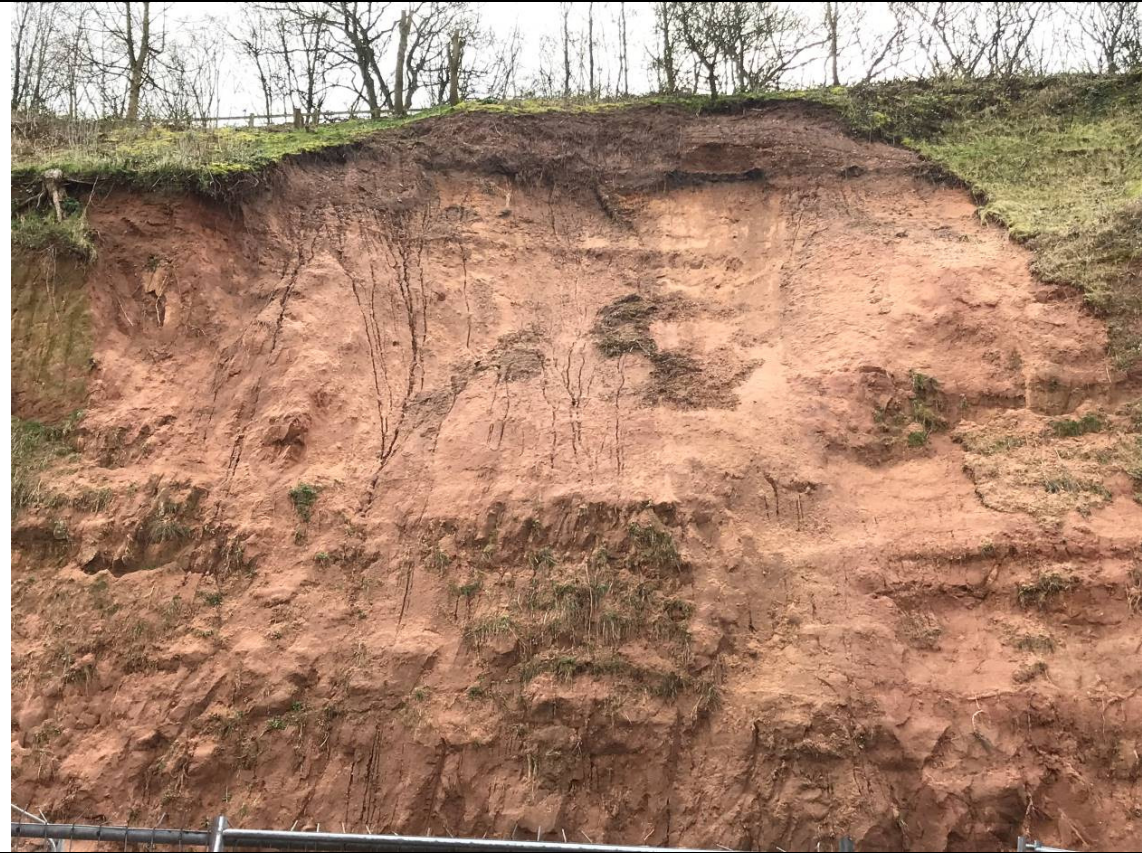
Photograph 2: Previous failure scar (Image taken on 18/02/2020)

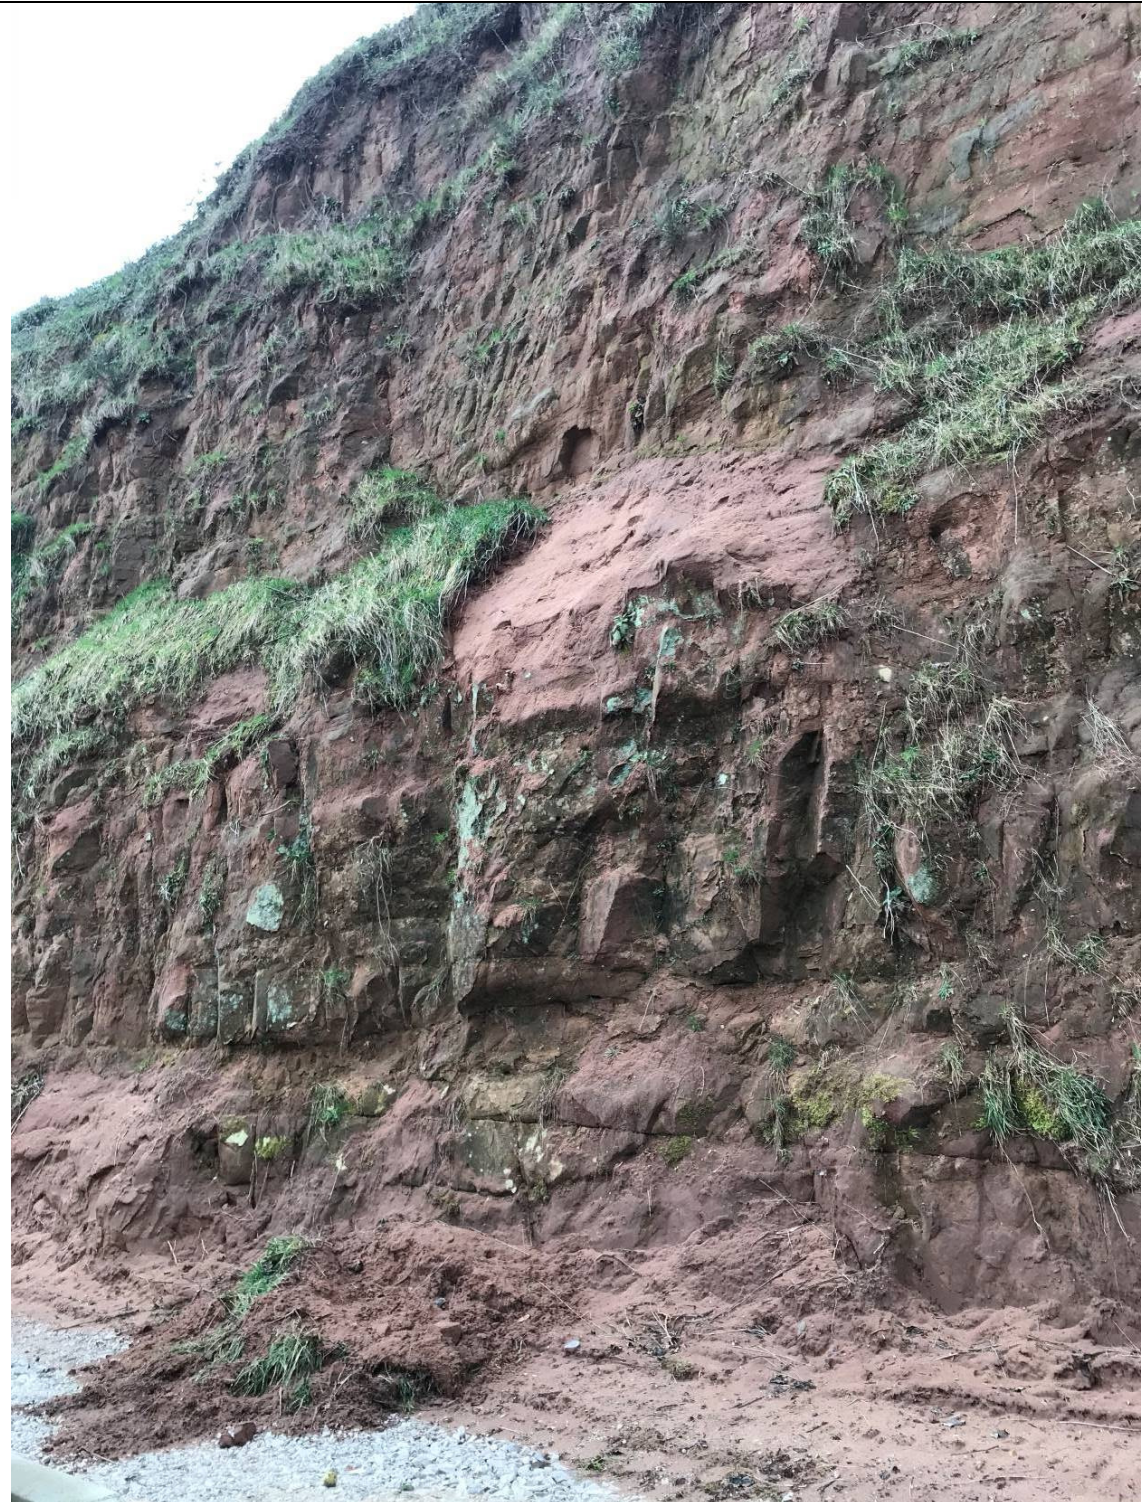
Ongoing block failure has occurred (as it has previously) and our recent inspection enclosed (18<sup>th</sup> February 2020) recorded some vegetation and small blocks had come down following the inspection on the 11<sup>th</sup> February. These small areas of debris are likely to have been influenced by high winds and rainfall, however they are characteristic of the low impact/low risk failure mechanisms commonly occurring at the site.

Photograph 3: Looking at a small landslide scar on the southern flank, middle of Unit 7. The small failure and debris occurred between the 11<sup>th</sup> and 18<sup>th</sup> of February 2019. (Image taken on 18/02/2020).

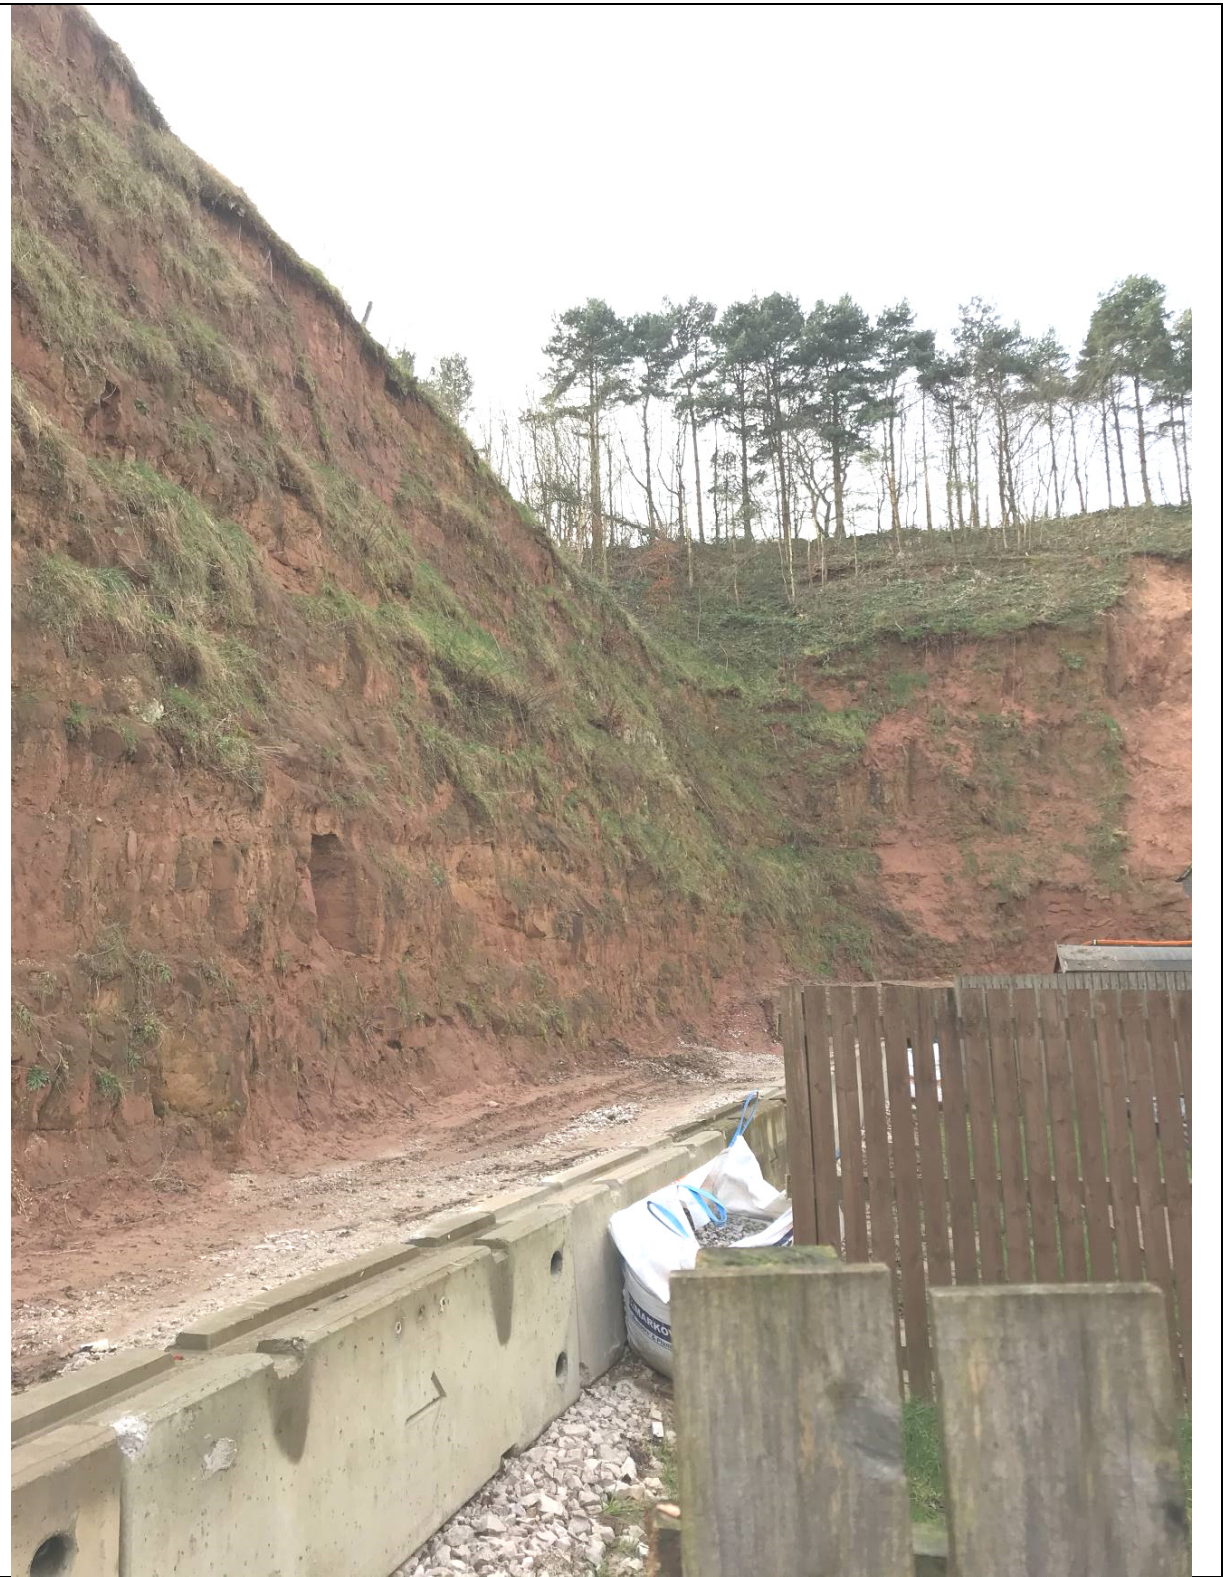
Photograph 4 : Looking west to the south west quarry corner (Image taken on 18/02/2020)

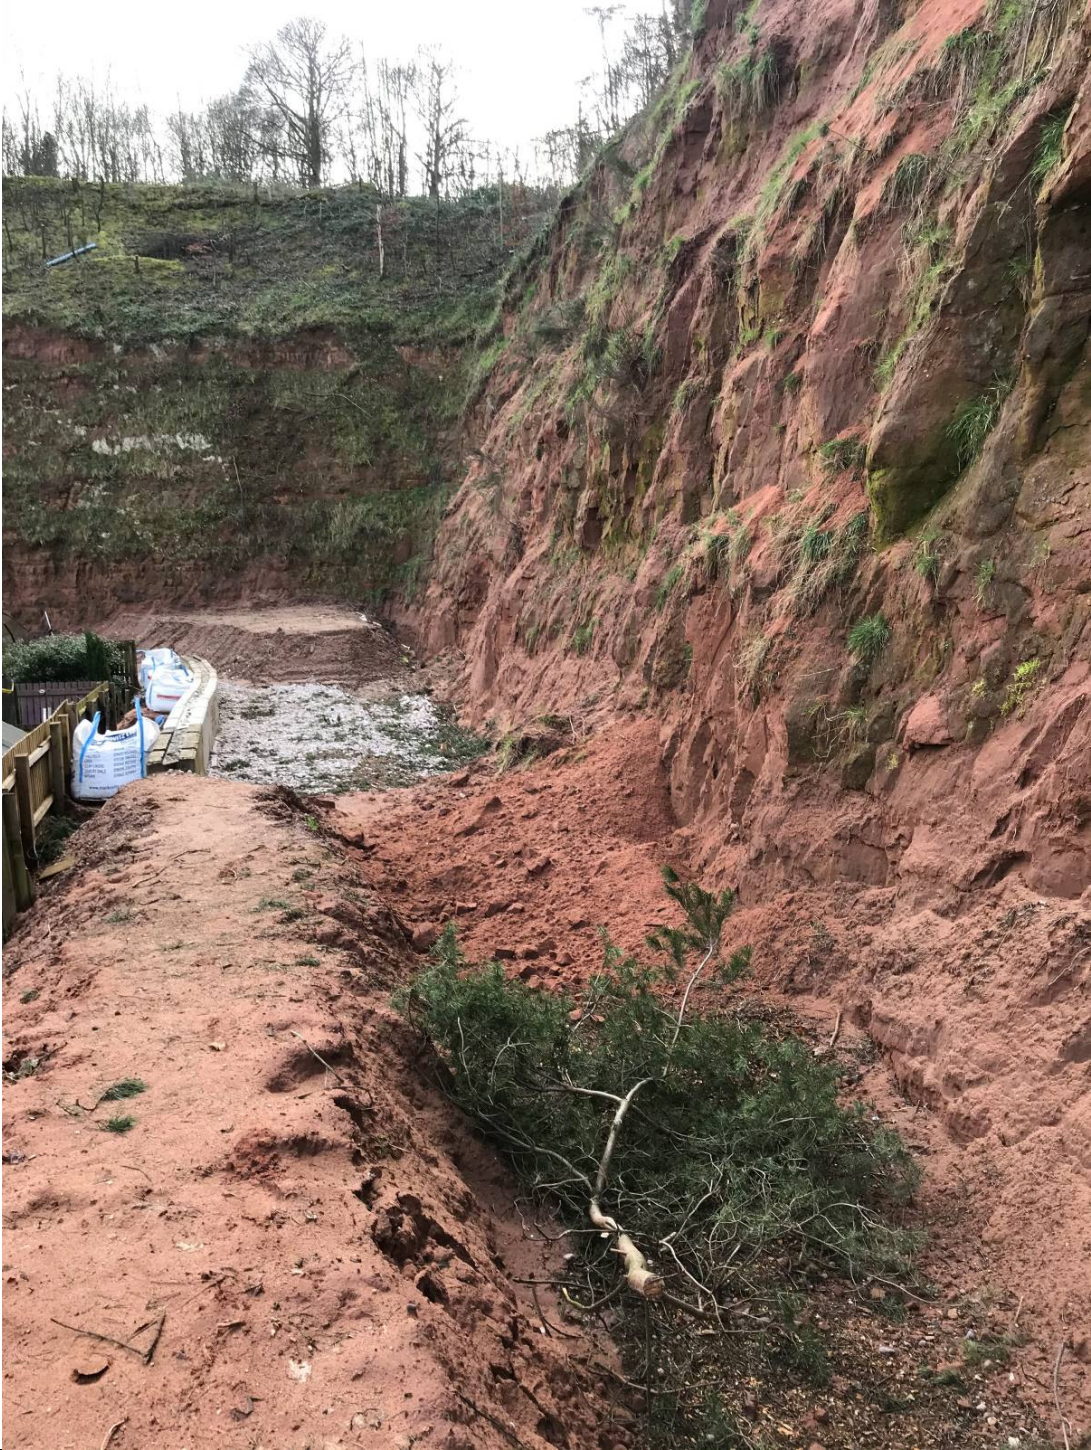
Photograph 5 : Looking at western flank and previous failure scar (Image taken on 18/02/2020)

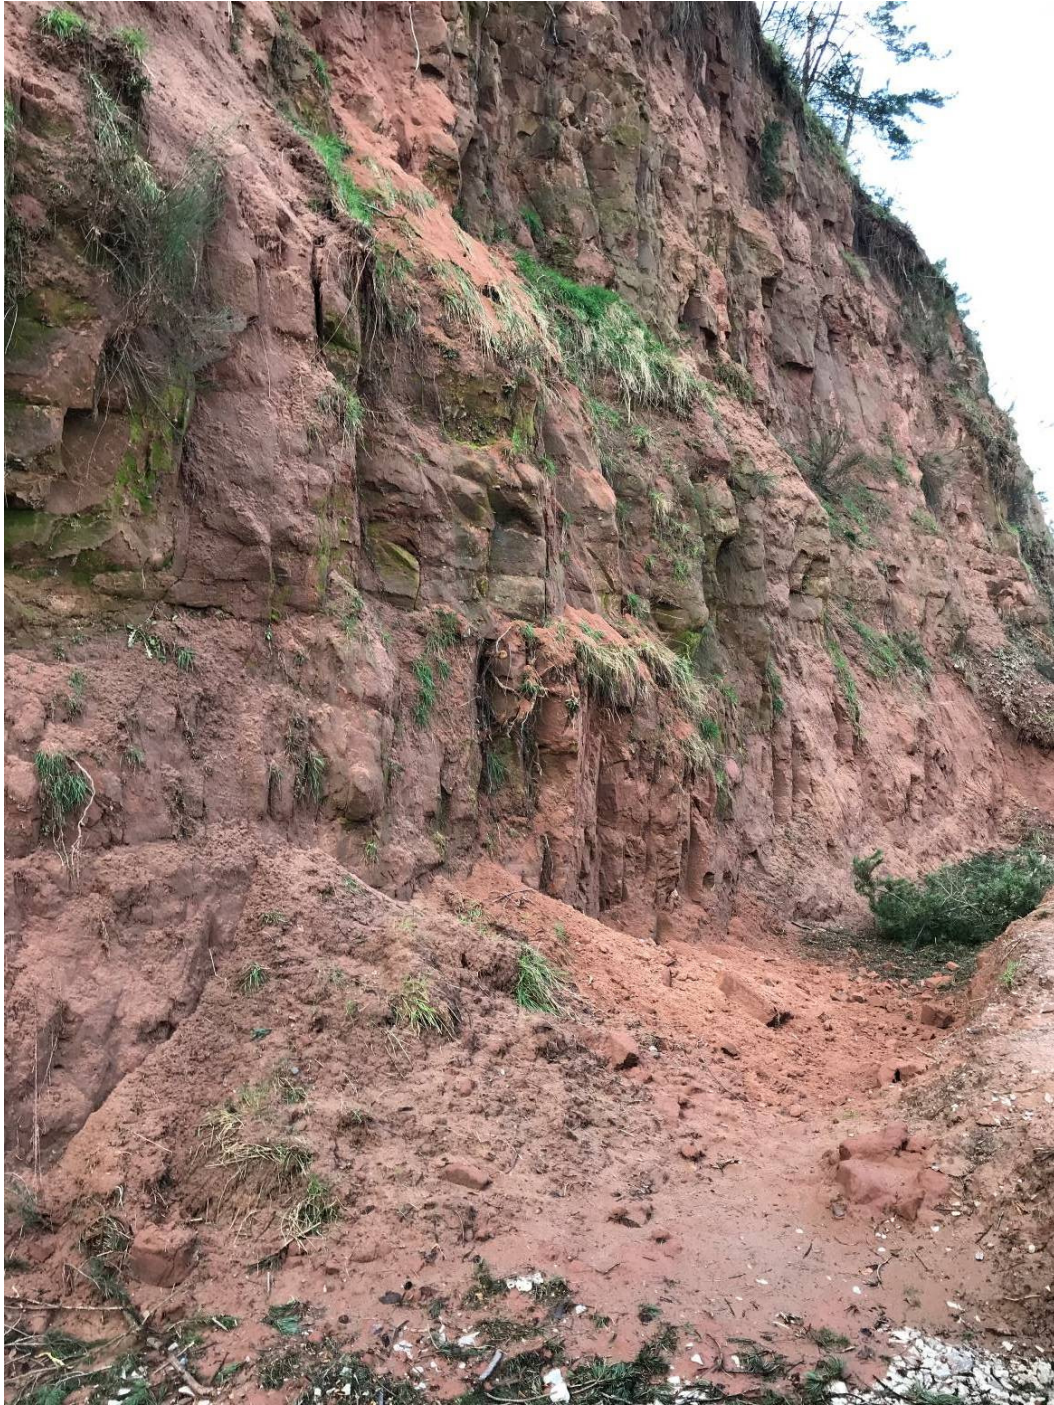
Photograph 6: Looking north to the end of Unit 8. Debris from a small failure reported on the 24<sup>th</sup> November 2019 is in the foreground, while debris in the background is from a later small failure that occurred between the 11th and 18th of February 2019. (Image taken on 18/02/2020).
