FH Reference: 125592	Project : Berryhill Landslip Remedial Works	Date of Site Visit: 30/04/2020

SITE INSPECTION - RESIDENTS MEMO

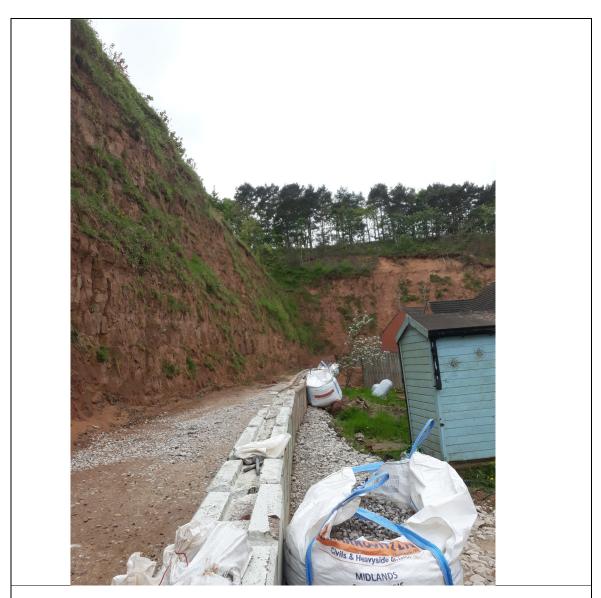
Photograph 1 : Looking along the southern flank of the quarry to the south west corner (Image taken on 16/04/2020)

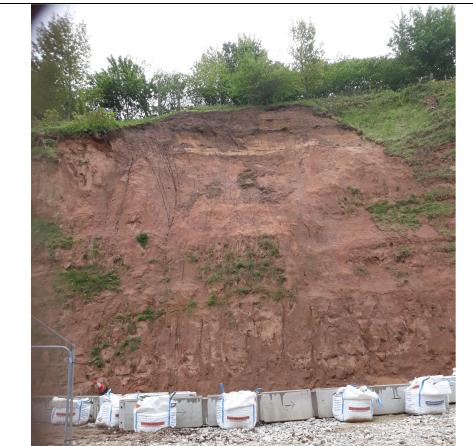
Photograph 2A: Previous failure scar (Image taken on 30/04/2020) with similar evidence of desiccation cracks and overhanging overburden/relic topsoil as that observed on 16/04/2020 inspection.

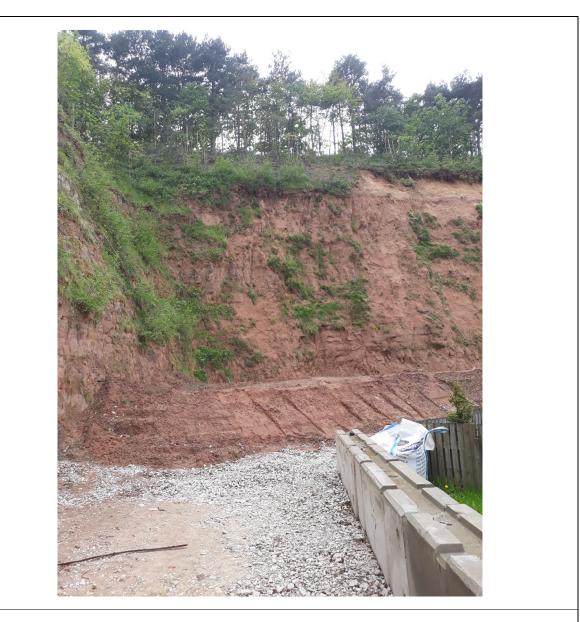
Photograph 3 : Looking west to the south west quarry corner (Image taken on 30/04/2020)

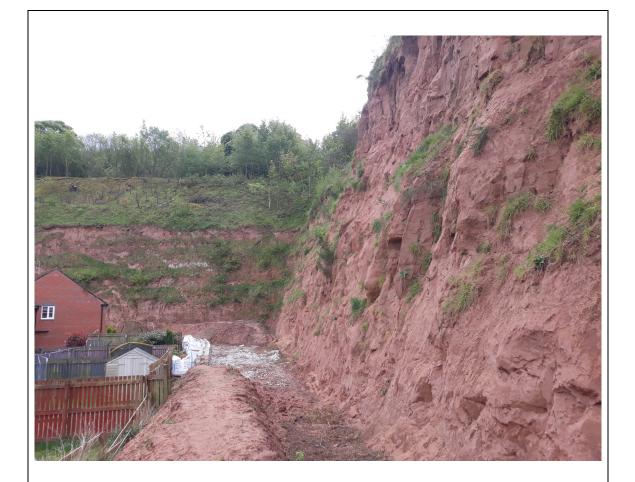
Photograph 4 : Looking at western flank and previous failure scar (Image taken on 30/04/2020)

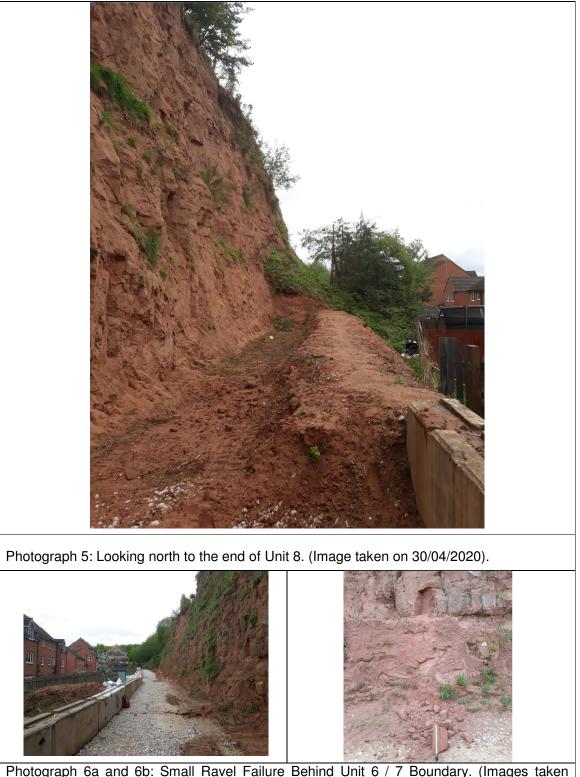
A photographic record of the quarry has been collated and is being updated on inspection. The recent inspection indicates very little change to that from the 16th April. One small ravel type failure was observed behind property number 52 on the boundary of Units 6 and 7 which comprises a small number of blocks from the quarry face no more than 2m high on the quarry face with the largest block being less than 40cm in length. Refer to Photos 6a and 6b below.

Photograph 6a and 6b: Small Ravel Failure Behind Unit 6 / 7 Boundary. (Images taken 30/04/2020).
