FH Reference: 125592	Project : Berryhill Landslip Remedial Works	Date of Site Visit: 01/12/2020
-------------------------	---	-----------------------------------

SITE INSPECTION - RESIDENTS MEMO

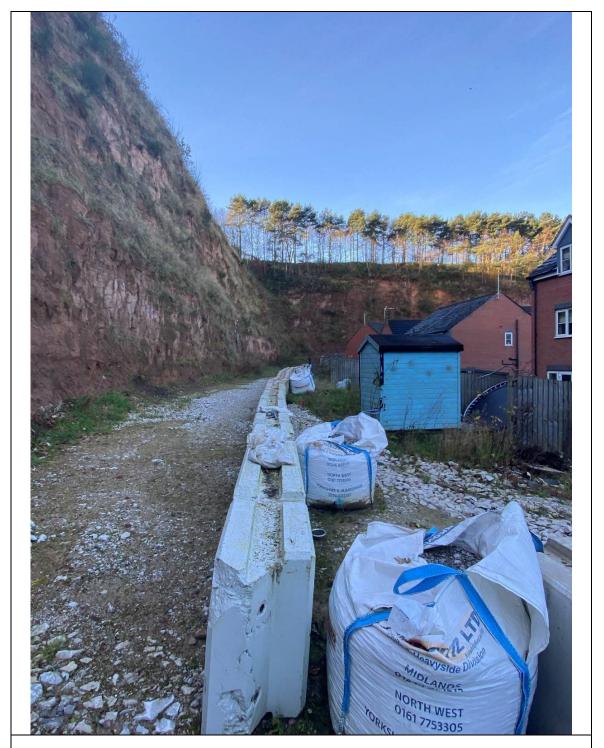
Photograph 1 : Looking along the southern flank of the quarry to the south west corner (Image taken on 01/12/2020)

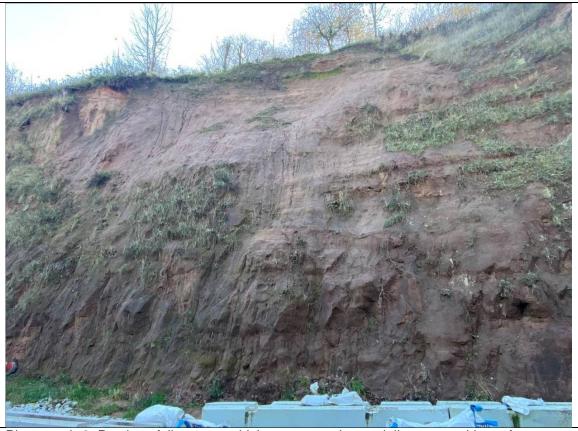
Photograph 2: Previous failure scar which appears to be partially saturated in surface water run-off (Image taken on 01/12/2020)

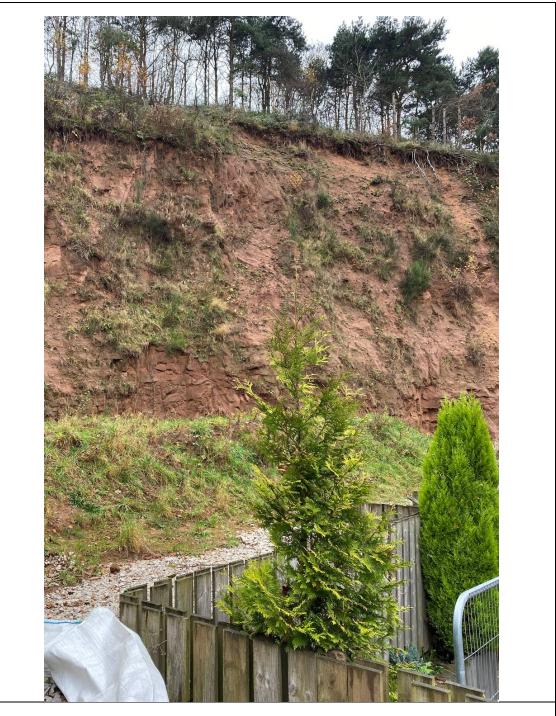
Photograph 3 : Looking west to the south west quarry corner (Image taken on 01/12/2020)

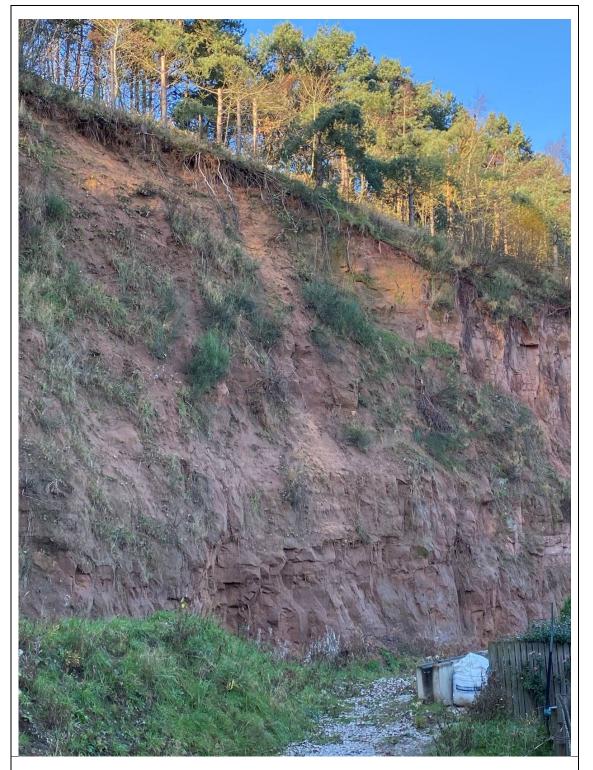
Evidence of soil spilling down the face was still present to the rear of Unit 8 (photo 4) originating from a previously identified vegetation overhang. The increase in potential undermining of this vegetation will continue to be monitored during our inspections.

Photograph 4: Looking at the western flank. Note towards the centre of picture the orange streak of sand being washed down the cliff face from what appears to be the soil crust at the crest of the cliff. This is creating talus (a sand mound with rocks in) at the toe of the cliff (Image taken on 01/12/2020).

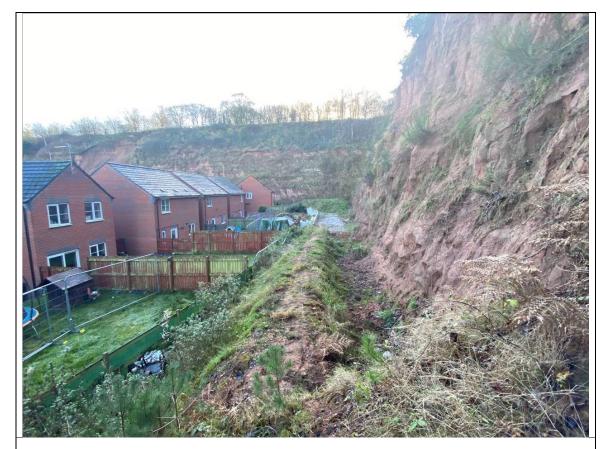
Photograph 5 : Looking at southern flank (background) and western flank (right-hand-side) (Image taken on 01/12/2020)

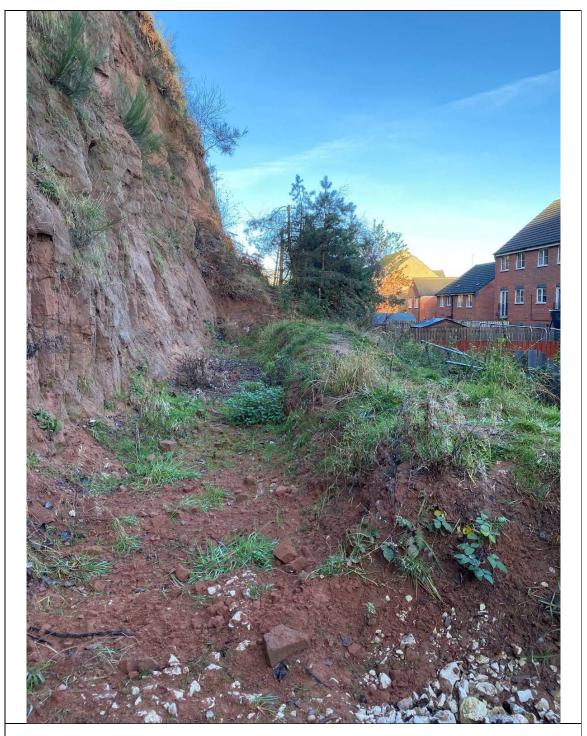
Photograph 6: Looking north to the end of Unit 8. Note the scattering of fresh soil debris in the foreground, originating from what appeared to the overhanging soil crust at the crest of the cliff face. (Image taken on 01/12/2020).
