FH Reference: 125592	Project : Berryhill Landslip Remedial Works	Date of Site Visit: 10/11/2020
<p>Mansfield District Council (MDC) have appointed Fairhurst to undertake regular site inspections of the quarry wall between completion of the emergency response works (w/e 24th November 2019) and the commencement of the permanent works in this portion of the quarry in early 2020.</p> <p>During a recent inspection on Tuesday 10th of November 2020, the weather was overcast with cloud. On days previous to this inspection there had been heavy rainfall in Mansfield.</p> <p>A photographic record of the quarry has been collated and is being updated on inspection and no significant visible changes have been noted from the previous site visit. As per recent visits, cliff faces were noted to be partially saturated with what appeared to be surface water run-off from heavy rainfall from days previous. Small ravelling failures (&lt;1m<sup>3</sup>) were evident in the rock trap, but still not to the extent that any rock trap clearance is necessary.</p> <p>Evidence of soil spilling down the face was still present to the rear of Unit 8 (photo 4) originating from a previously identified vegetation over

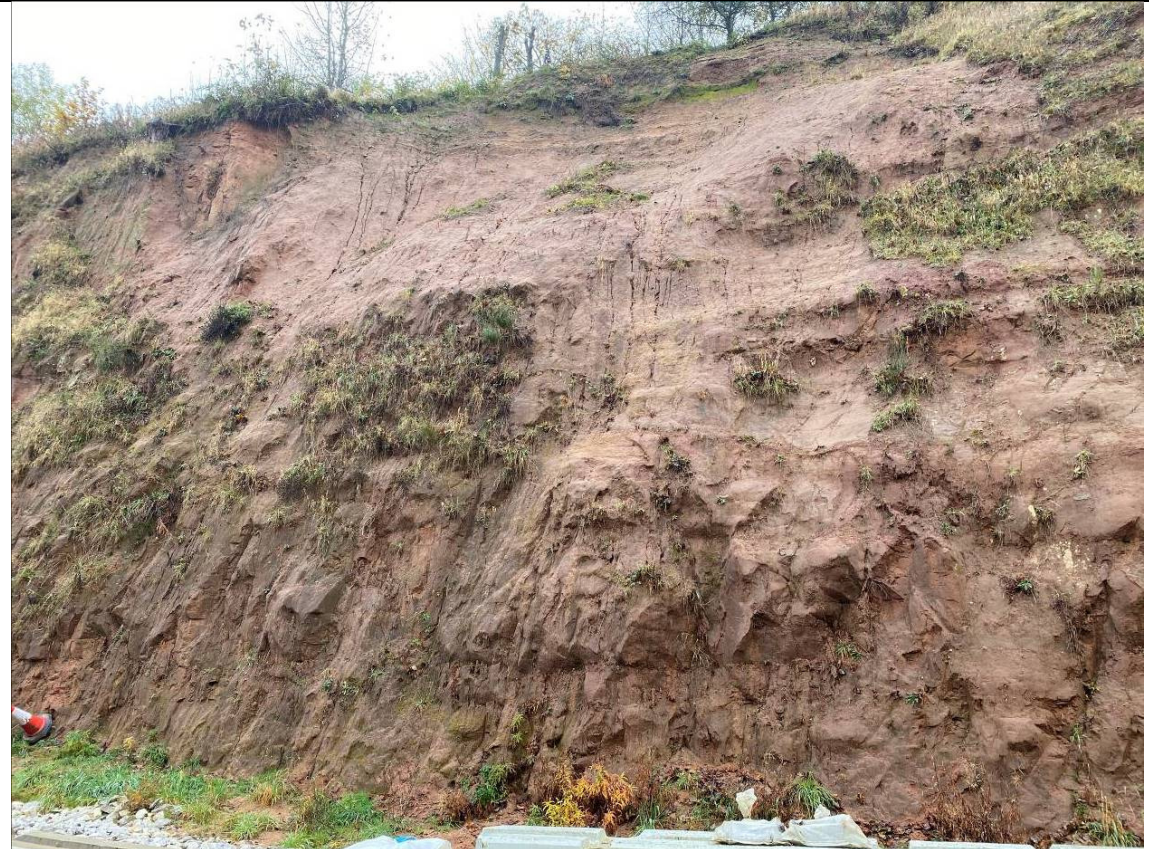
Photograph 2: Previous failure scar (Image taken on 10/11/2020)

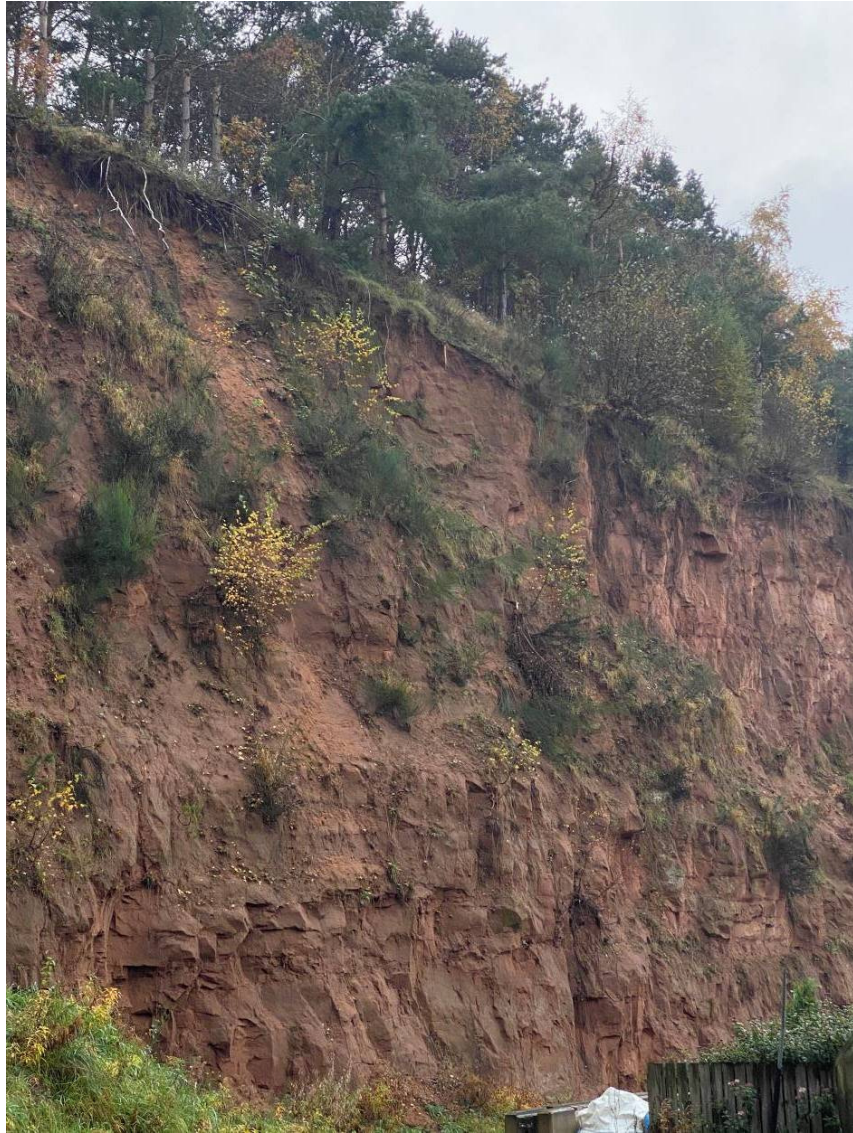
Photograph 4: Looking at the western flank. Evidence of overburden spalling from upper cliff face in Unit 8 as identified on 3<sup>rd</sup> November 2020 (Image taken on 10/11/2020).
