FH Reference: 125592	Project : Berryhill Landslip Remedial Works	Date of Site Visit: 03/11/2020
<p>Mansfield District Council (MDC) have appointed Fairhurst to undertake regular site inspections of the quarry wall between completion of the emergency response works (w/e 24th November 2019) and the commencement of the permanent works in this portion of the quarry in early 2020.</p> <p>During a recent inspection on Tuesday 3rd of November 2020, the weather was overcast with cloud. On days previous to this inspection there had been heavy rainfall in Mansfield.</p> <p>A photographic record of the quarry has been collated and is being updated on inspection and no significant visible changes have been noted from the previous site visit. As per recent visits, cliff faces were noted to be partially saturated with what appeared to be surface water run-off from heavy rainfall from days previous. Small ravelling failures (<1m³) were evident in the rock trap, but still not to the extent that any rock trap clearance is necessary.</p> <p>Fresh evidence of soil spilling down the face was noted to the rear of Unit 8 (photo 4) originating from a previously identified vegetation overhang. The increas

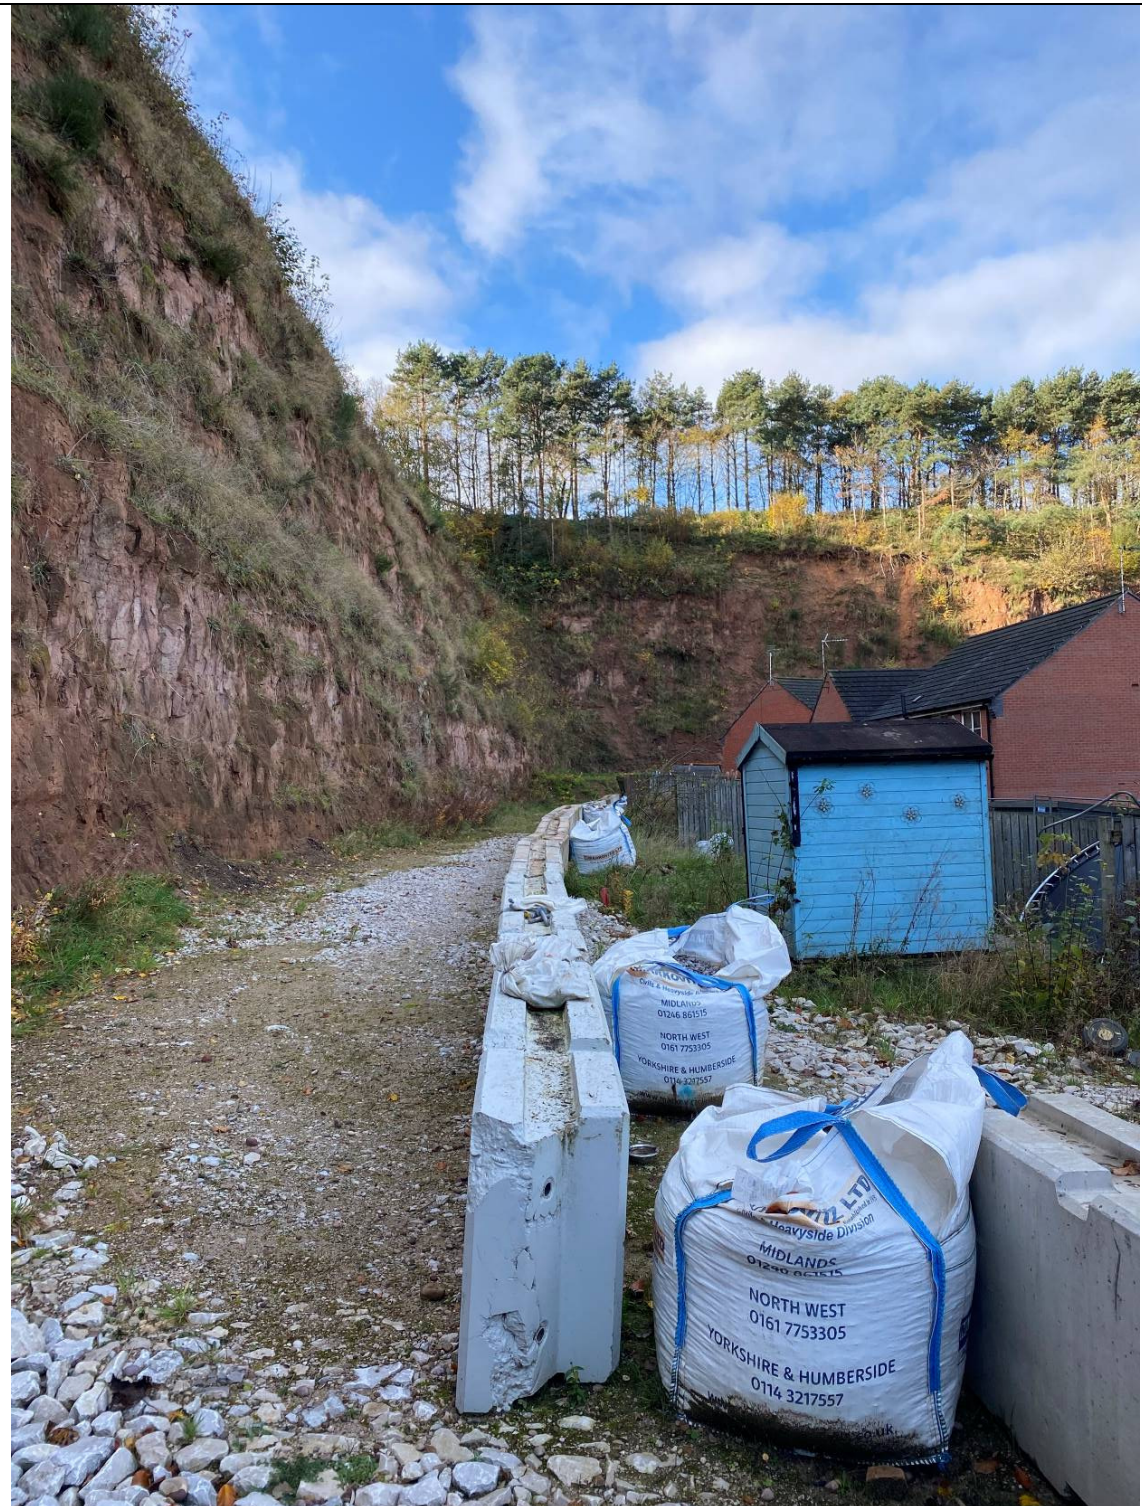
Photograph 1: Looking along the southern flank of the quarry to the south west corner (Image taken on 03/11/2020)

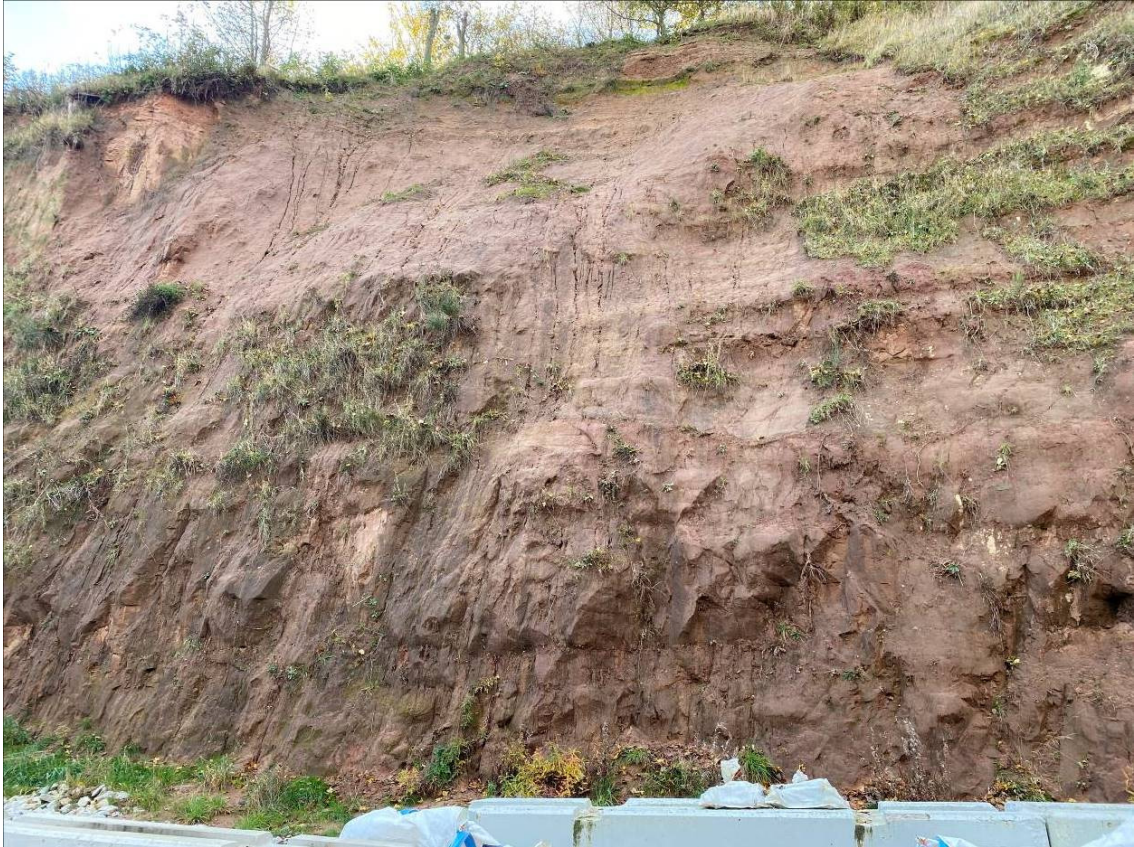
Photograph 2: Previous failure scar (Image taken on 03/11/2020)

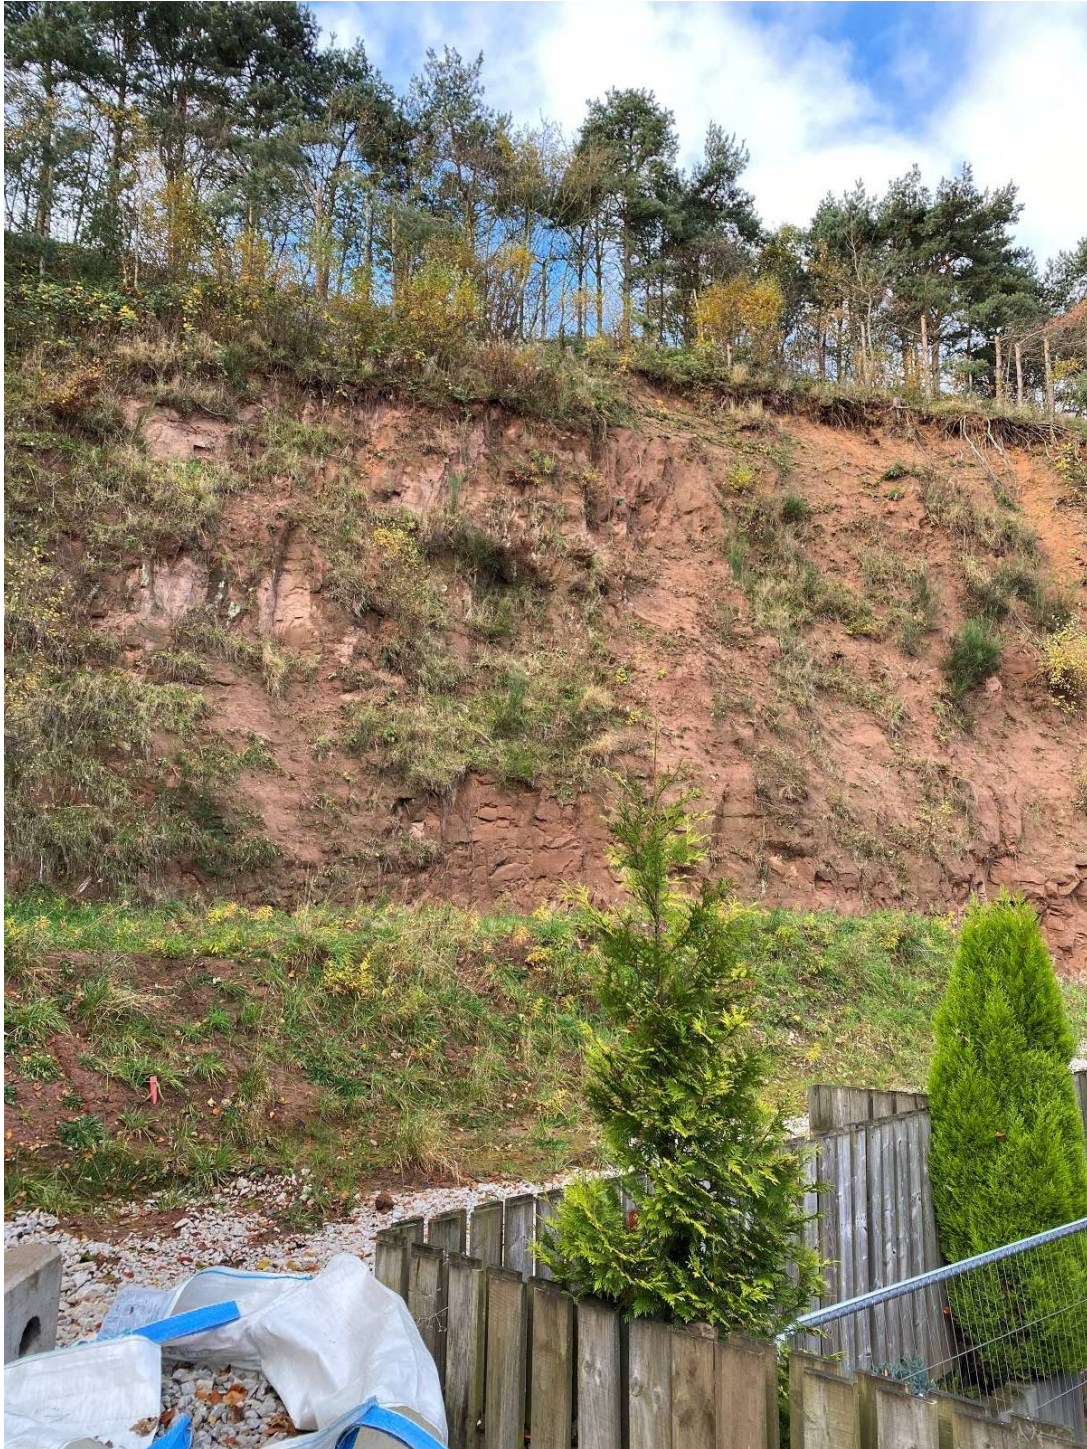
Photograph 3 : Looking west to the south west quarry corner (Image taken on 03/11/2020)

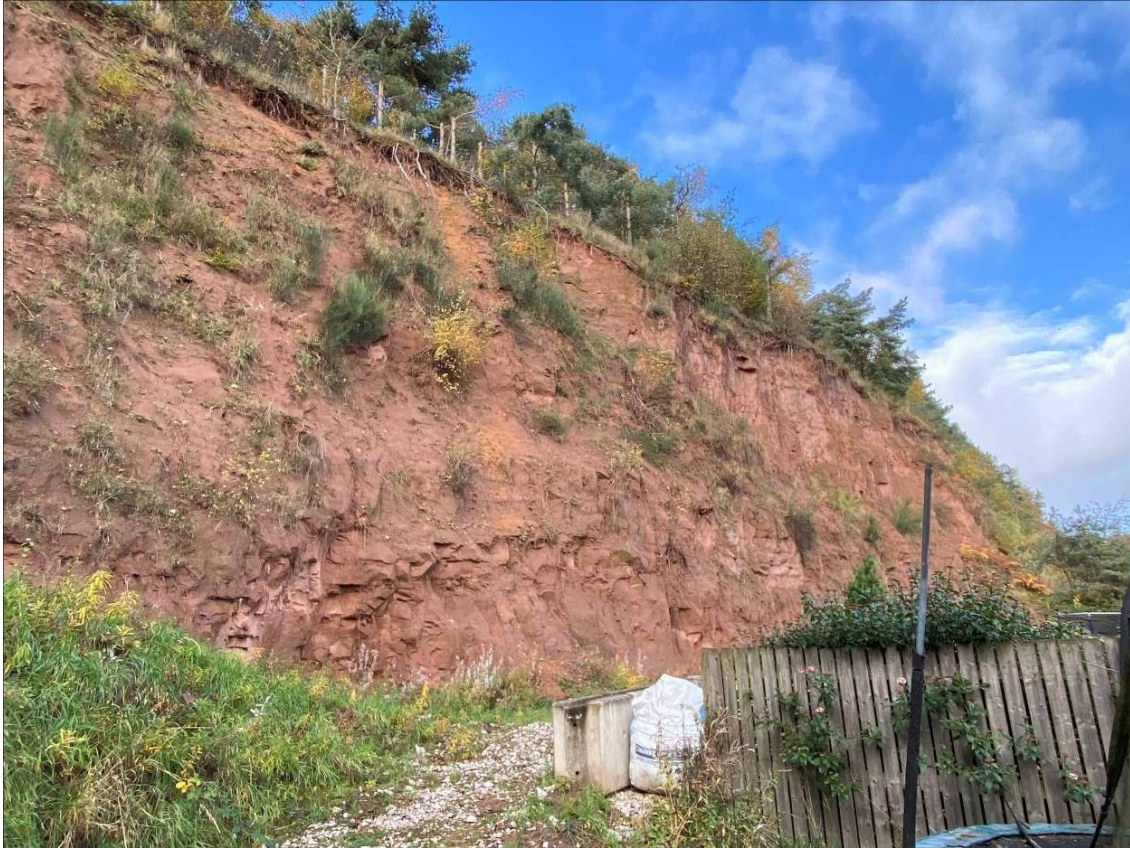
Photograph 4: Looking at the western flank. Note towards the centre of picture the orange streak of sand being washed down the cliff face from what appears to be the soil crust at the crest of the cliff. This is creating talus and sand mound at the toe of the cliff (Image taken on 03/11/2020).

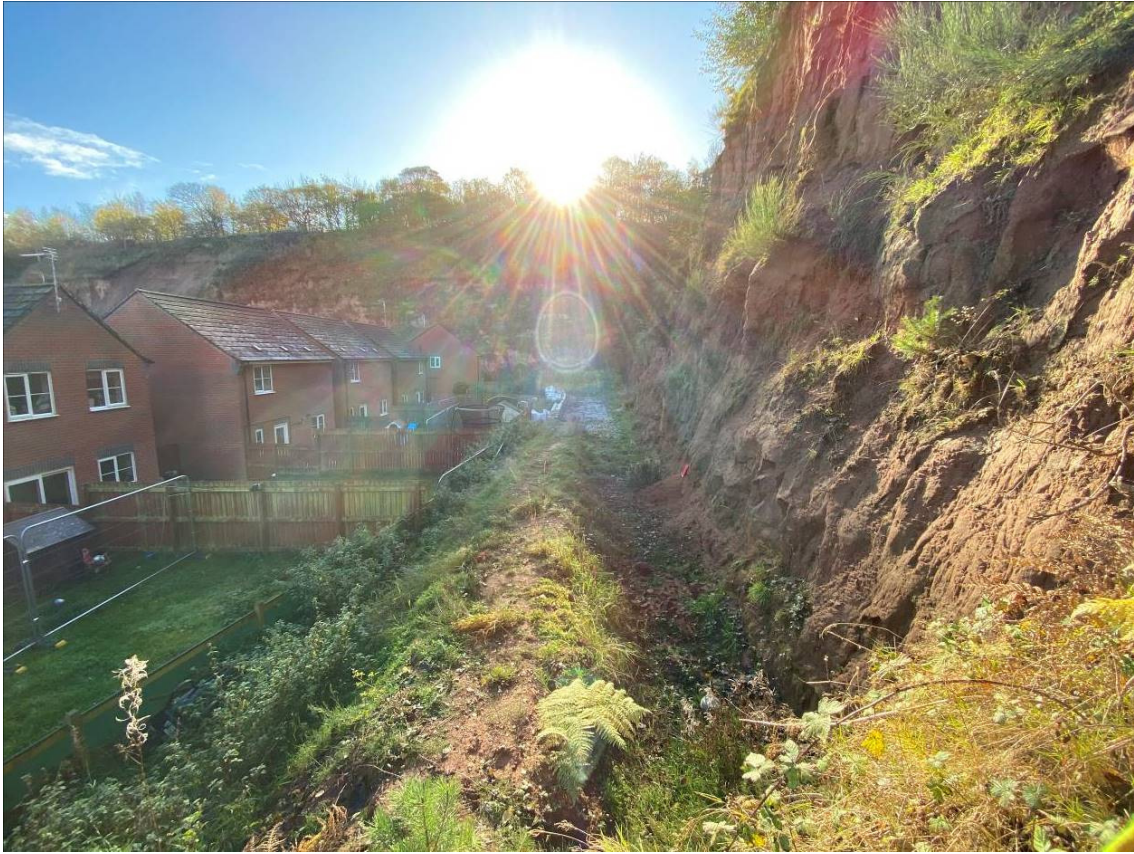
Photograph 5: Looking at the southern flank (background) and western flank (right-hand-side) with temporary earthwork bund and rock trap next to it (Image taken on 03/11/2020)

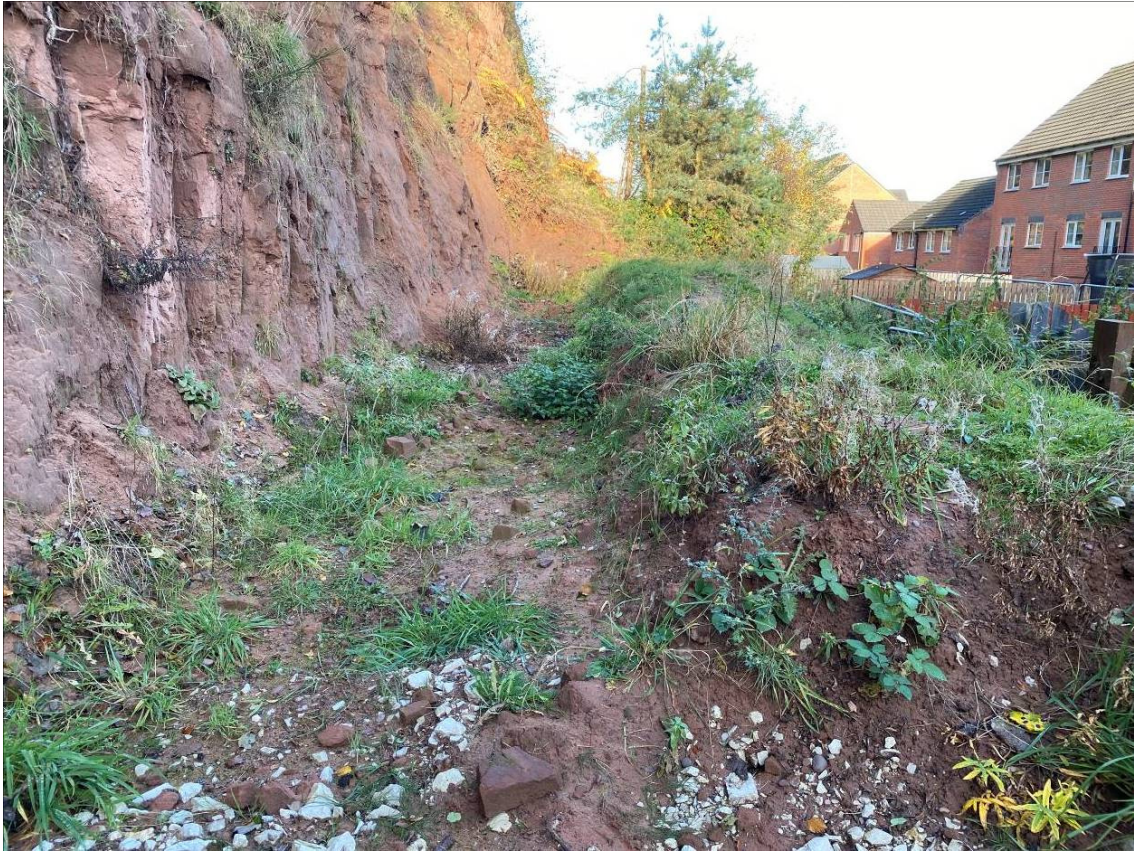
Photograph 6: Looking north to the end of Unit 8. The western flank is to the left-hand-side of the photograph with temporary earthwork bund and rock trap next to it. Note the scattering of small $<30\text{cm}^3$ unravelled sandstone blocks in the rock trap. (Image taken on 03/11/2020).
