FH Reference: 125592	Project : Berryhill Landslip Remedial Works	Date of Site Visit: 15/12/2020
<p>Mansfield District Council (MDC) have appointed Fairhurst to undertake regular site inspections of the quarry wall between completion of the emergency response works (w/e 24th November 2019) and the commencement of the permanent works in this portion of the quarry in early 2020.</p> <p>During a recent inspection on Tuesday 15th of December 2020, the weather was sunny. On days previous to this inspection there had been heavy rainfall in Mansfield.</p> <p>A photographic record of the quarry has been collated and is being updated on inspection and no significant visible changes have been noted from the previous site visit. As per recent visits, cliff faces were noted to be partially saturated with what appeared to be surface water run-off from heavy rainfall from days previous. Small ravelling failures (<1m³) including a fresh mass of material behind Unit 7 (Photo 3) resulting in a c. 2.5m³ tallus contained behind the rock trap bund. The material comprised entirely weathered/residual soil and potentially some overburden soils.</p> <p>Fairhurst are not aware of any reported issues to MDC

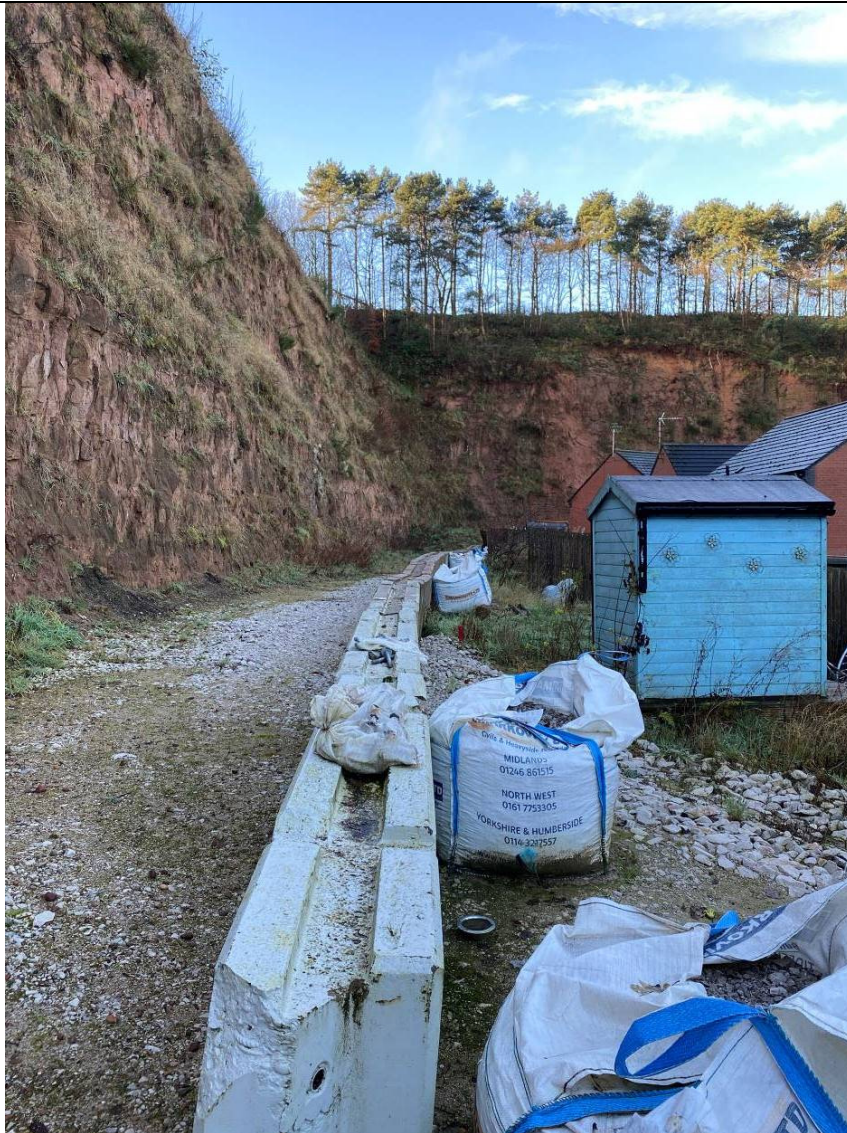
Photograph 1 : Looking along the southern flank of the quarry to the south west corner
(Image taken on 15/12/2020)

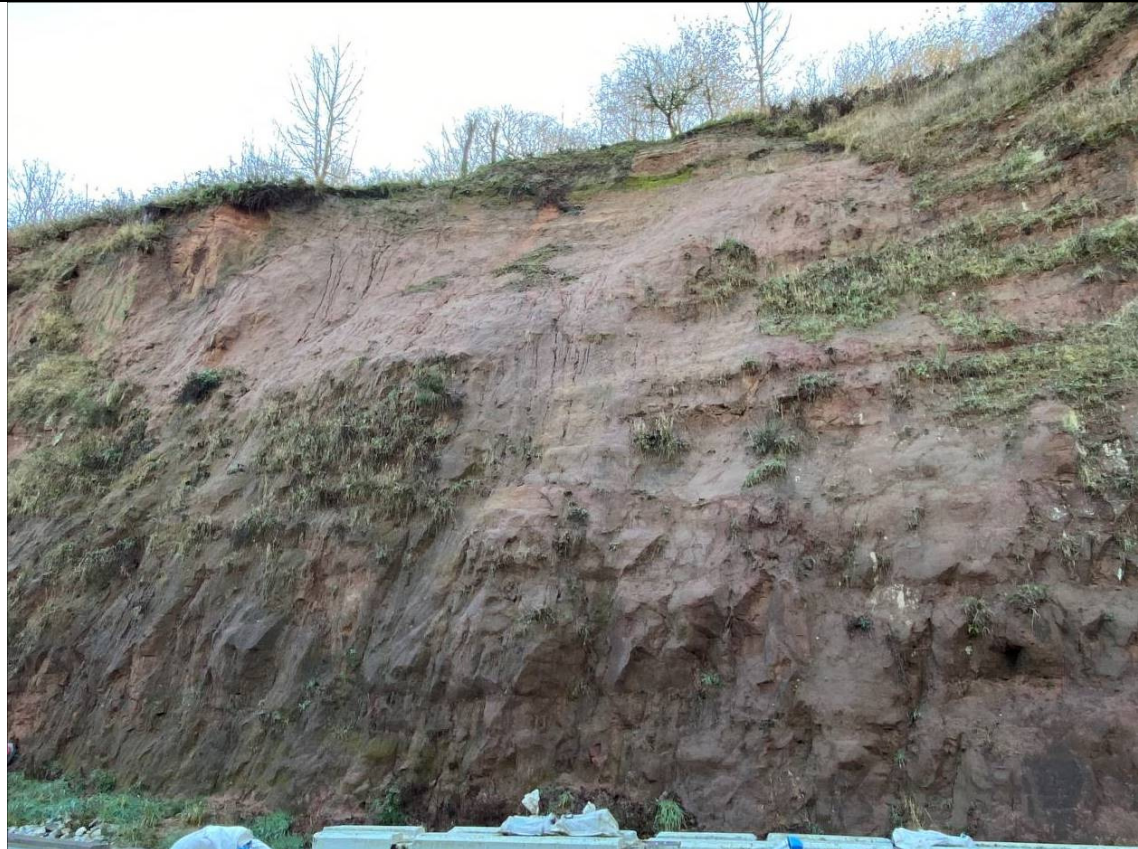
Photograph 2: Previous failure scar which appears to be partially saturated in surface water run-off (Image taken on 15/12/2020)

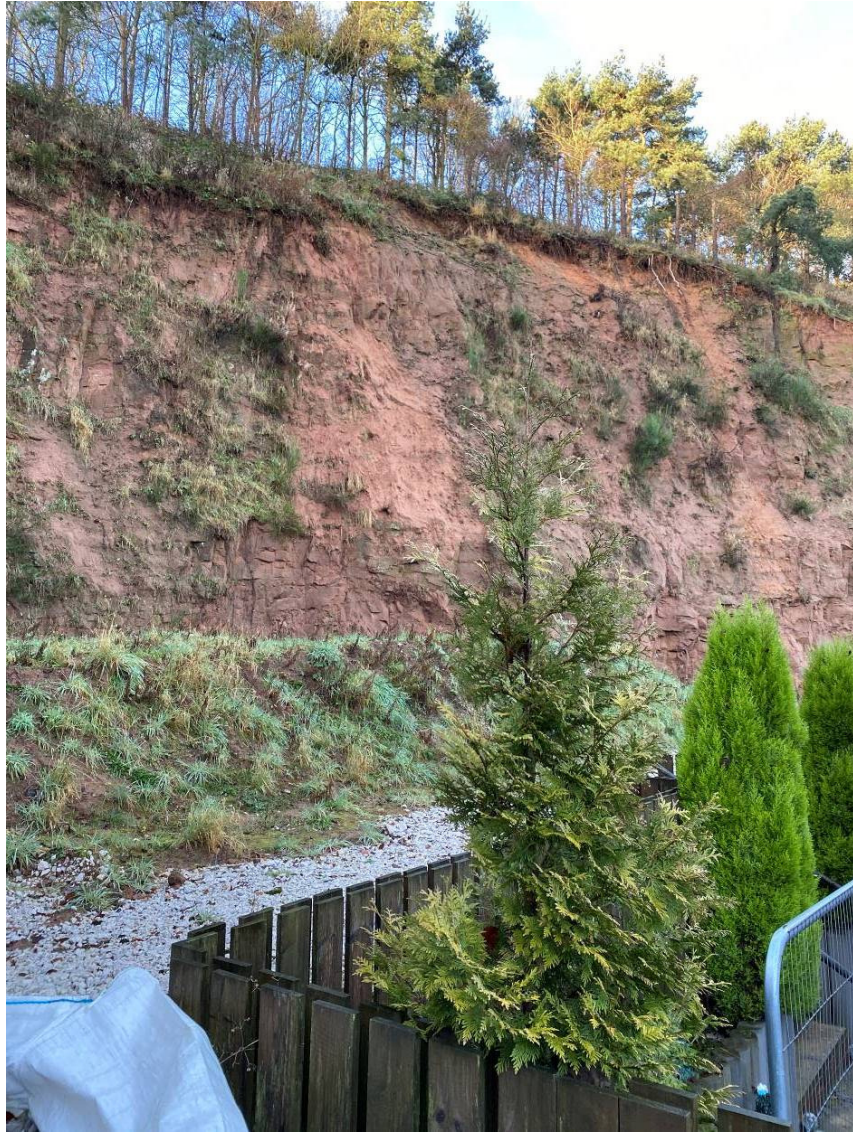
Photograph 3: Looking west to the south west quarry corner (Image taken on 15/12/2020). Note towards the centre of picture the orange streak of sand identifying a small failure resulting in c. 2.5m³ of talus behind the rock trap bund. (Image taken on 15/12/2020).

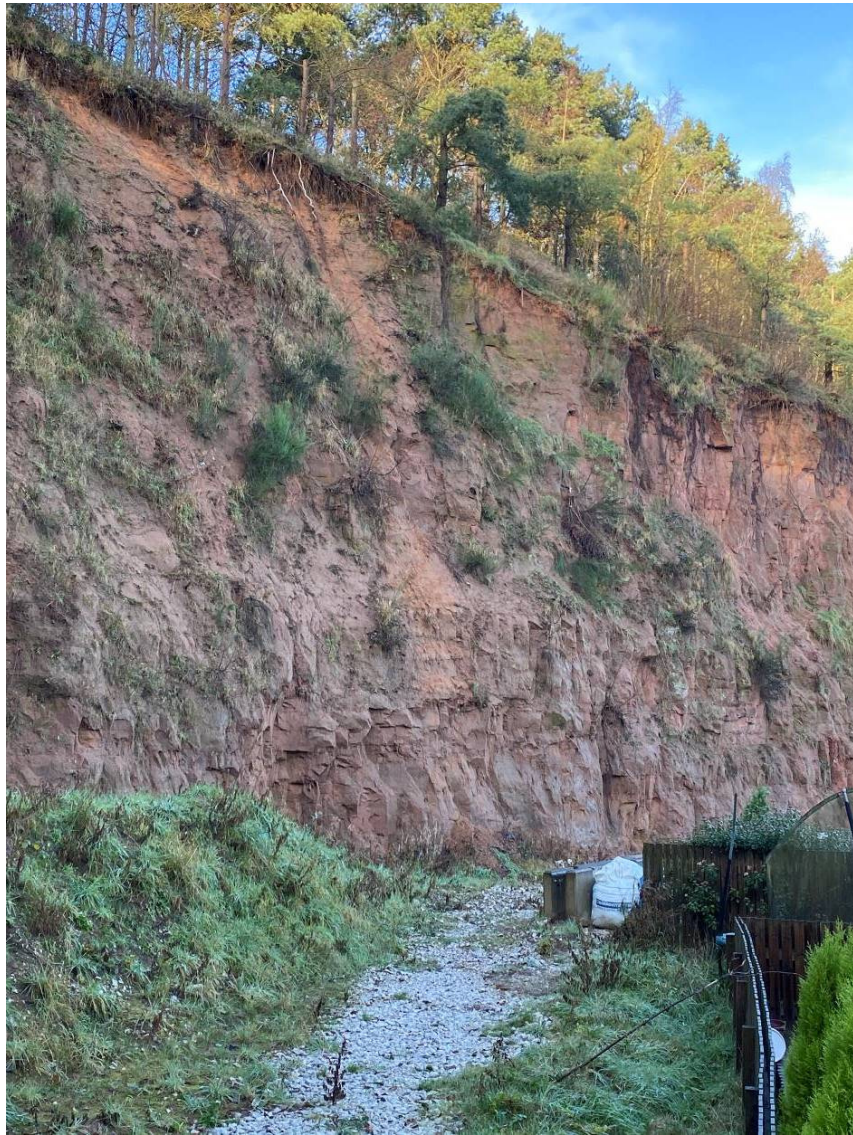
Photograph 4: Looking at the western flank. Note towards the centre of picture the orange streak of sand being washed down the cliff face from what appears to be the soil crust at the crest of the cliff. This is creating talus (a sand mound with rocks in) at the toe of the cliff (Image taken on 15/12/2020). No significant changes since previous inspection evident.

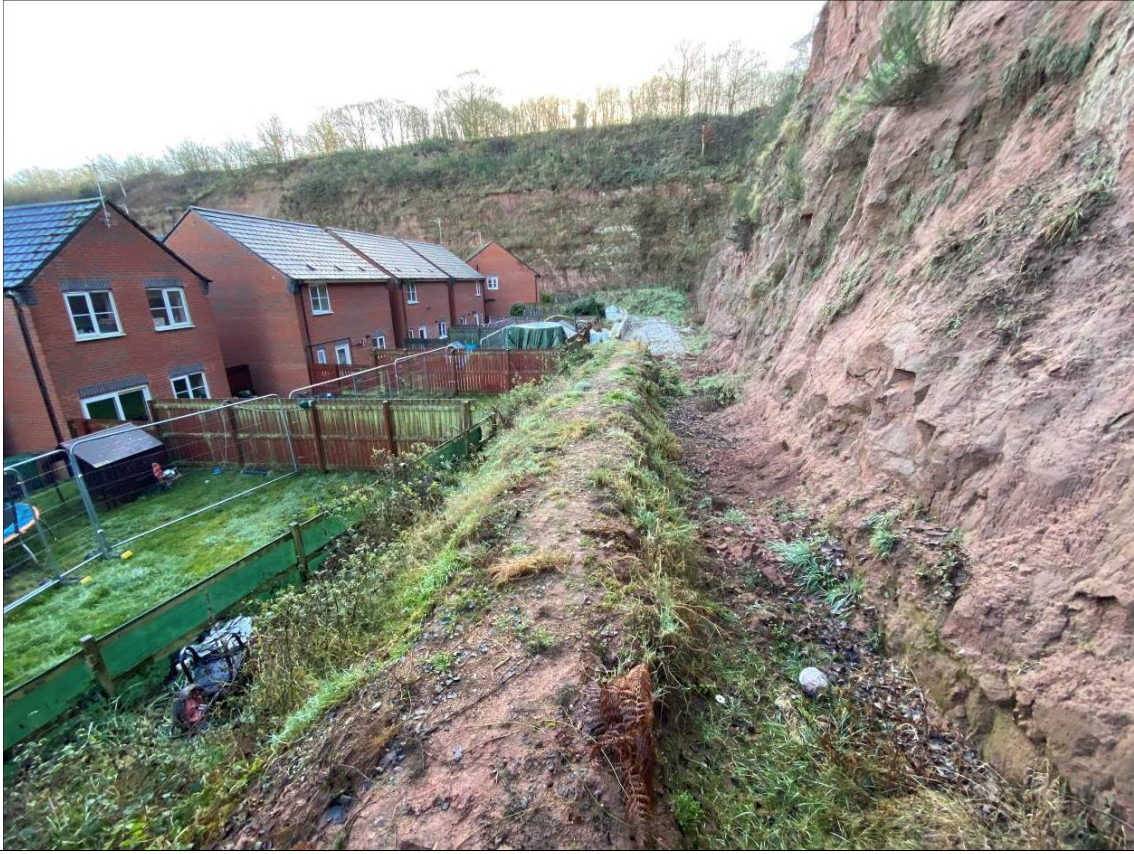
Photograph 5 : Looking at southern flank (background) and western flank (right-hand-side)
(Image taken on 15/12/2020)

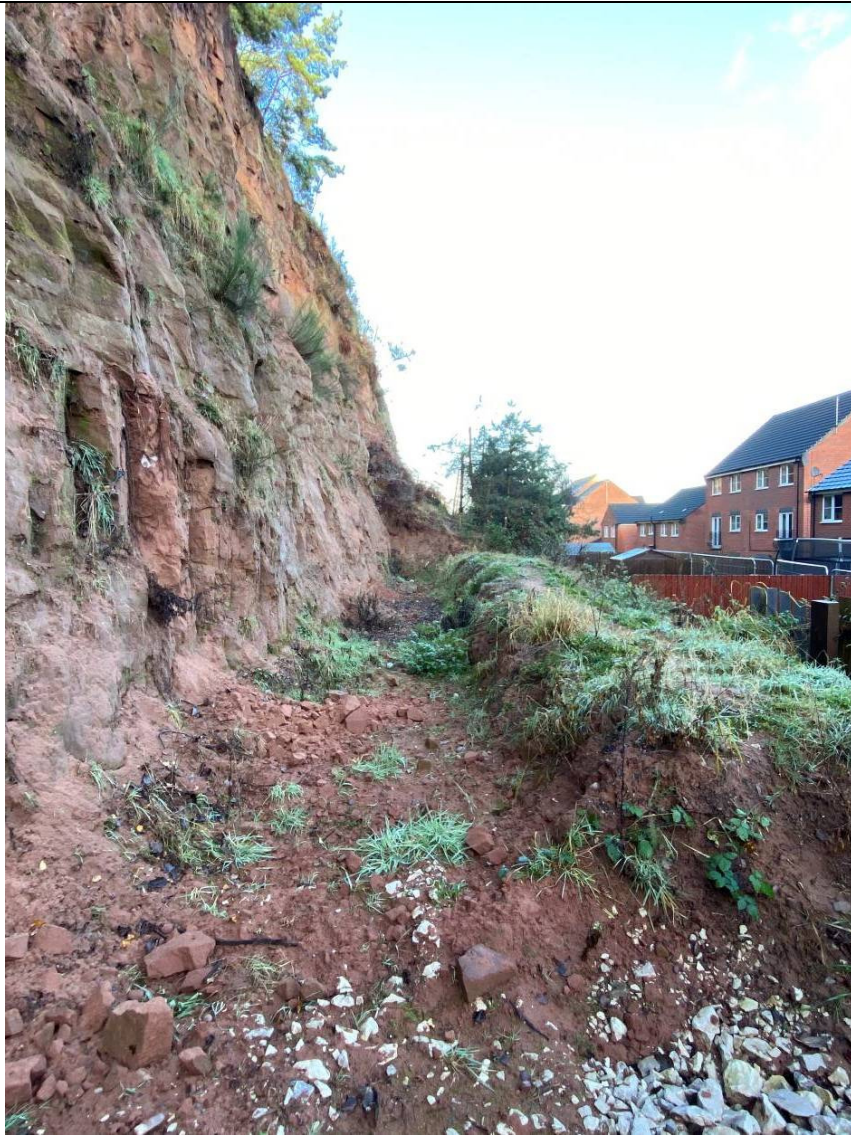
Photograph 6: Looking north to the end of Unit 8. No significant changes noted from previous inspection. (Image taken on 15/12/2020).
