FH Reference: 125592	Project : Berryhill Landslip Remedial Works	Date of Site Visit: 05/01/2021
<p>Mansfield District Council (MDC) have appointed Fairhurst to undertake regular site inspections of the quarry wall between completion of the emergency response works (w/e 24th November 2019) and the commencement of the permanent works in this portion of the quarry in early 2020.</p> <p>A photographic record of the quarry has been collated and is being updated after each weekly routine inspection.</p> <p>During a recent inspection on Tuesday 5th of January 2021, the weather was overcast. On days previous to this inspection there had been heavy rain and light snowfall in Mansfield. As per the last site visit on the 29th of December 2020, the cliff faces were partially saturated with what appeared to be surface water run-off from heavy rain and light snowfall from previous days.</p> <p>As previously reported, a failure of overburden/soil/completely weathered rock from the upper part of the slope occurred on the 23rd December 2020, resulting in mobilisation of emergency response, Fairhurst Engineers and specialist contractors. The failure debris was removed from the rock trap and placed b

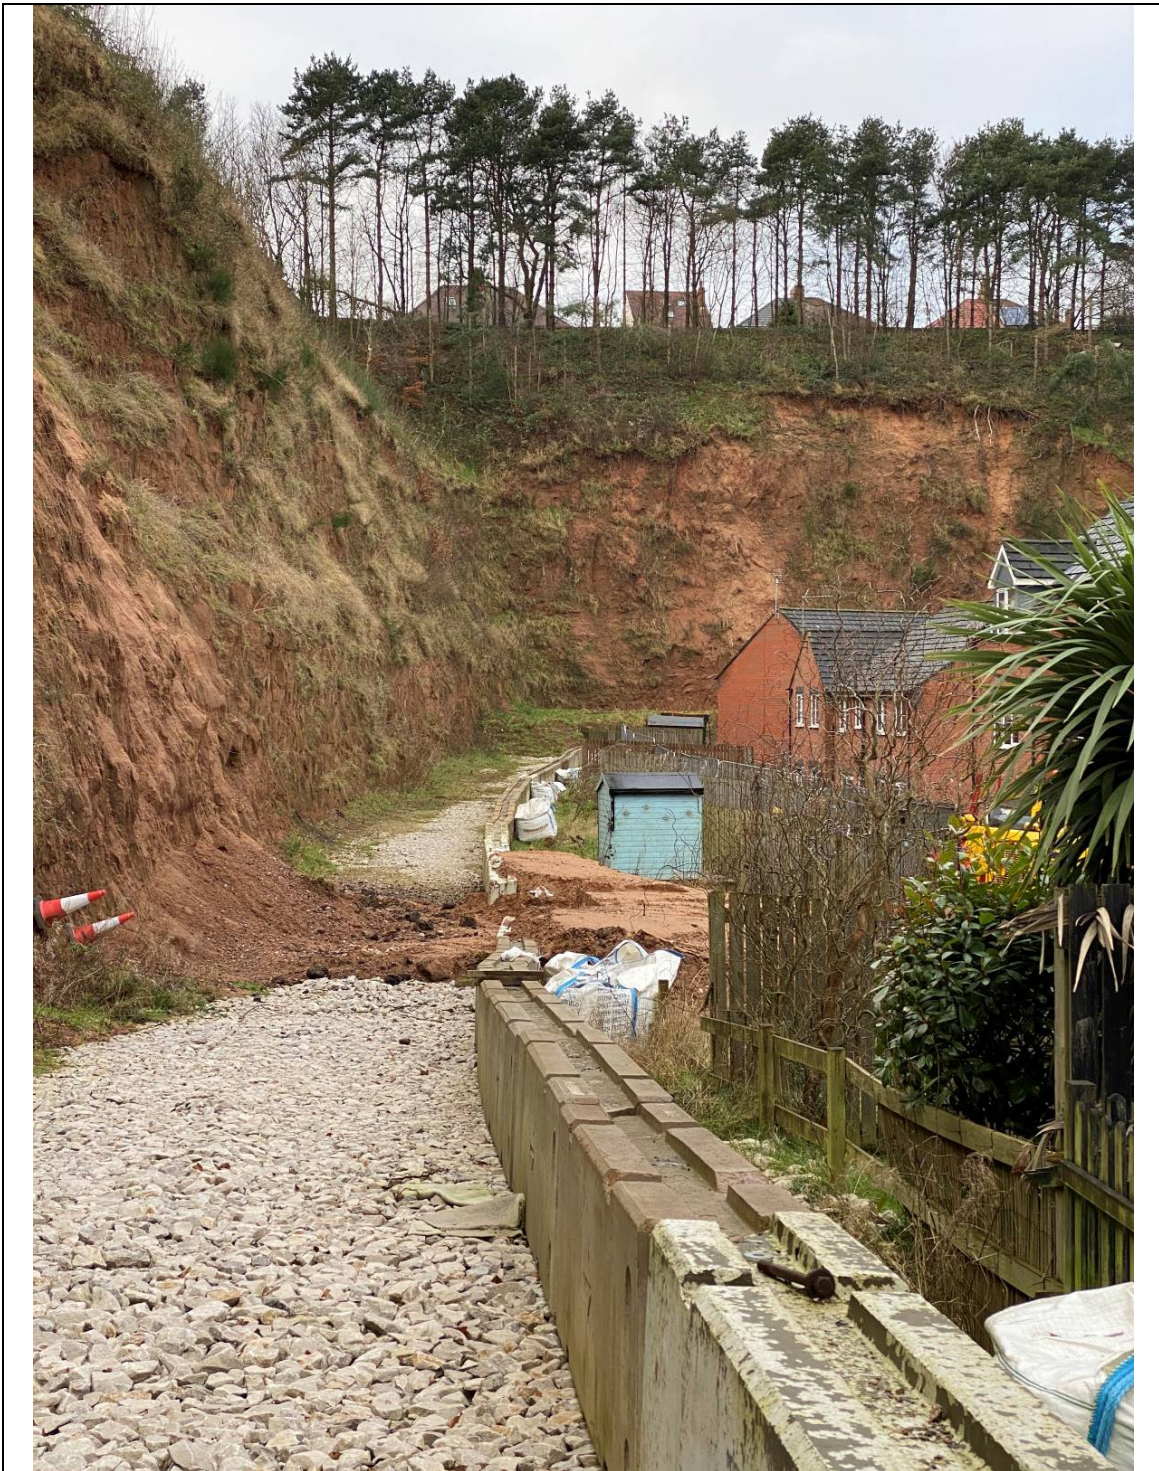
Photograph 1: Looking along the southern flank of the quarry to the south west corner. Note, the small amount ($\sim 3\text{m}^3$) of slope debris at the toe of the slope, contained within the rock trap. The debris has amassed following the clear up operations from a recent failure on the night of 23rd of December 2020 and originates from the residual material at the crest of the recent failure scar (Image taken on 05/01/2021)

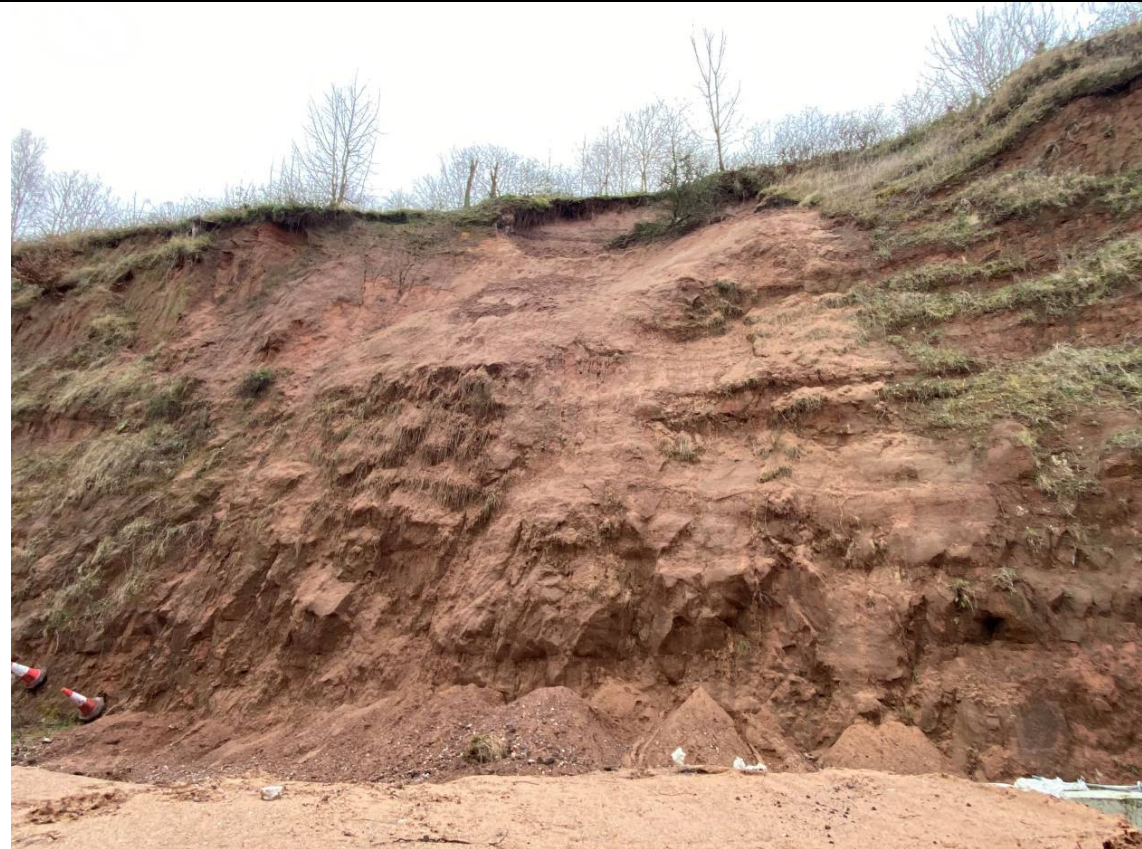
Photograph 2: Previous failure scars which appears to be partially saturated in surface water run-off from recent rain and snowfall. Note the small amount of failure debris ($\sim 3\text{m}^3$) at the toe of the slope which has amassed since the clear up operation of a recent failure on the 23rd of December 2020. (Image taken on 05/01/2021)

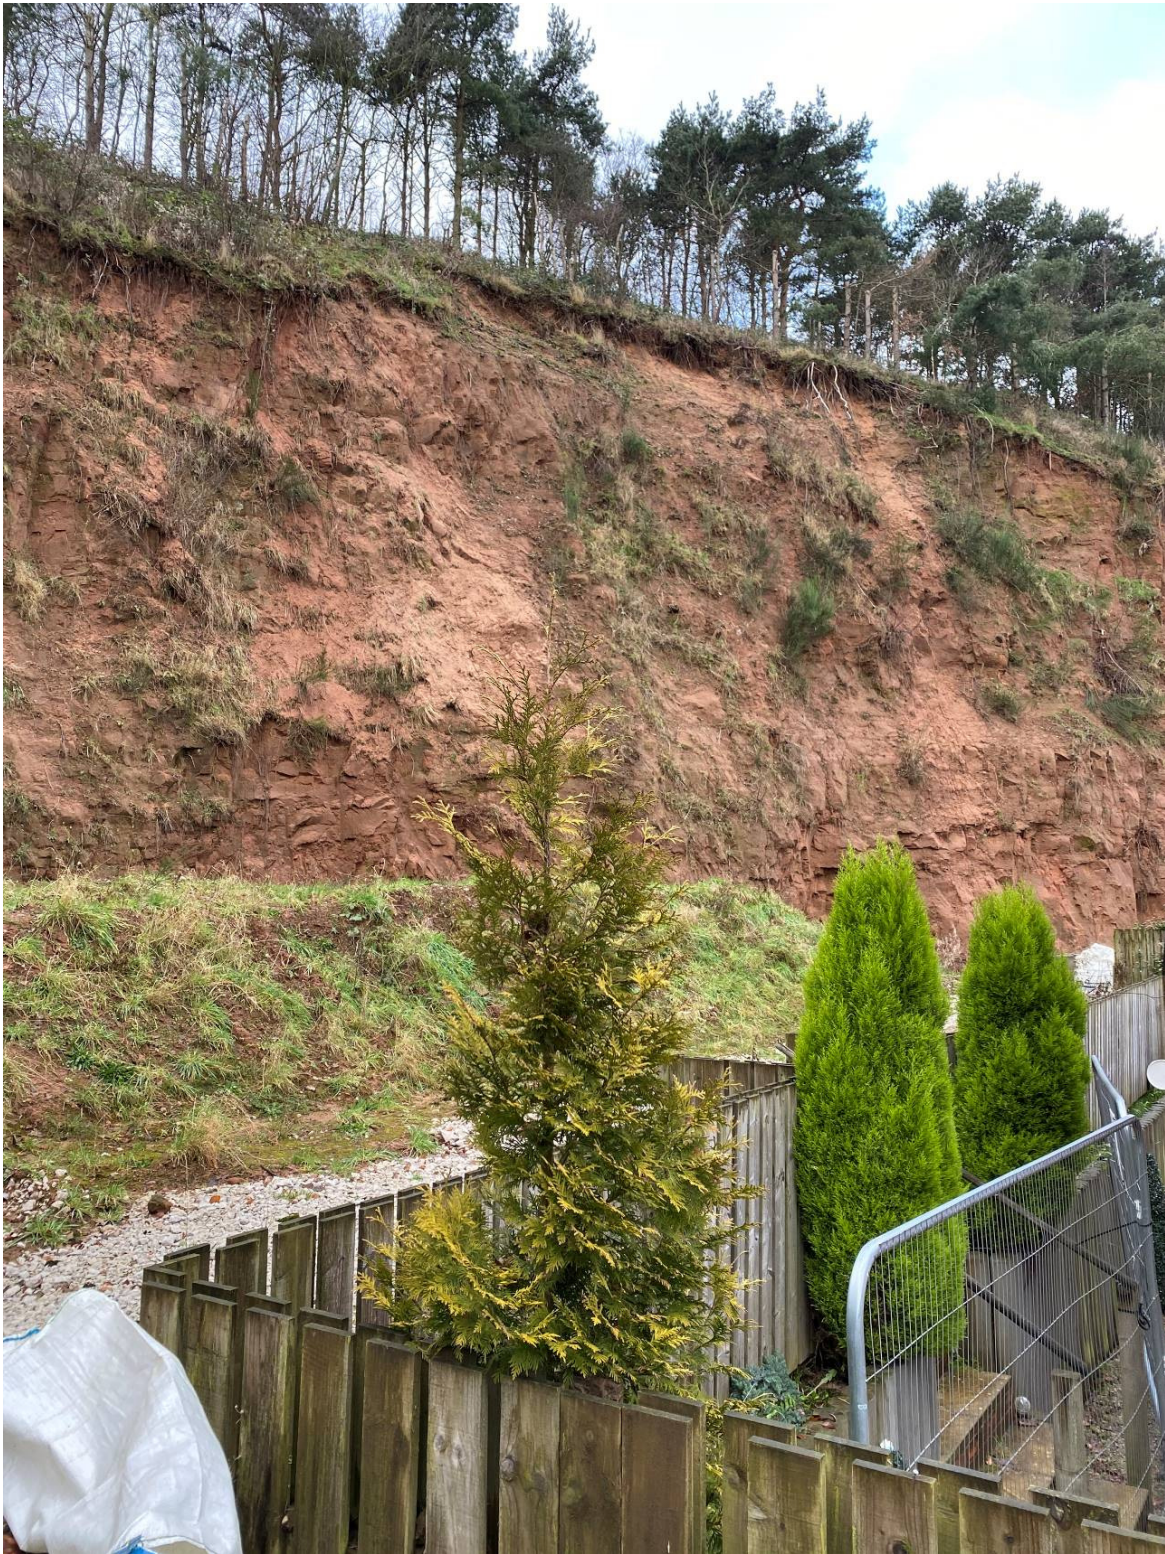
Photograph 4: Looking at the western flank where sand had previously been washed down the cliff face. No additional debris was on top of the talus at the toe of the cliff (Image taken on 05/01/2021).
