### **Mansfield District Council**

### Conservation Area Character Appraisal and Management Plan.

### Mansfield Woodhouse Conservation Area

November 2011

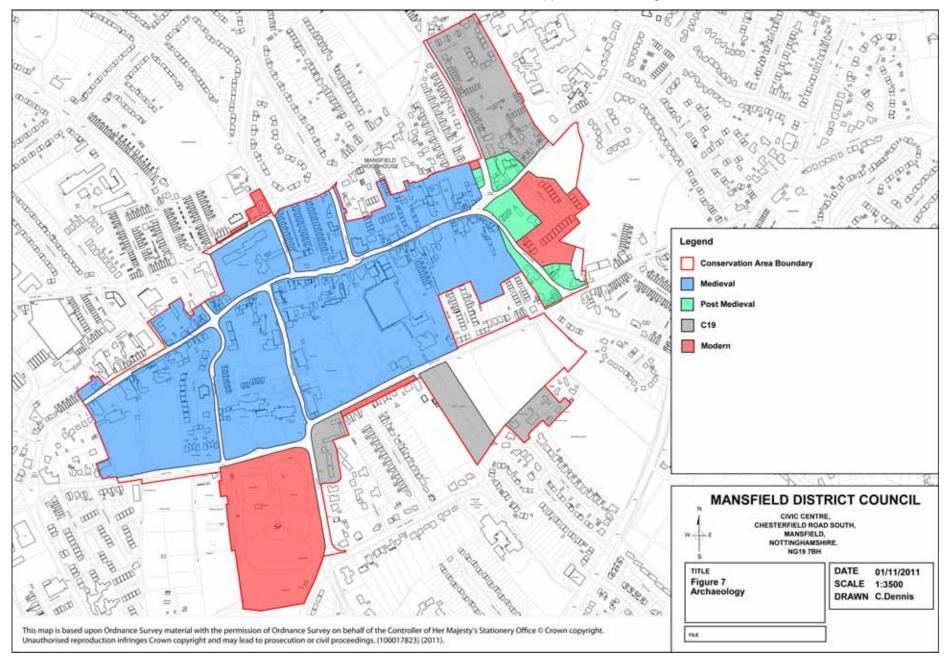
- 4.28 A record of all known archaeology is held at the Sites and Monuments Records kept by Nottinghamshire County Council. However, such is the richness of historical evidence, below and above ground that any proposals for future development must consider and take the opportunity to understand more about the history of the area. Figure 7 'Archaeology' indicates the phases of development.

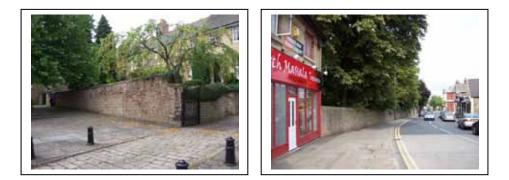
#### 4.117 Street Surfaces

Like the buildings, there is a consistent use of stone paving materials on Station Street and High Street with riven stone particularly prominent in the area of the old cross on Church Street and the pavements near Clerkson's Hall and High street. York stone paving is also used extensively in the area of Albert square and Kerb edges are also of stone. Limestone sets have been used under archway entrances to the yards off High Street and Albert Street.

- 4.130 Mansfield Woodhouse is fortunate to have a good number of areas that have retained their York stone riven paving and natural kerbs. There are also entrances in to yards and properties that have retained their stone sets. However, some footpaths have tarmac surfacing with concrete kerbs and stone sets are rarely seen except on Church Street and yard entrances on High street and Albert Street. Even here, once further in to a yard the surface returns to tarmac. Where original surface paving is present this should be retained and traditional paving reintroduced when the opportunity arises.

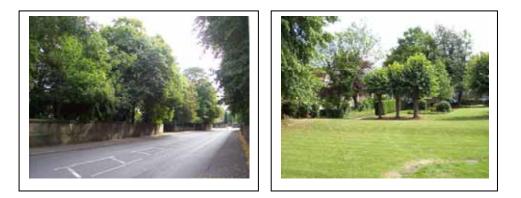
4.121 Mansfield Woodhouse Conservation Area has numerous mature trees, many planted in private gardens but that can be seen in street views, often overhanging stone walls along Priory Road, Church Street, Station Street, High Street and other areas. These include sycamore, yew, beech and lime trees. Their contribution to the appearance and character of the area is significant for they provide natural beauty in their colours affecting changes in the sunlight through shade. Those trees protected by Tree Preservation Orders (T.P.O) are plotted on plan at Figure11 and at appendix B.

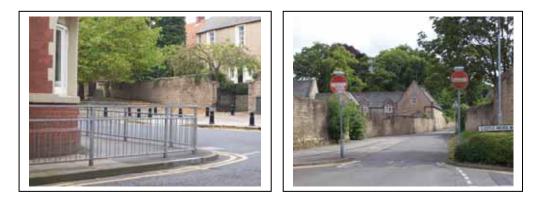
- 4.131 Excessive or unnecessary road markings can harm the appearance of the Conservation Area. Road markings should generally be avoided unless there is no alternative solution to be found. Road markings should only be implemented where there is a statutory requirement to do so and then only to the minimum required to achieve compliance. The District Council and Nottinghamshire County Council should seek ways to reduce the visually negative impact of road markings within the Conservation Area. For example, 50mm wide double no parking lines could be used in a rosemary colour rather than standard 100mm double yellow lines. There is a lack of consistency in the use of highway lighting columns with some standard off the shelf style columns and some of a more traditional style. The use of standard 'off the shelf' lighting columns, excessive traffic signage and pedestrian guard rails detracts from the visual guality of the Conservation Area. For example, pedestrian guard railing on the corner of Church Street and High Street adjacent to the former Portland Hotel detracts from the visual quality of this area. There is similar guard railing outside the grade II listed Burnaby house that detracts from its setting.

Street furniture including bollards, bins and seating, together with traffic signs should be rationalised to avoid clutter and use a uniform high quality design and finish. The duplication of traffic signs harms the appearance of the Conservation Area.

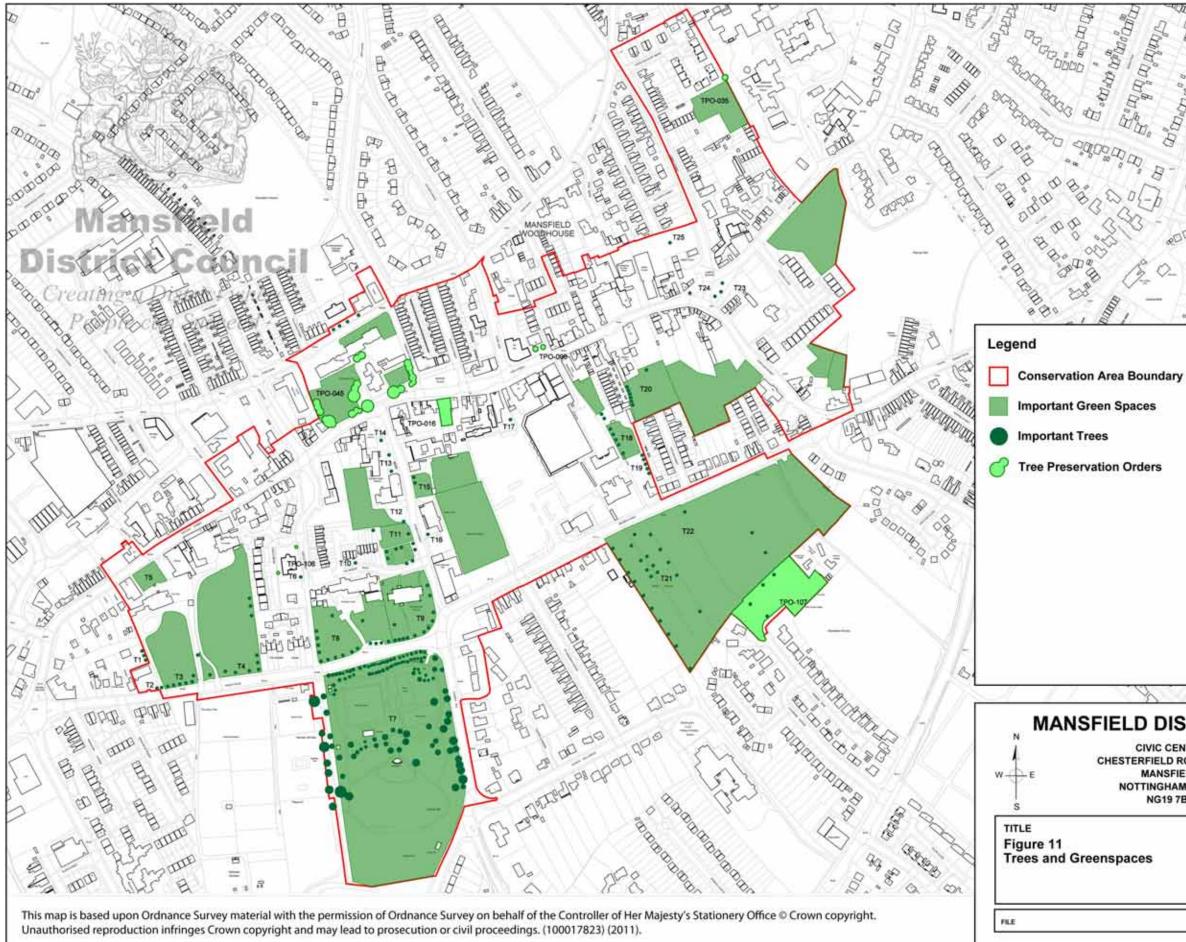
- 4.119 Mansfield Woodhouse is blessed with a variety of green spaces that provide a soft and natural contrast to the buildings and streets. It is the quality of buildings and green spaces and the relationship and balance between them that makes the settlement special.
- 4.120 Individually, the large garden plots of properties, planted with mature trees and hedgerows make a significant contribution to the character of the Conservation Area. The large green spaces on Church Street, Priory Road and Welbeck Road are too important to lose and should be protected from development that would cause them harm. These green spaces make a special contribution to the character and appearance of the Mansfield Woodhouse Conservation Area and they are plotted on plan at figure 11.

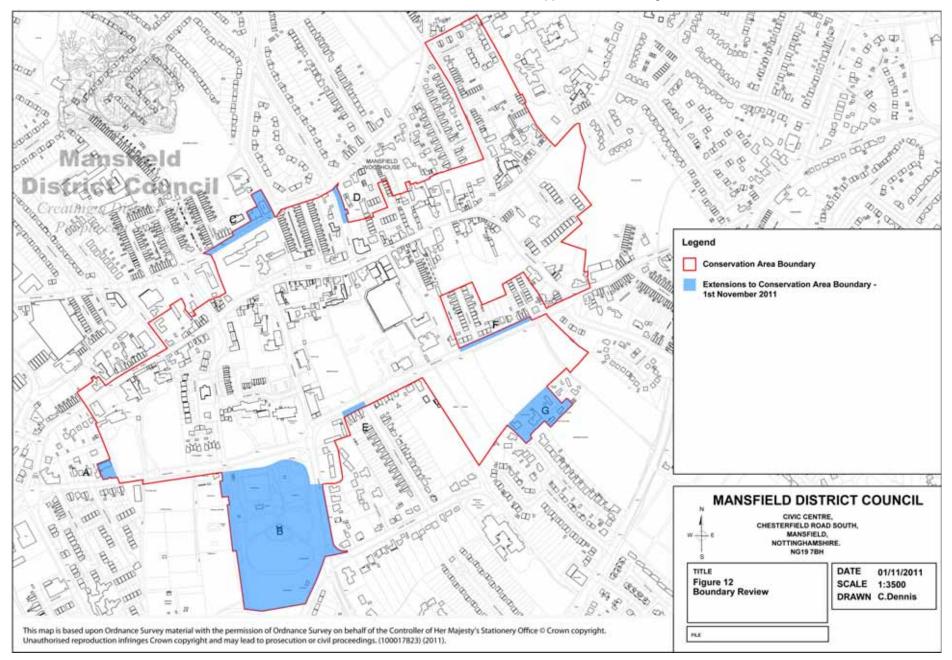
- 5.4 **Area B** The Conservation Area boundary has been extended to include land and structures within Yeoman Hill Park and land and walls on Church Hill, marked B on figure 12. Yeoman Hill Park is a designed landscape of the early C20 and retains its 1930's art deco bandstand (recently restored). Unaltered in its design since it was originally laid out, this park is an important green space and set piece of its time and while the war memorial and lime trees that are close to Priory Road are already within the Conservation Area it is recommended that the Conservation Area be extended to include the rest of the Park which has a number of mature trees that make a significant contribution to the character of the area. Church Hill is enclosed by high stone boundary walls either side of the road which combined with the views towards St Edmunds Church to the north make a significant contribution to the character and appearance of the area,

- 5.8 **Area F** The Conservation Area boundary has been extended to include the stone walls to front gardens of numbers 7- 27 Welbeck Road as they make a positive contribution to the views, character and appearance of Welbeck Road at its east end; Land marked E at figure 12.

- 5.9 Area G The Conservation Area boundary has been extended to include land and buildings at Leeming Park within the Conservation Area on land marked F at Figure 12. This includes the C19 Old Vicarage and adjacent properties; the Old Vicarage is an architecturally grand Arts and Crafts gothic style stone building standing on the bough of the hill above Millennium Green commanding views to the north and is historically associated with St Edmunds Church. A gate in to the field allowed access from the Old Vicarage down to Welbeck Road. This building and adjacent properties are relevant to the C19 expansion of the Settlement.
